**RE: Northeast Quadrant Flood Risk Mitigation Project,
Phases 3&4 – Levee (Dike) Stability and Seepage Analysis**

Township of Cranford NJ

Levee Reliability Study

SLOPE STABILITY AND SEEPAGE ANALYSIS REPORT

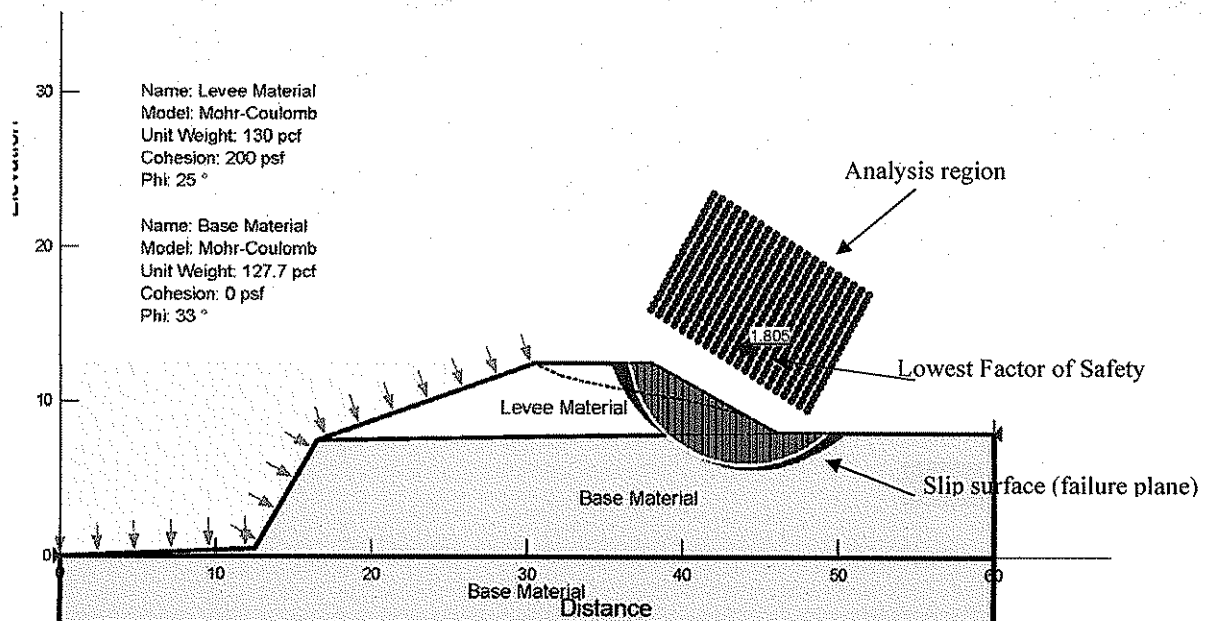
This figure shows the two materials, the water level and the slip circle with the lowest factor of safety. The grid of red dots shows the region where the potential failure circles were centered.

The lowest factor of safety is shown as a brighter red dot with the value beside it.

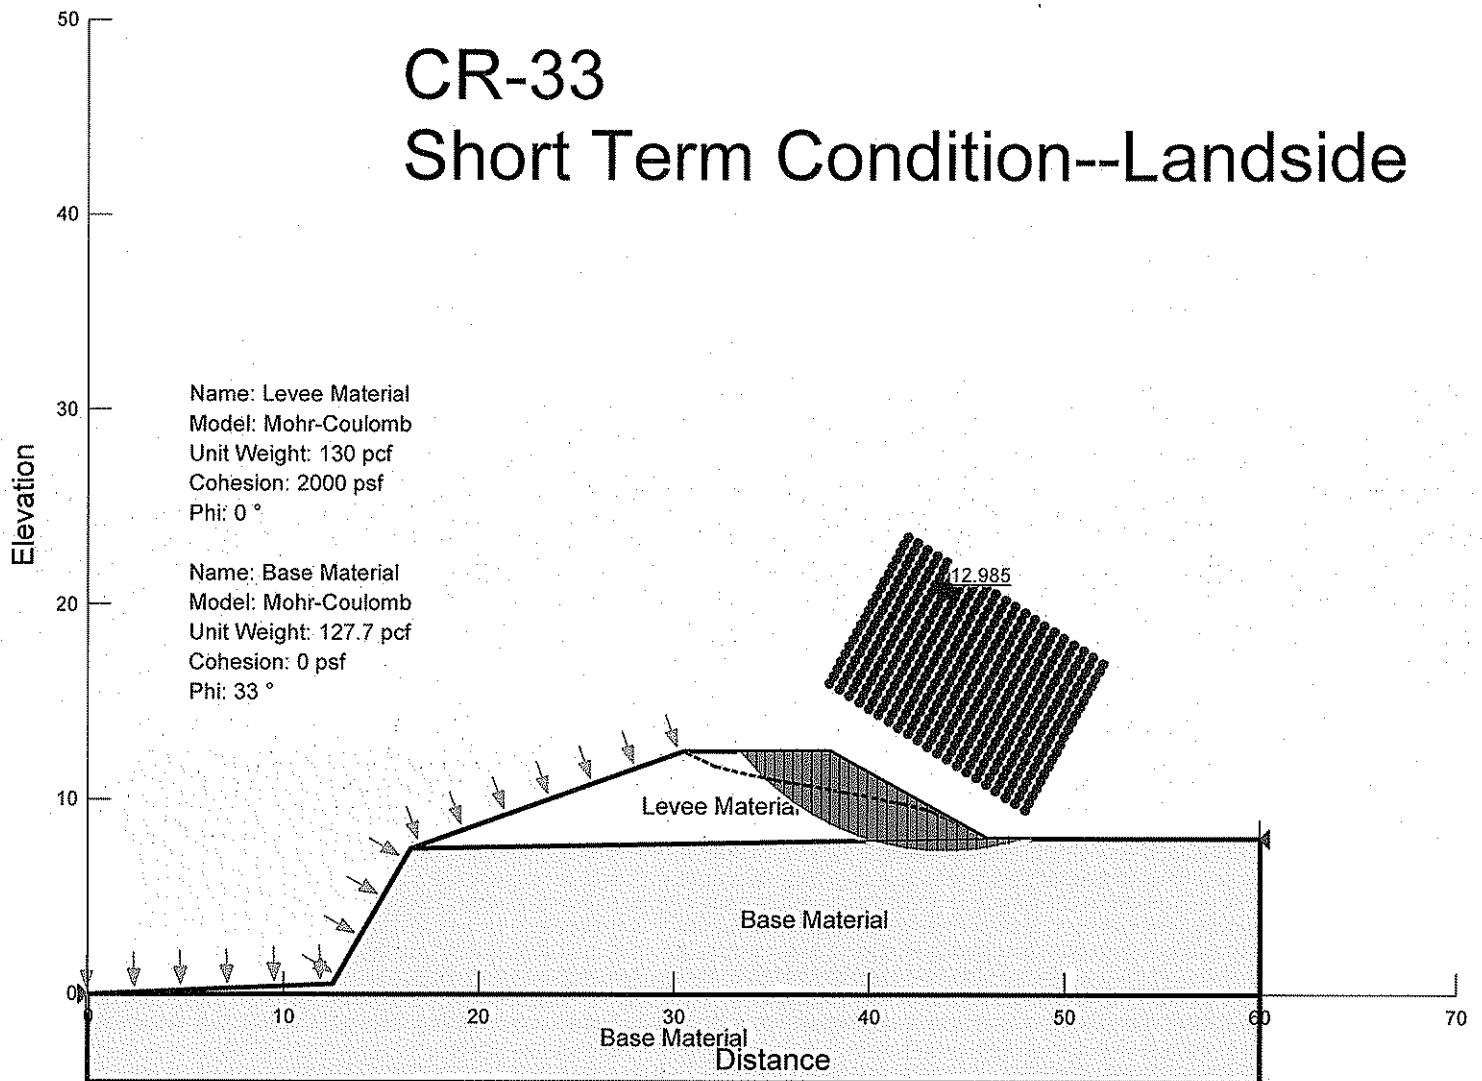
CR-33

Short Term Condition--Landside

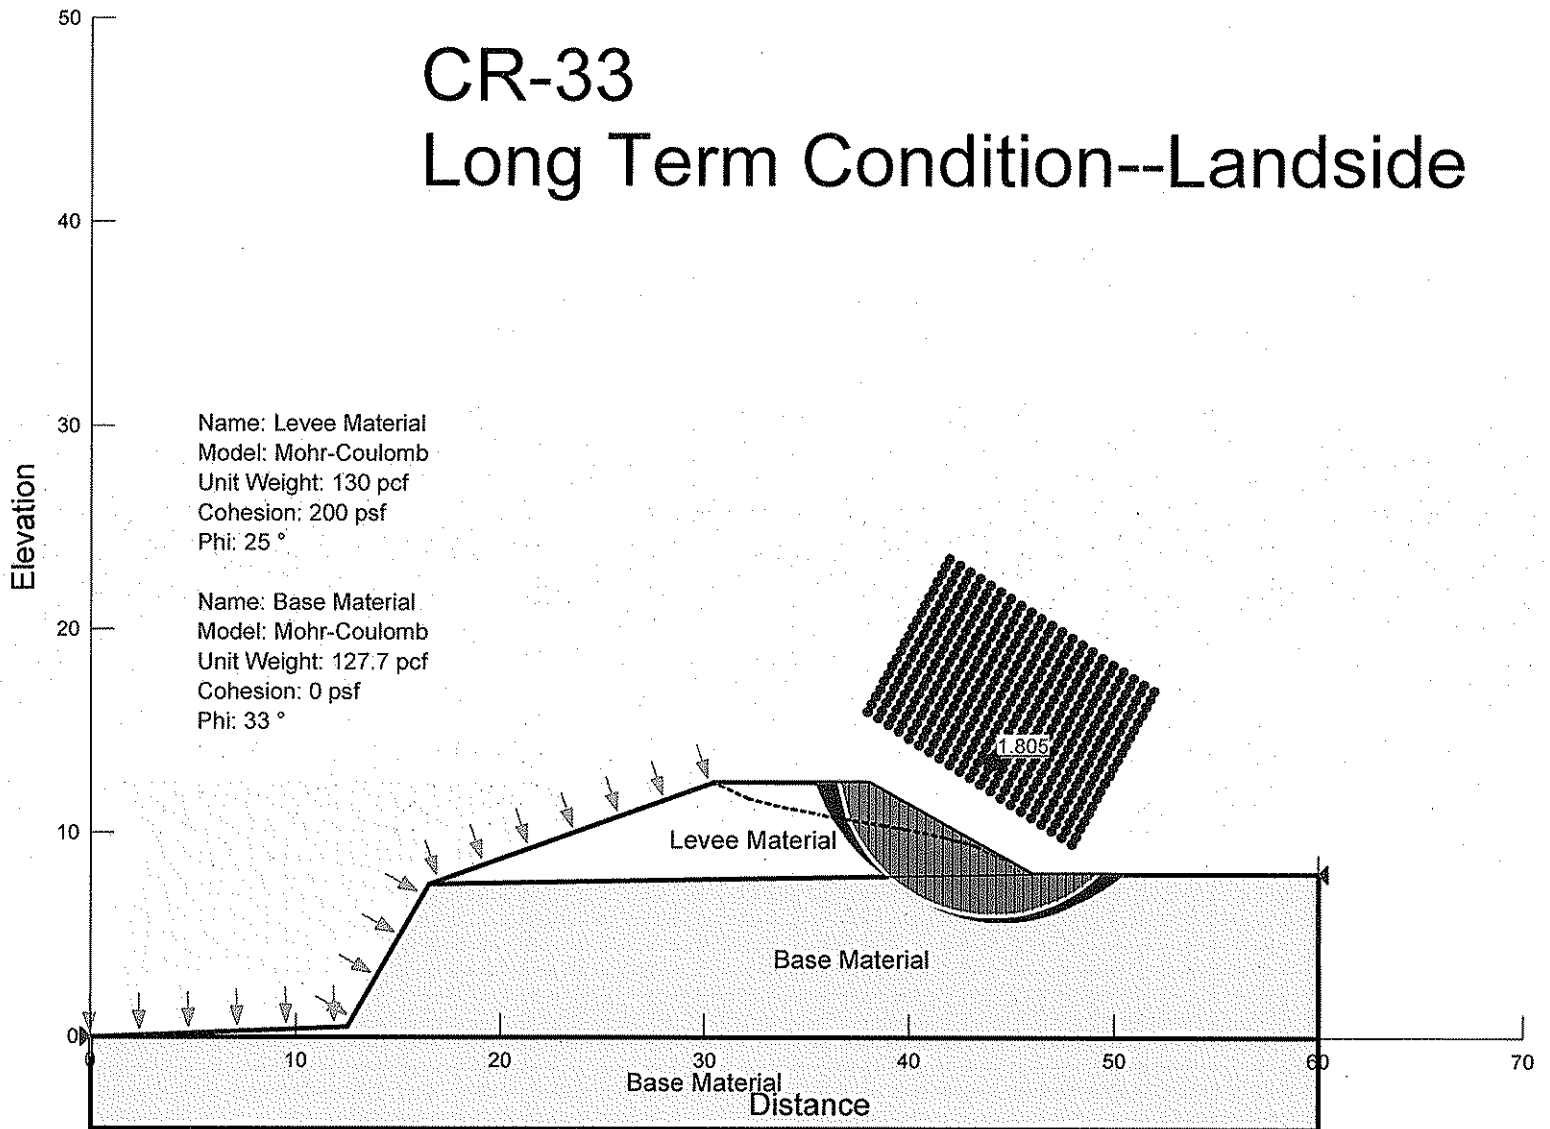
CR-33

Long Term Condition--Landside

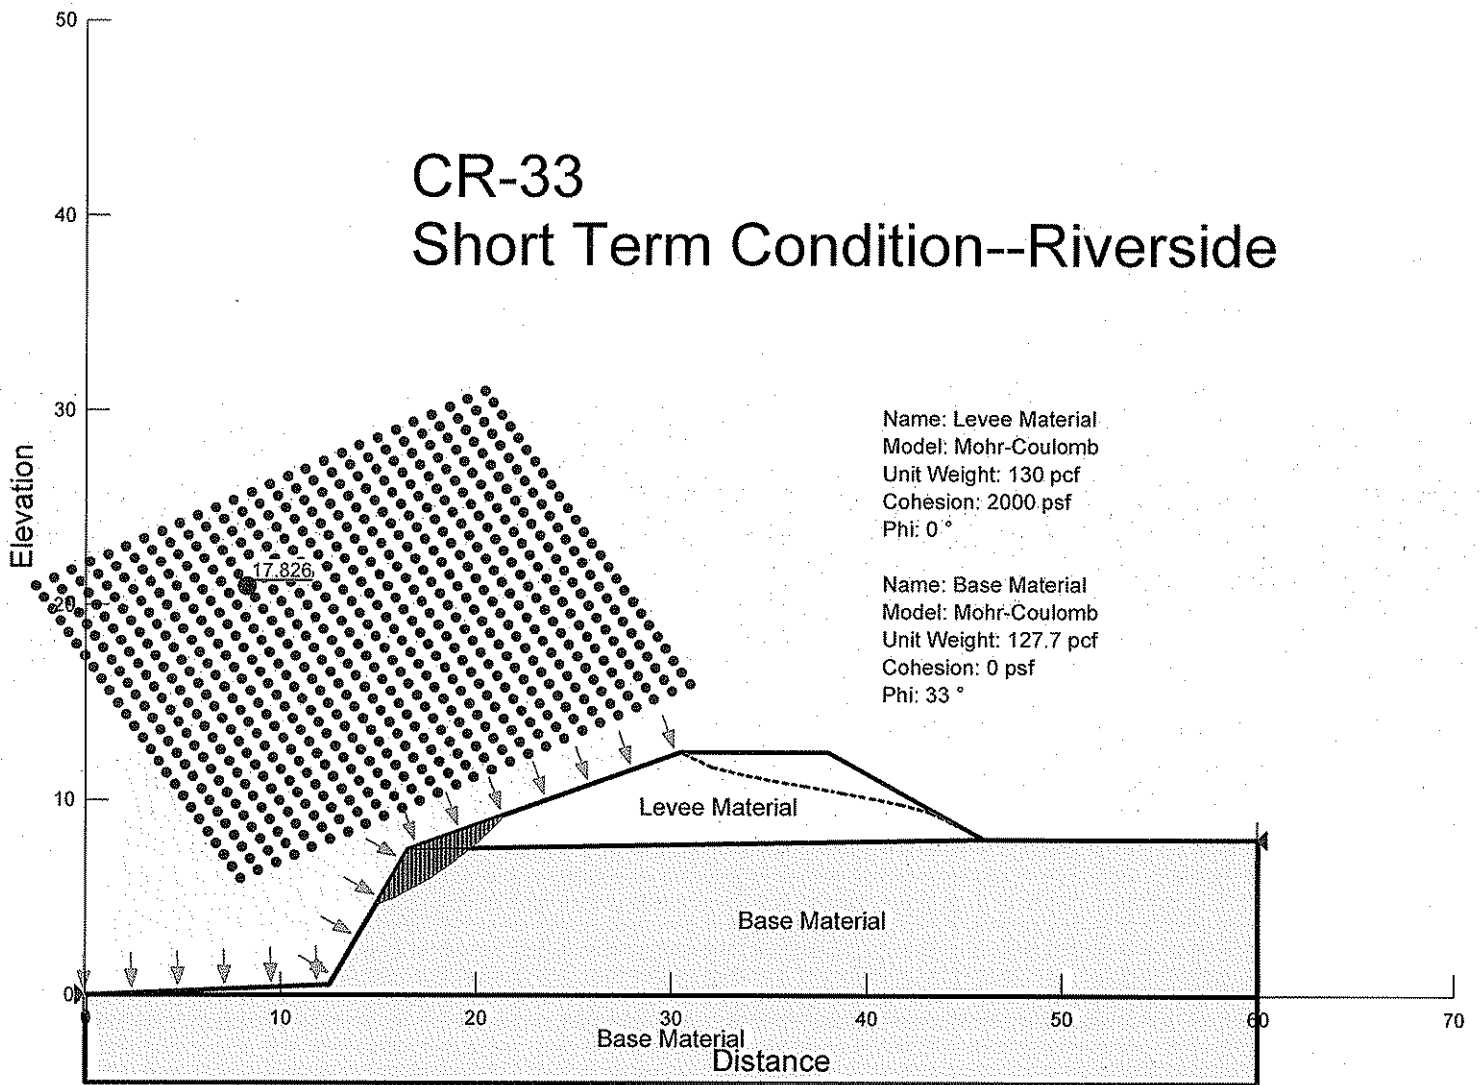
CR-33

Short Term Condition--Riverside

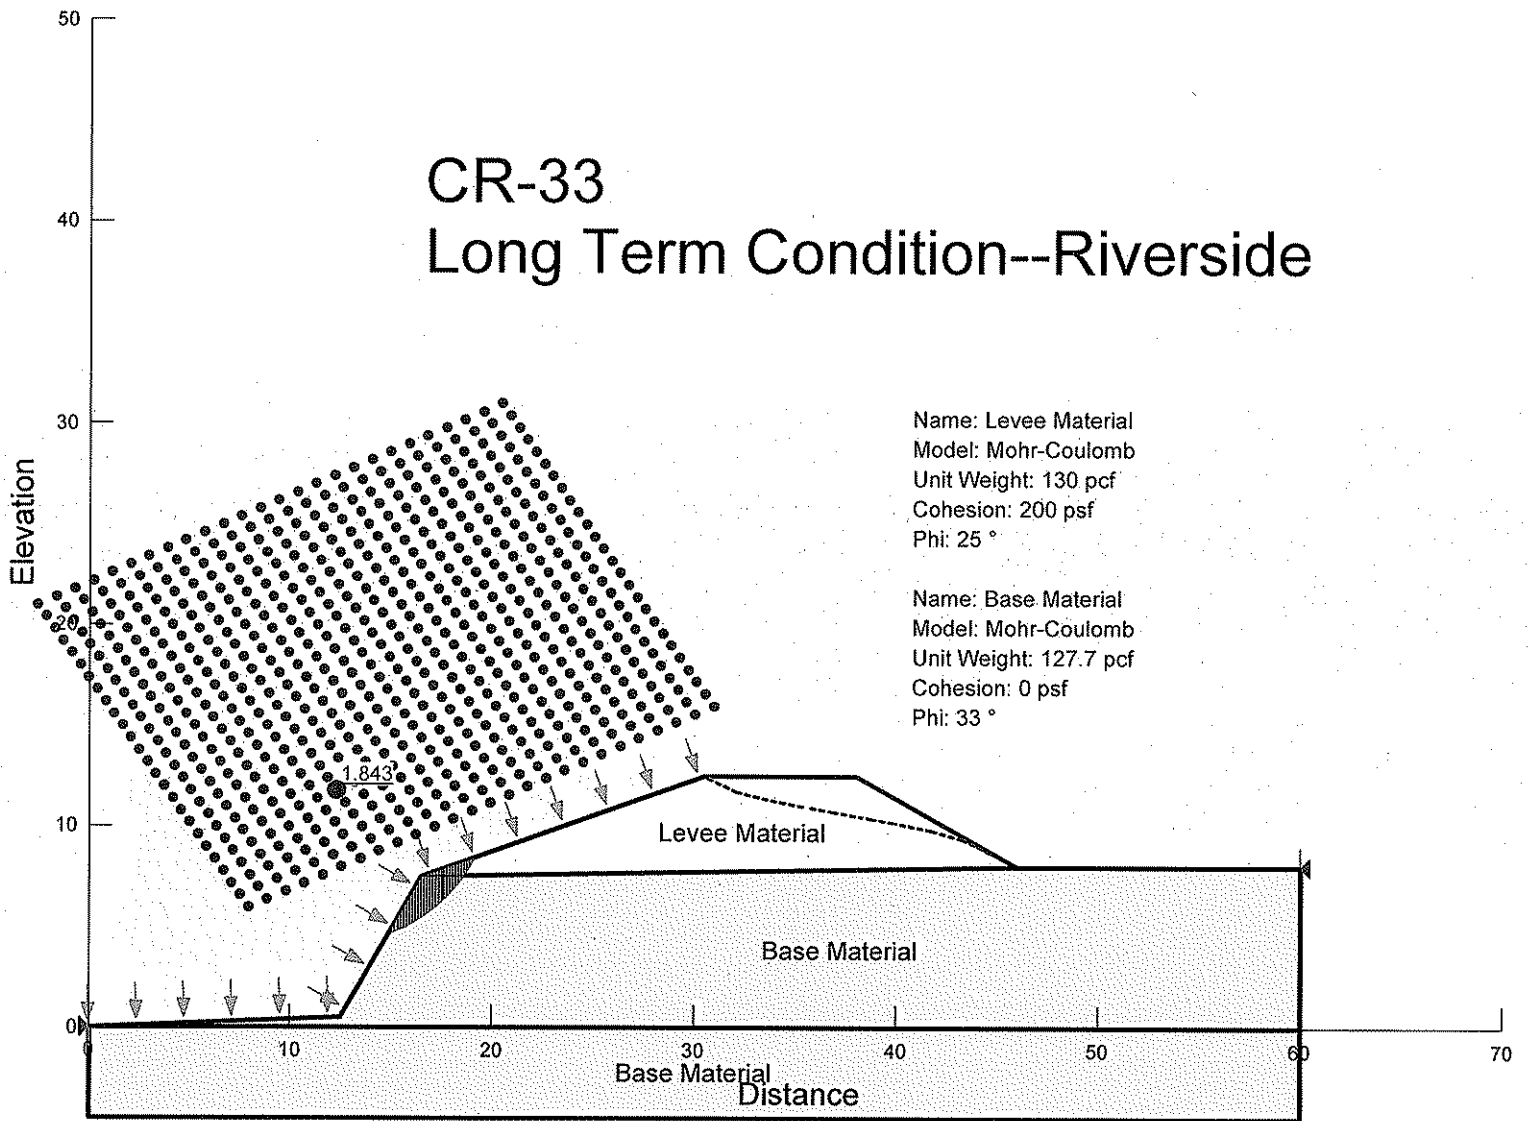
CR-33

Long Term Condition--Riverside

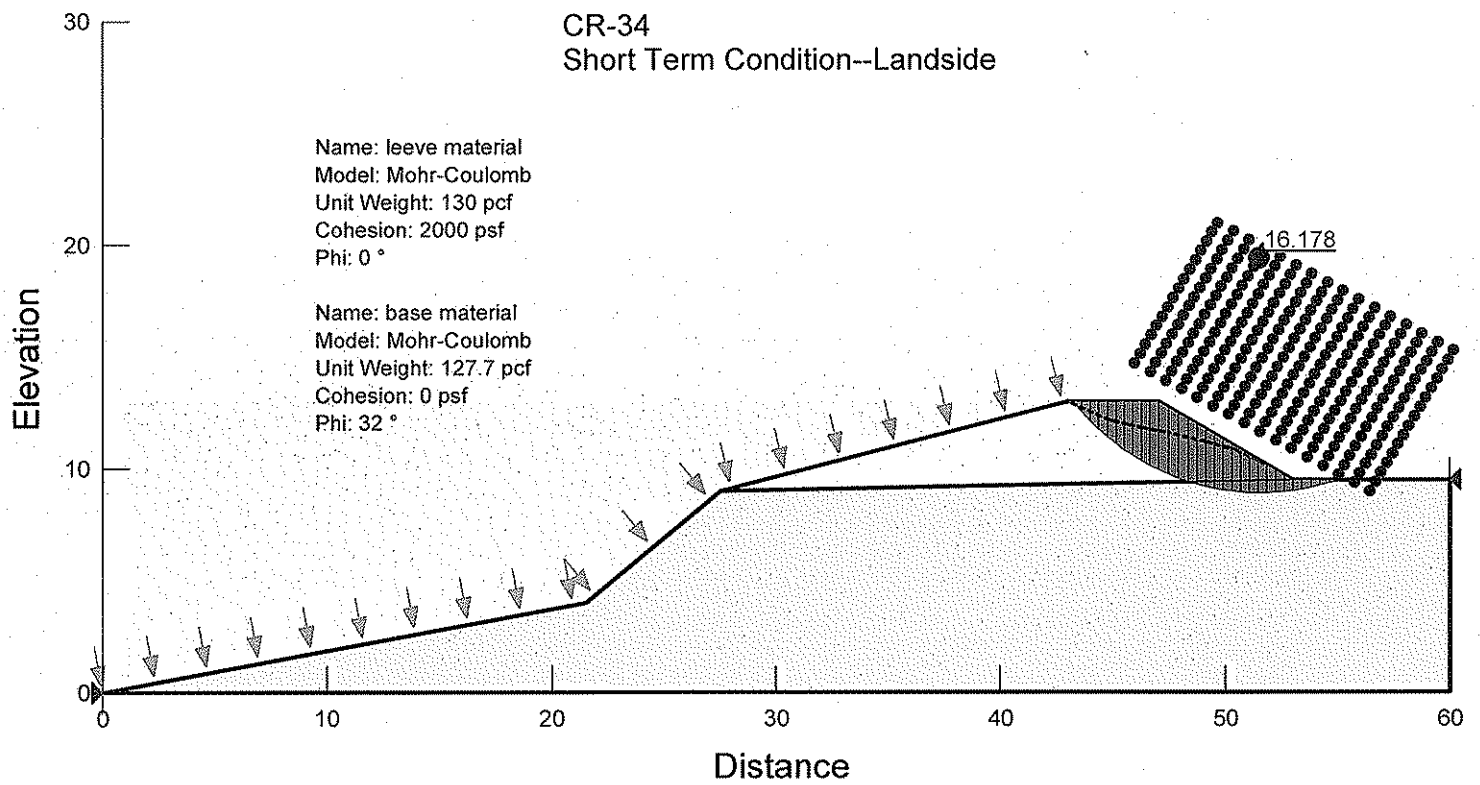
CR-34
Short Term Condition--Landside

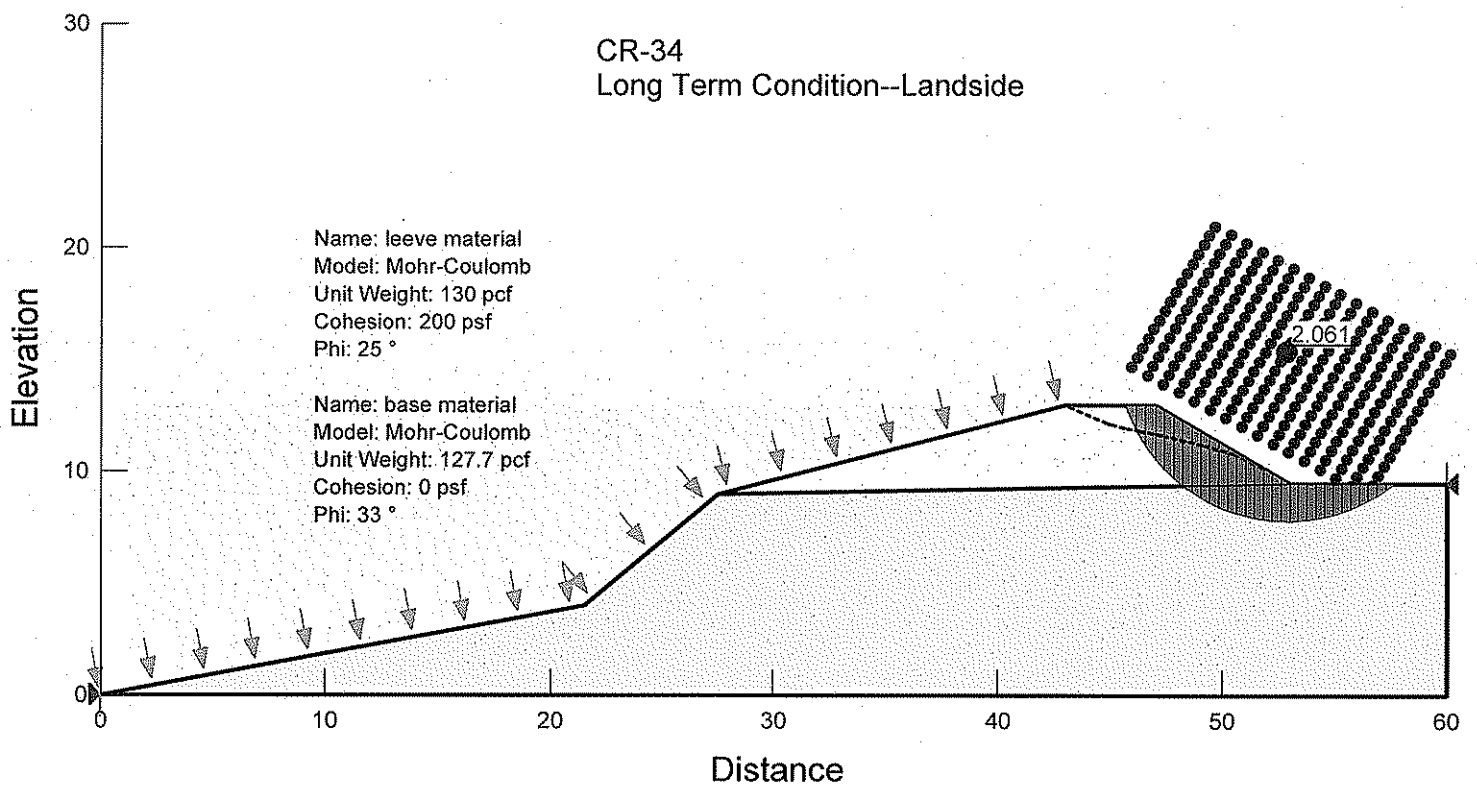
CR-34
Long Term Condition--Landside

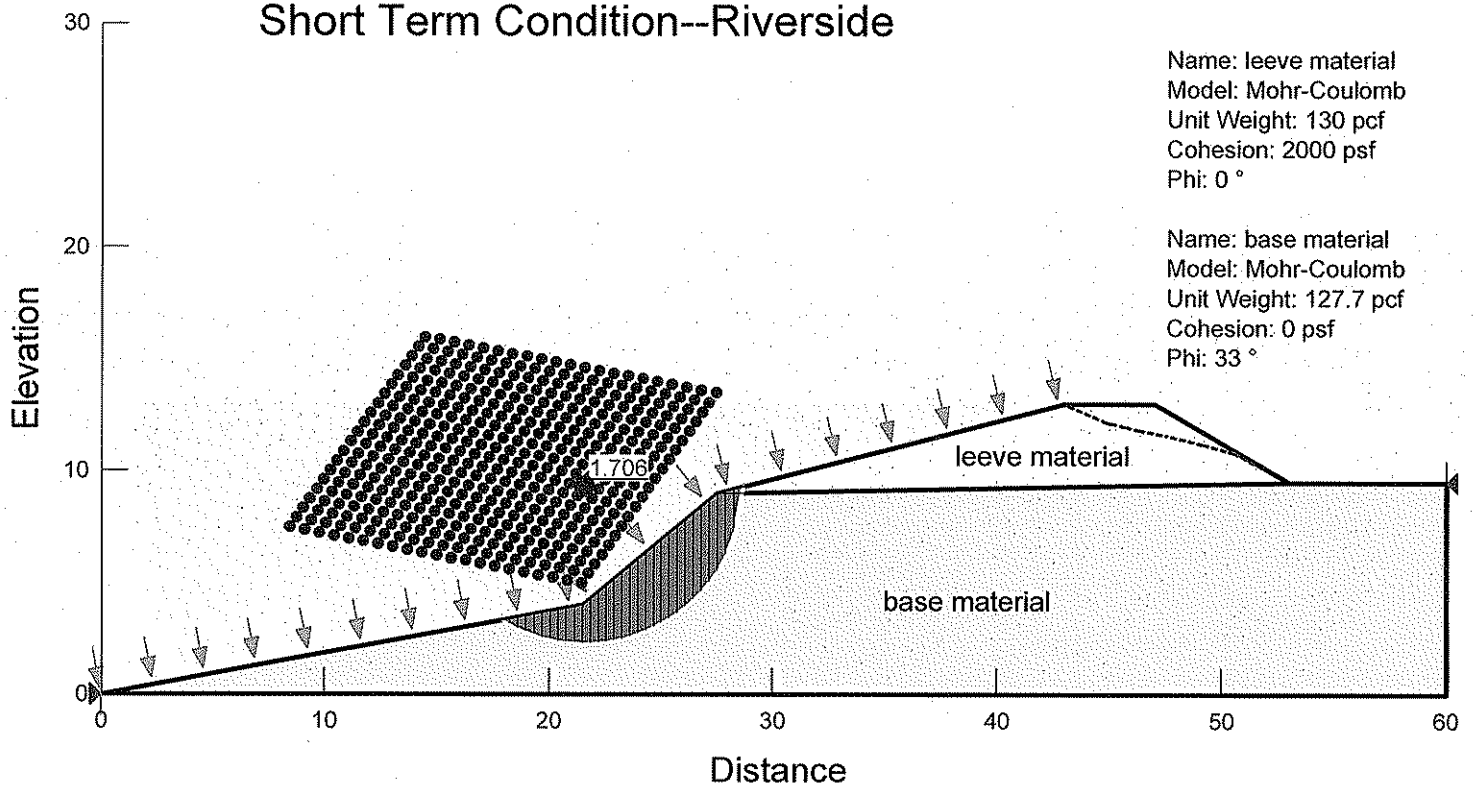
CR-34 Short Term Condition--Riverside

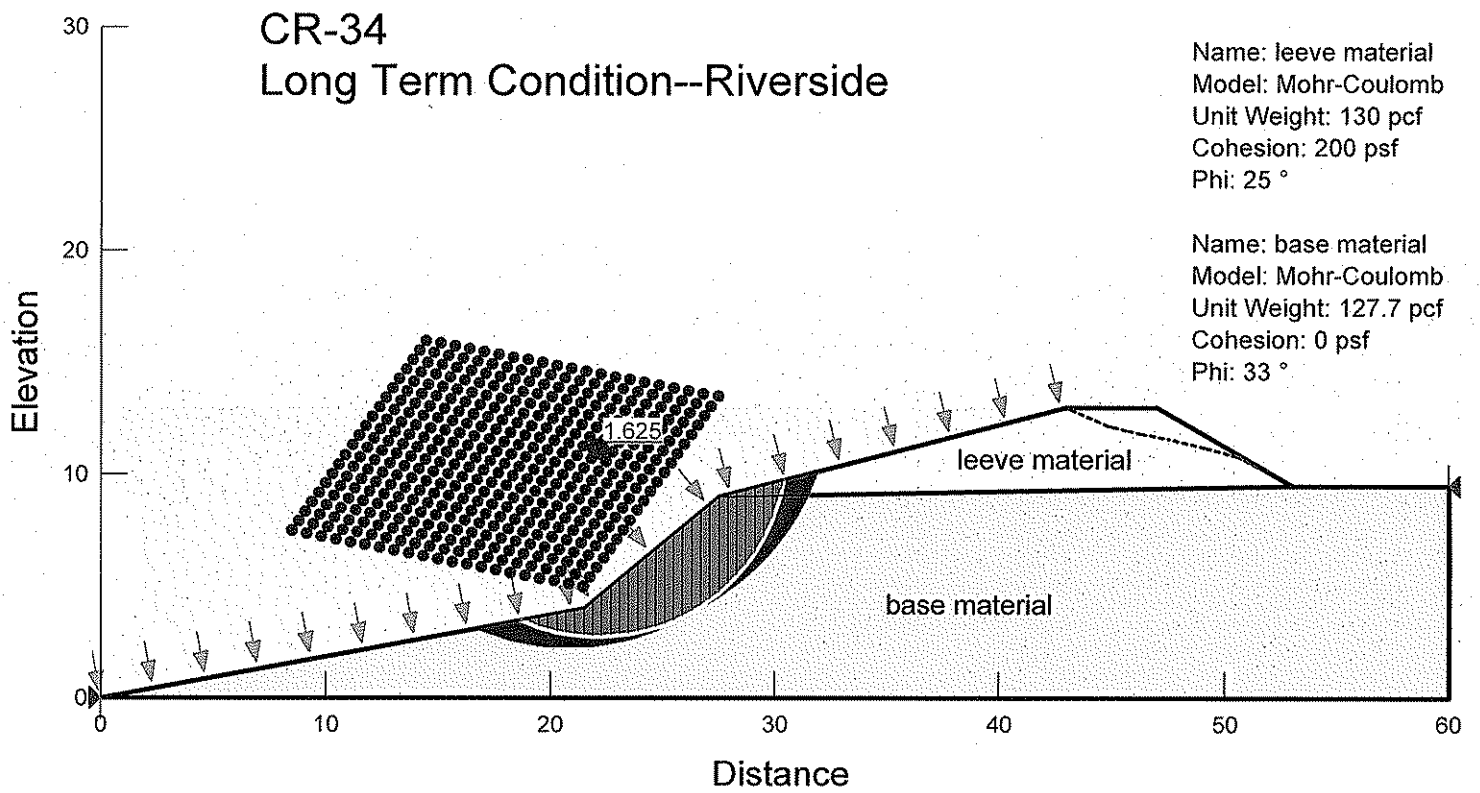
CR-34
Long Term Condition--Riverside

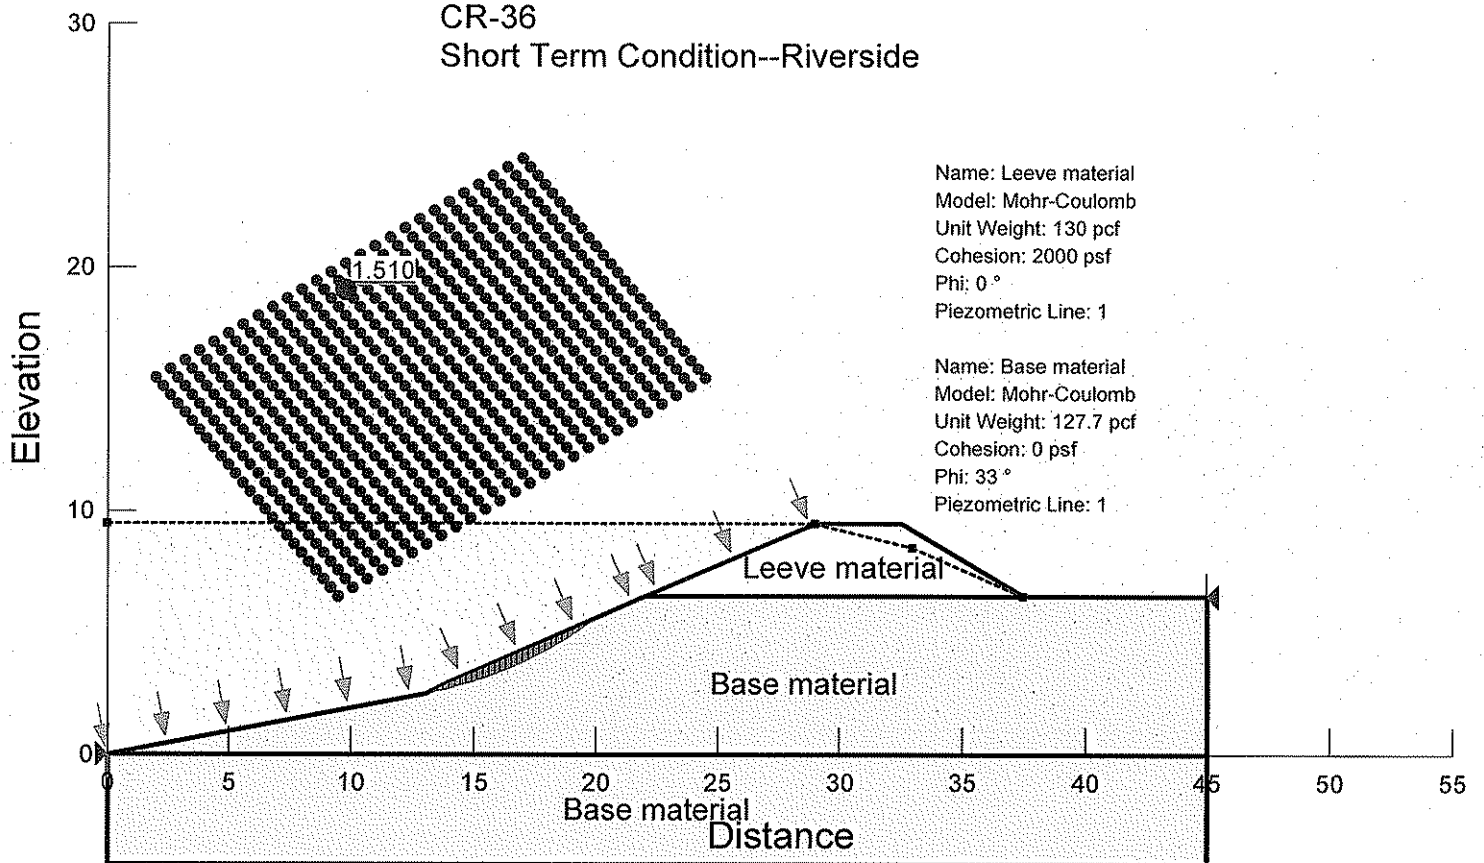
CR-36
Short Term Condition--Riverside

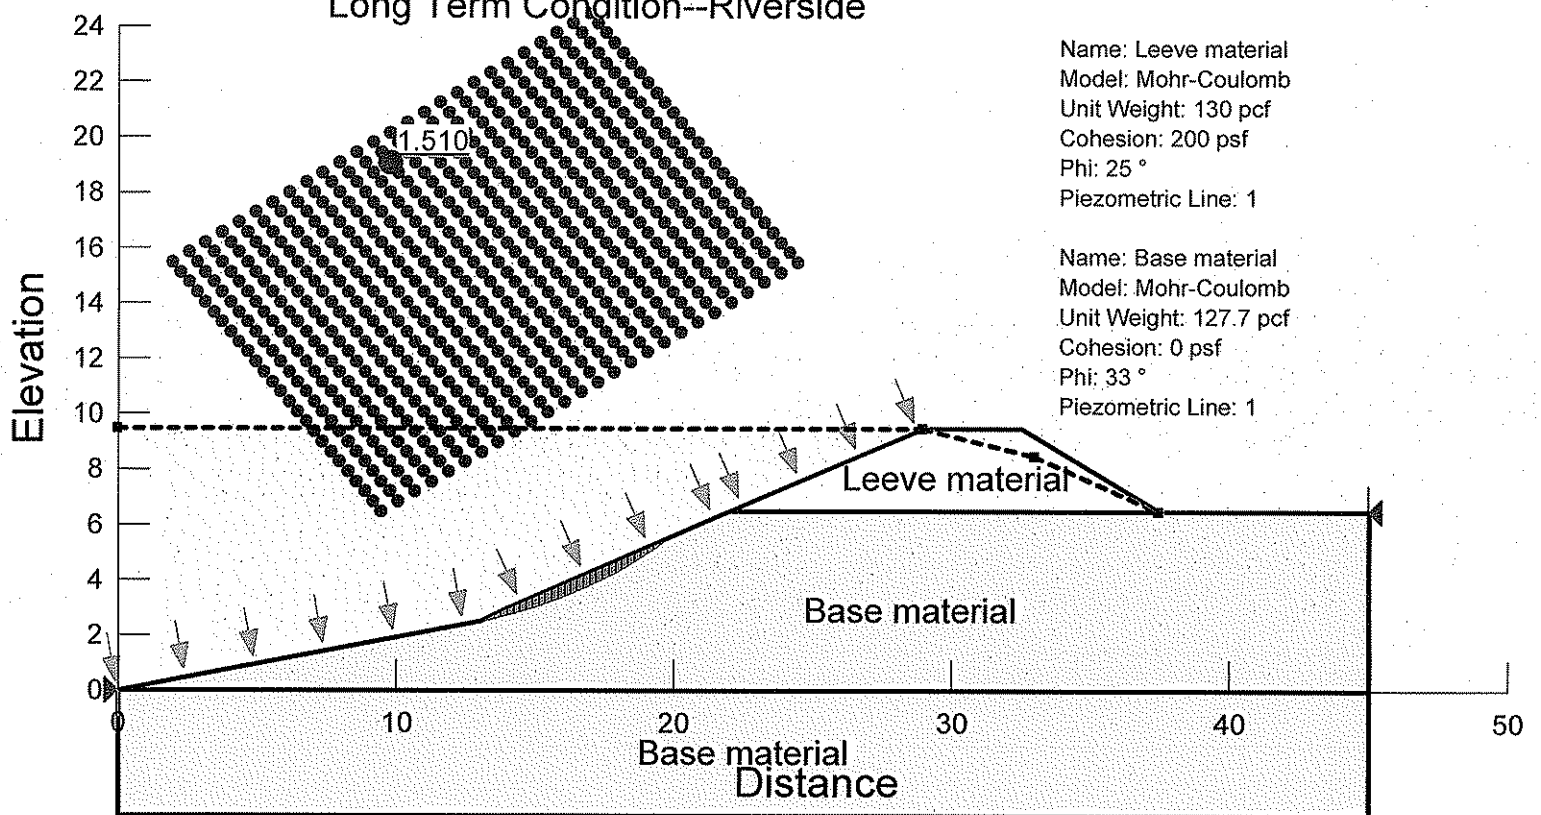
CR-36
Long Term Condition--Riverside

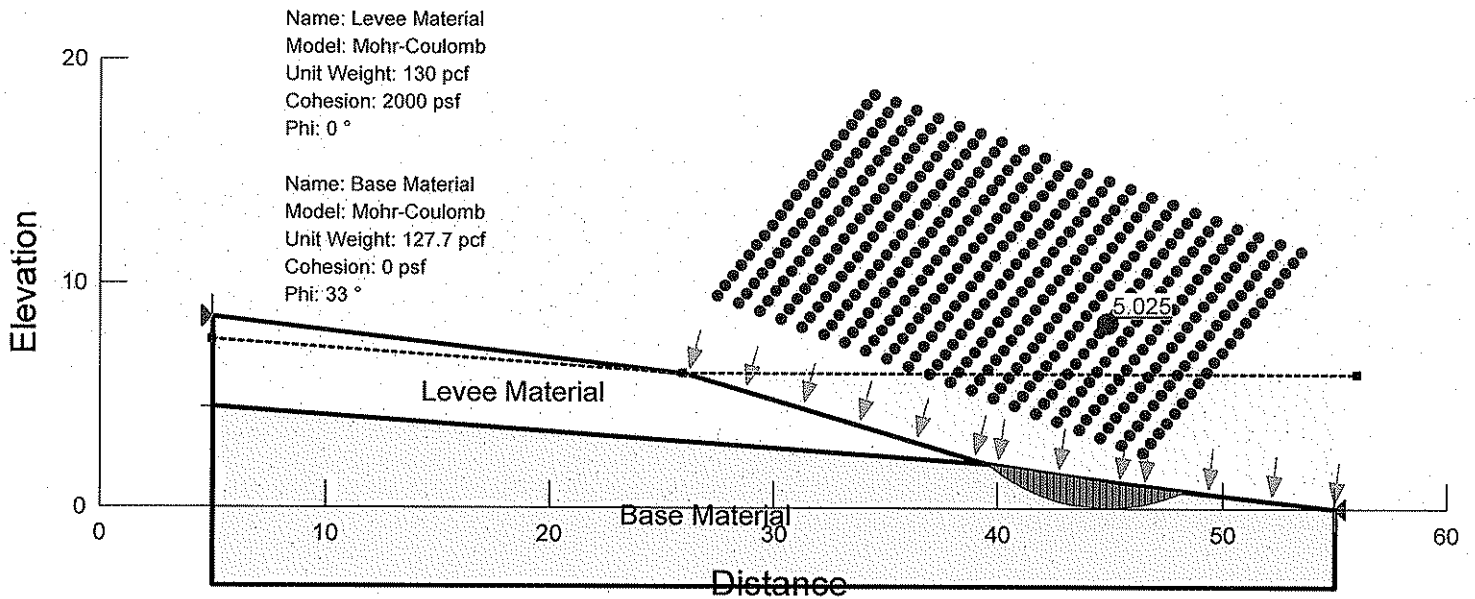
CR-36W

Short Term Condition--Riverside

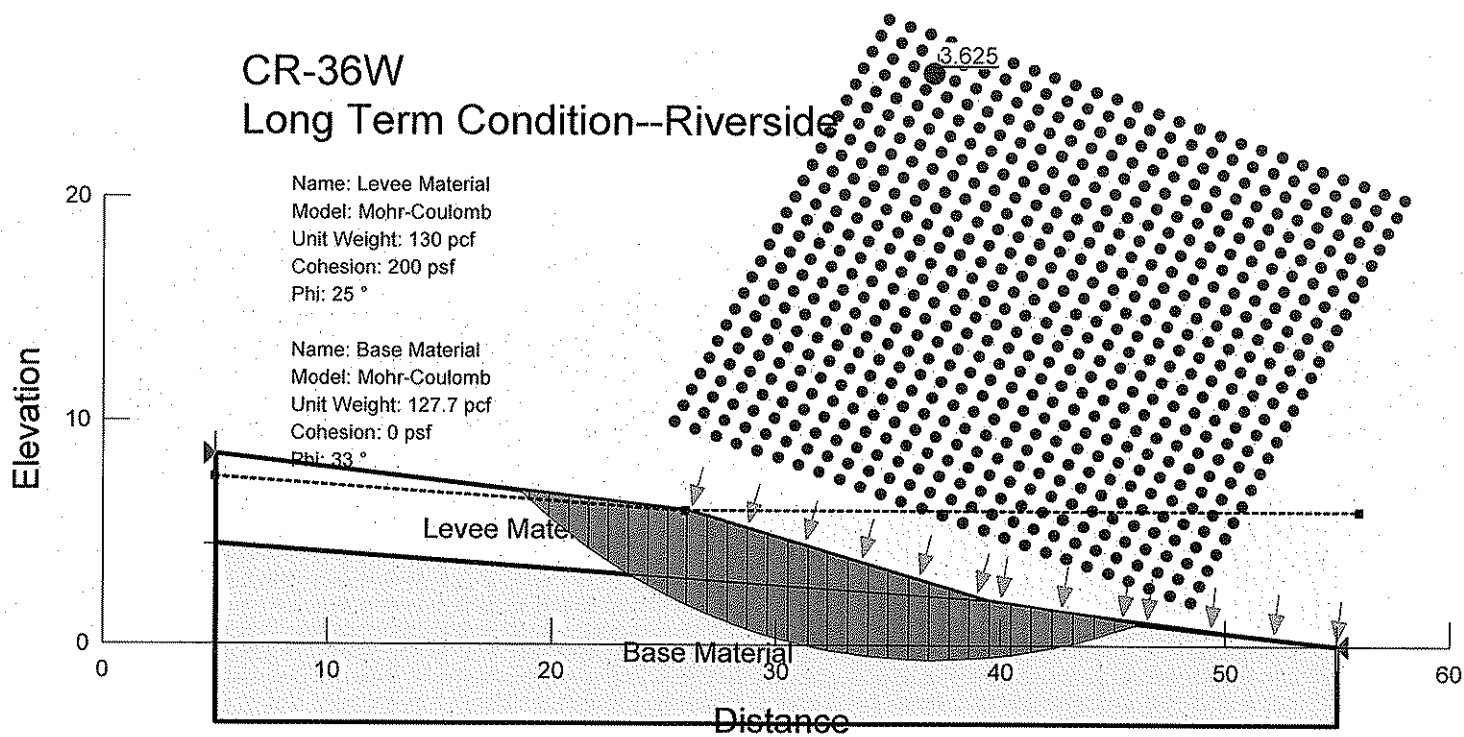
CR-36W Long Term Condition--Riverside

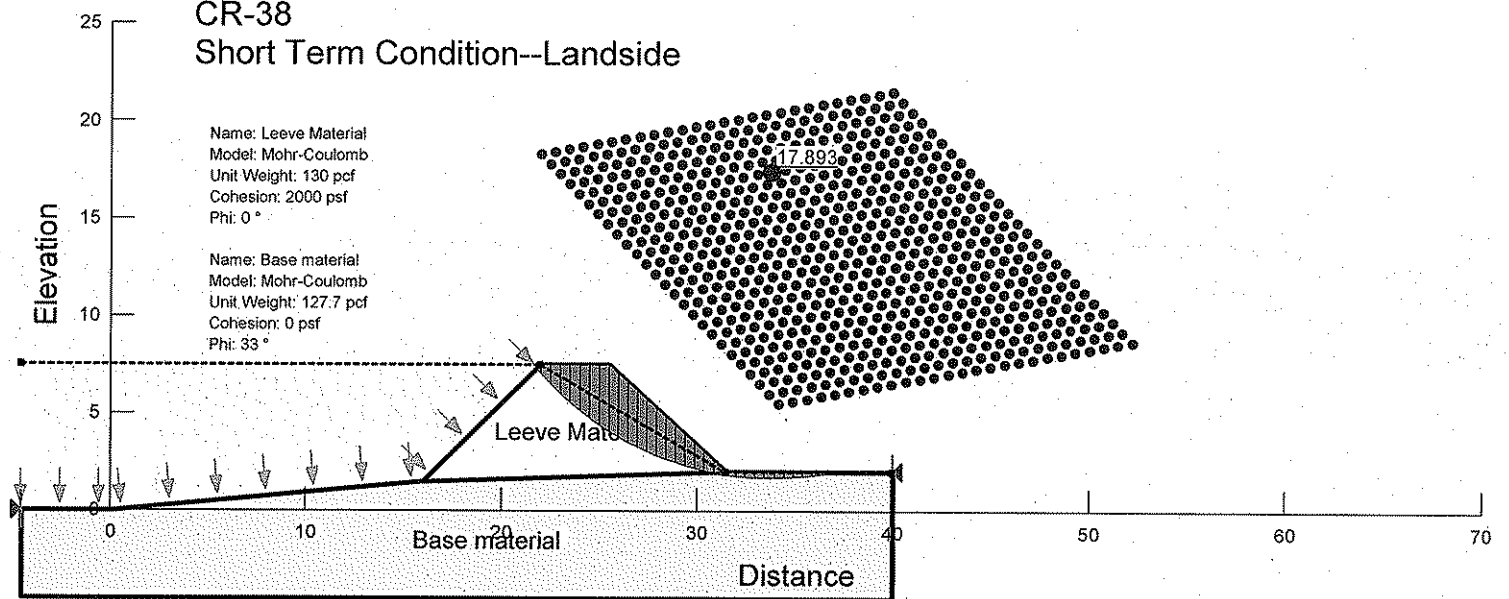
CR-38 Short Term Condition--Landside

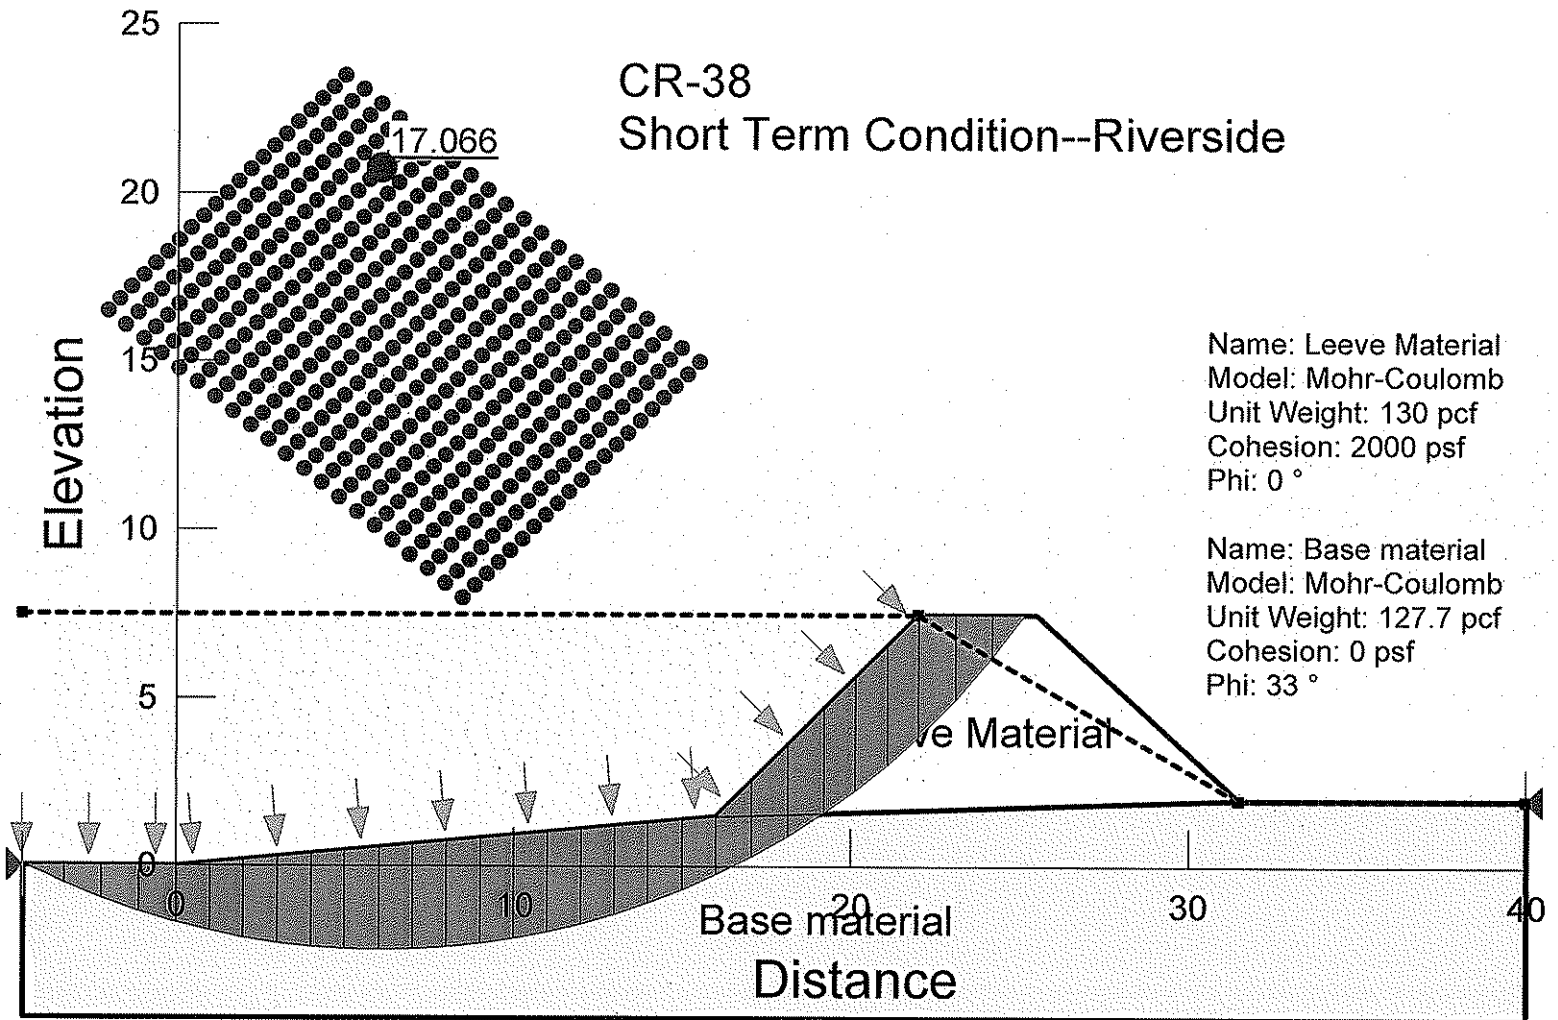
CR-38
Short Term Condition--Riverside

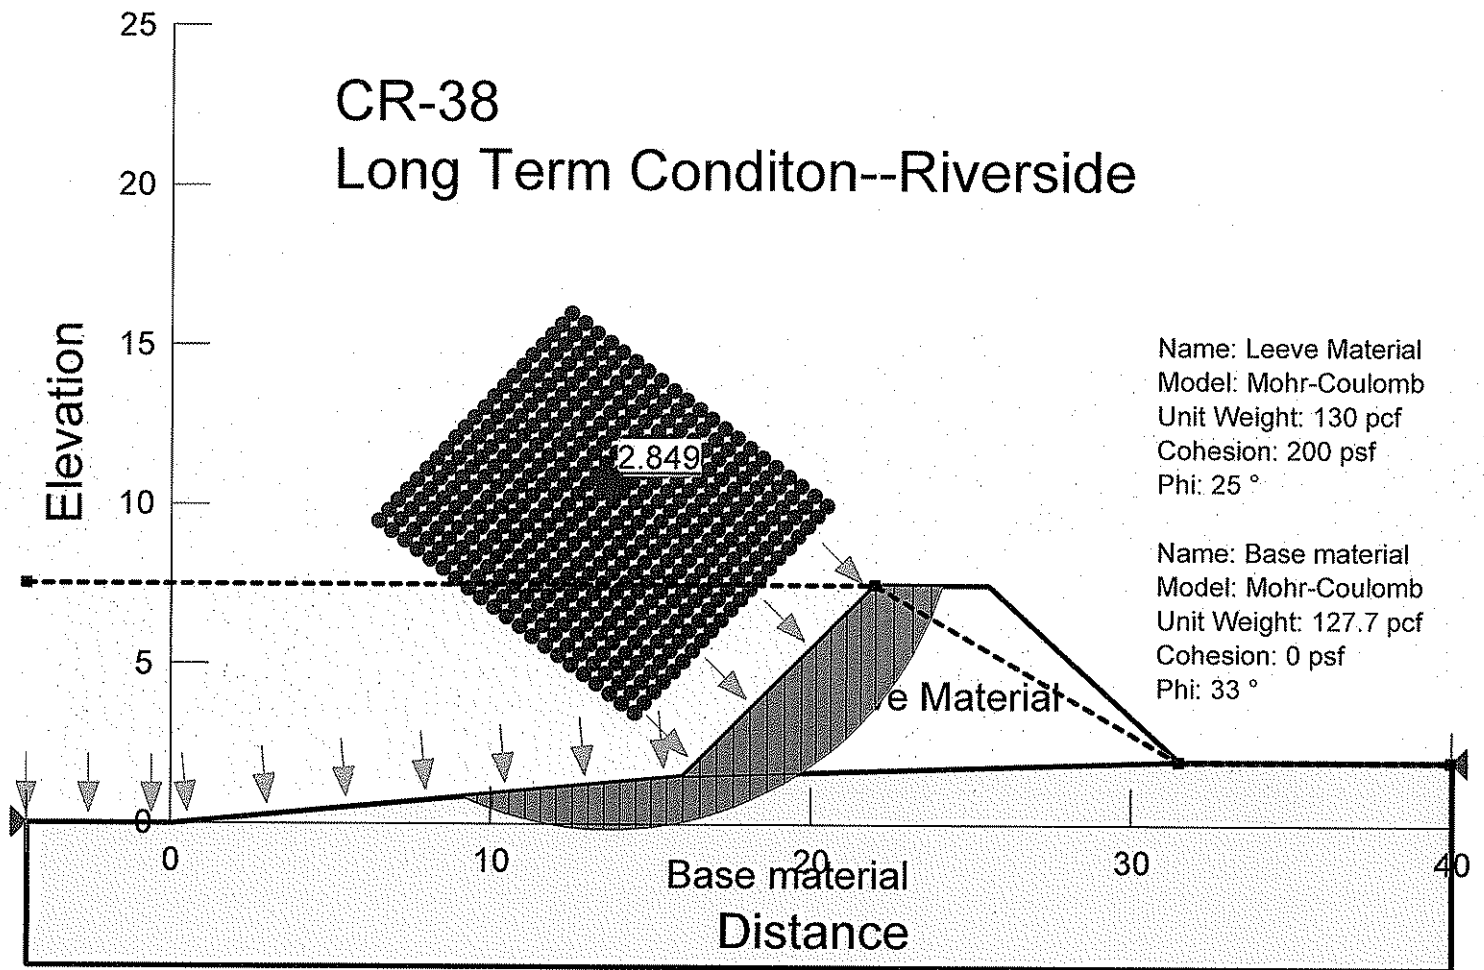
CR-38 Long Term Conditon--Riverside
