# **ENGINEERING REPORT**

## **TAX DAY STORM**

**(APRIL 15-16, 2007)**

**Township of Cranford  
Engineering Department  
Room 100 – Municipal Building  
8 Springfield Avenue  
Cranford, NJ 07016**

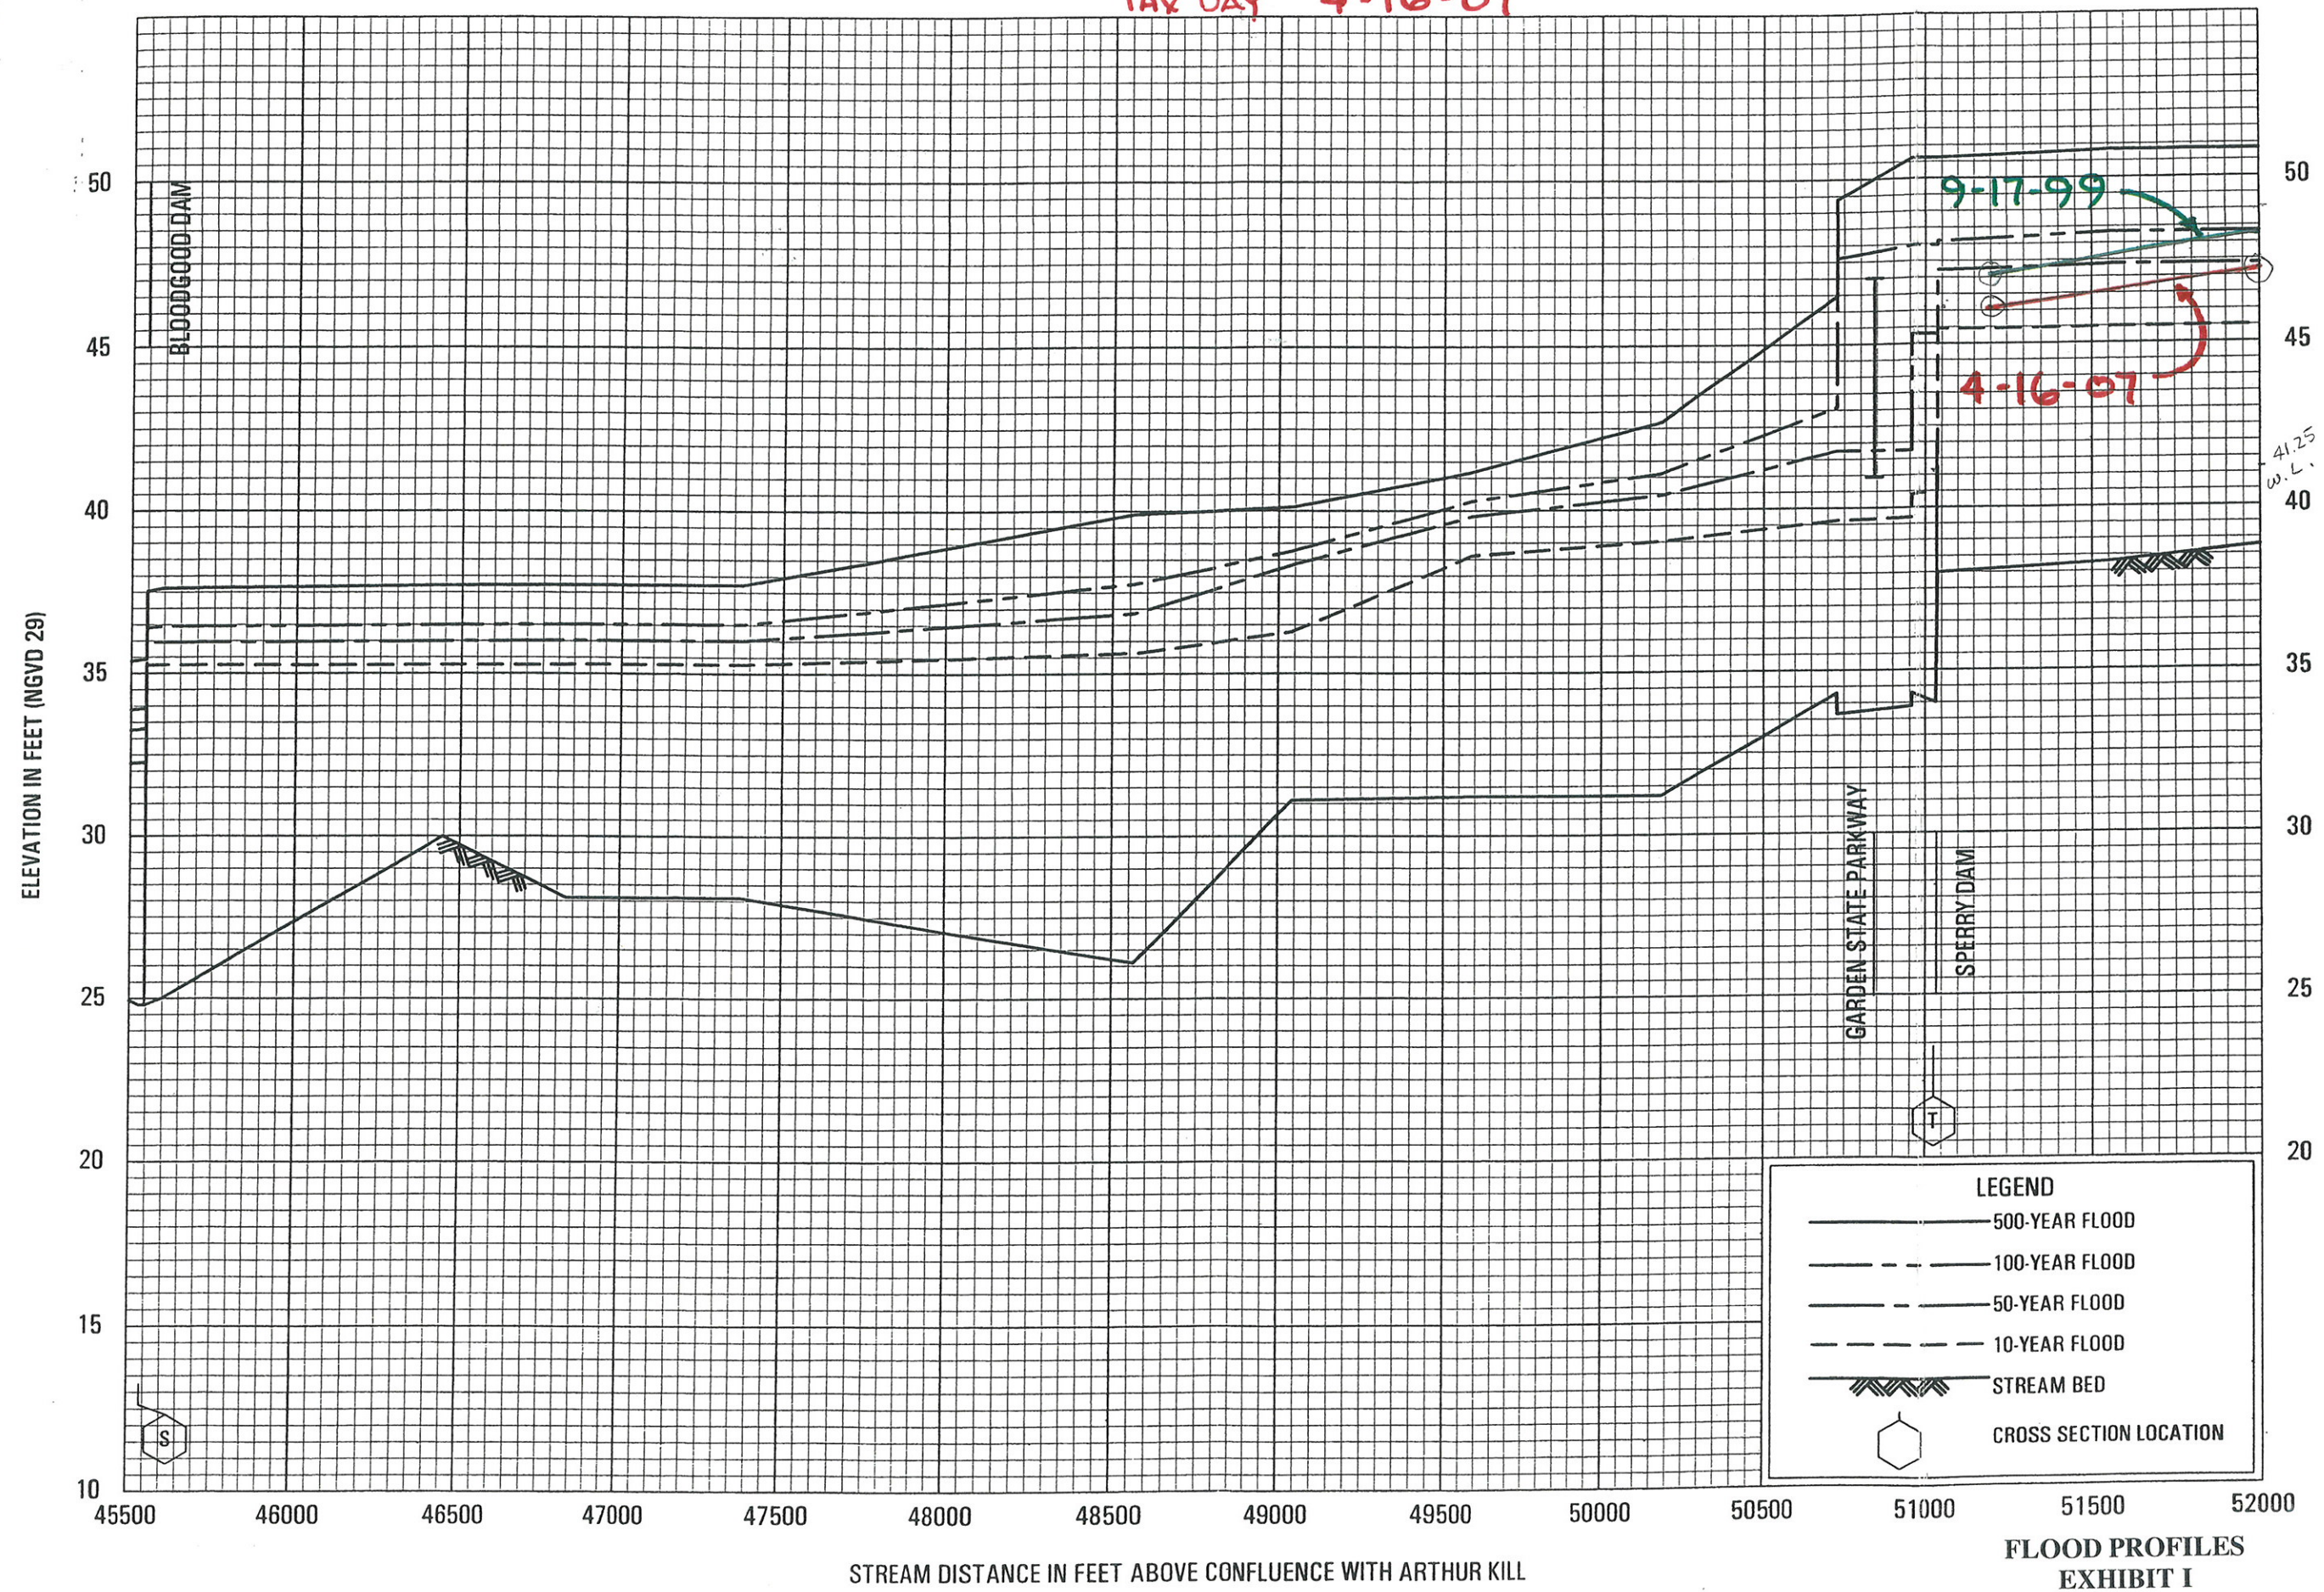
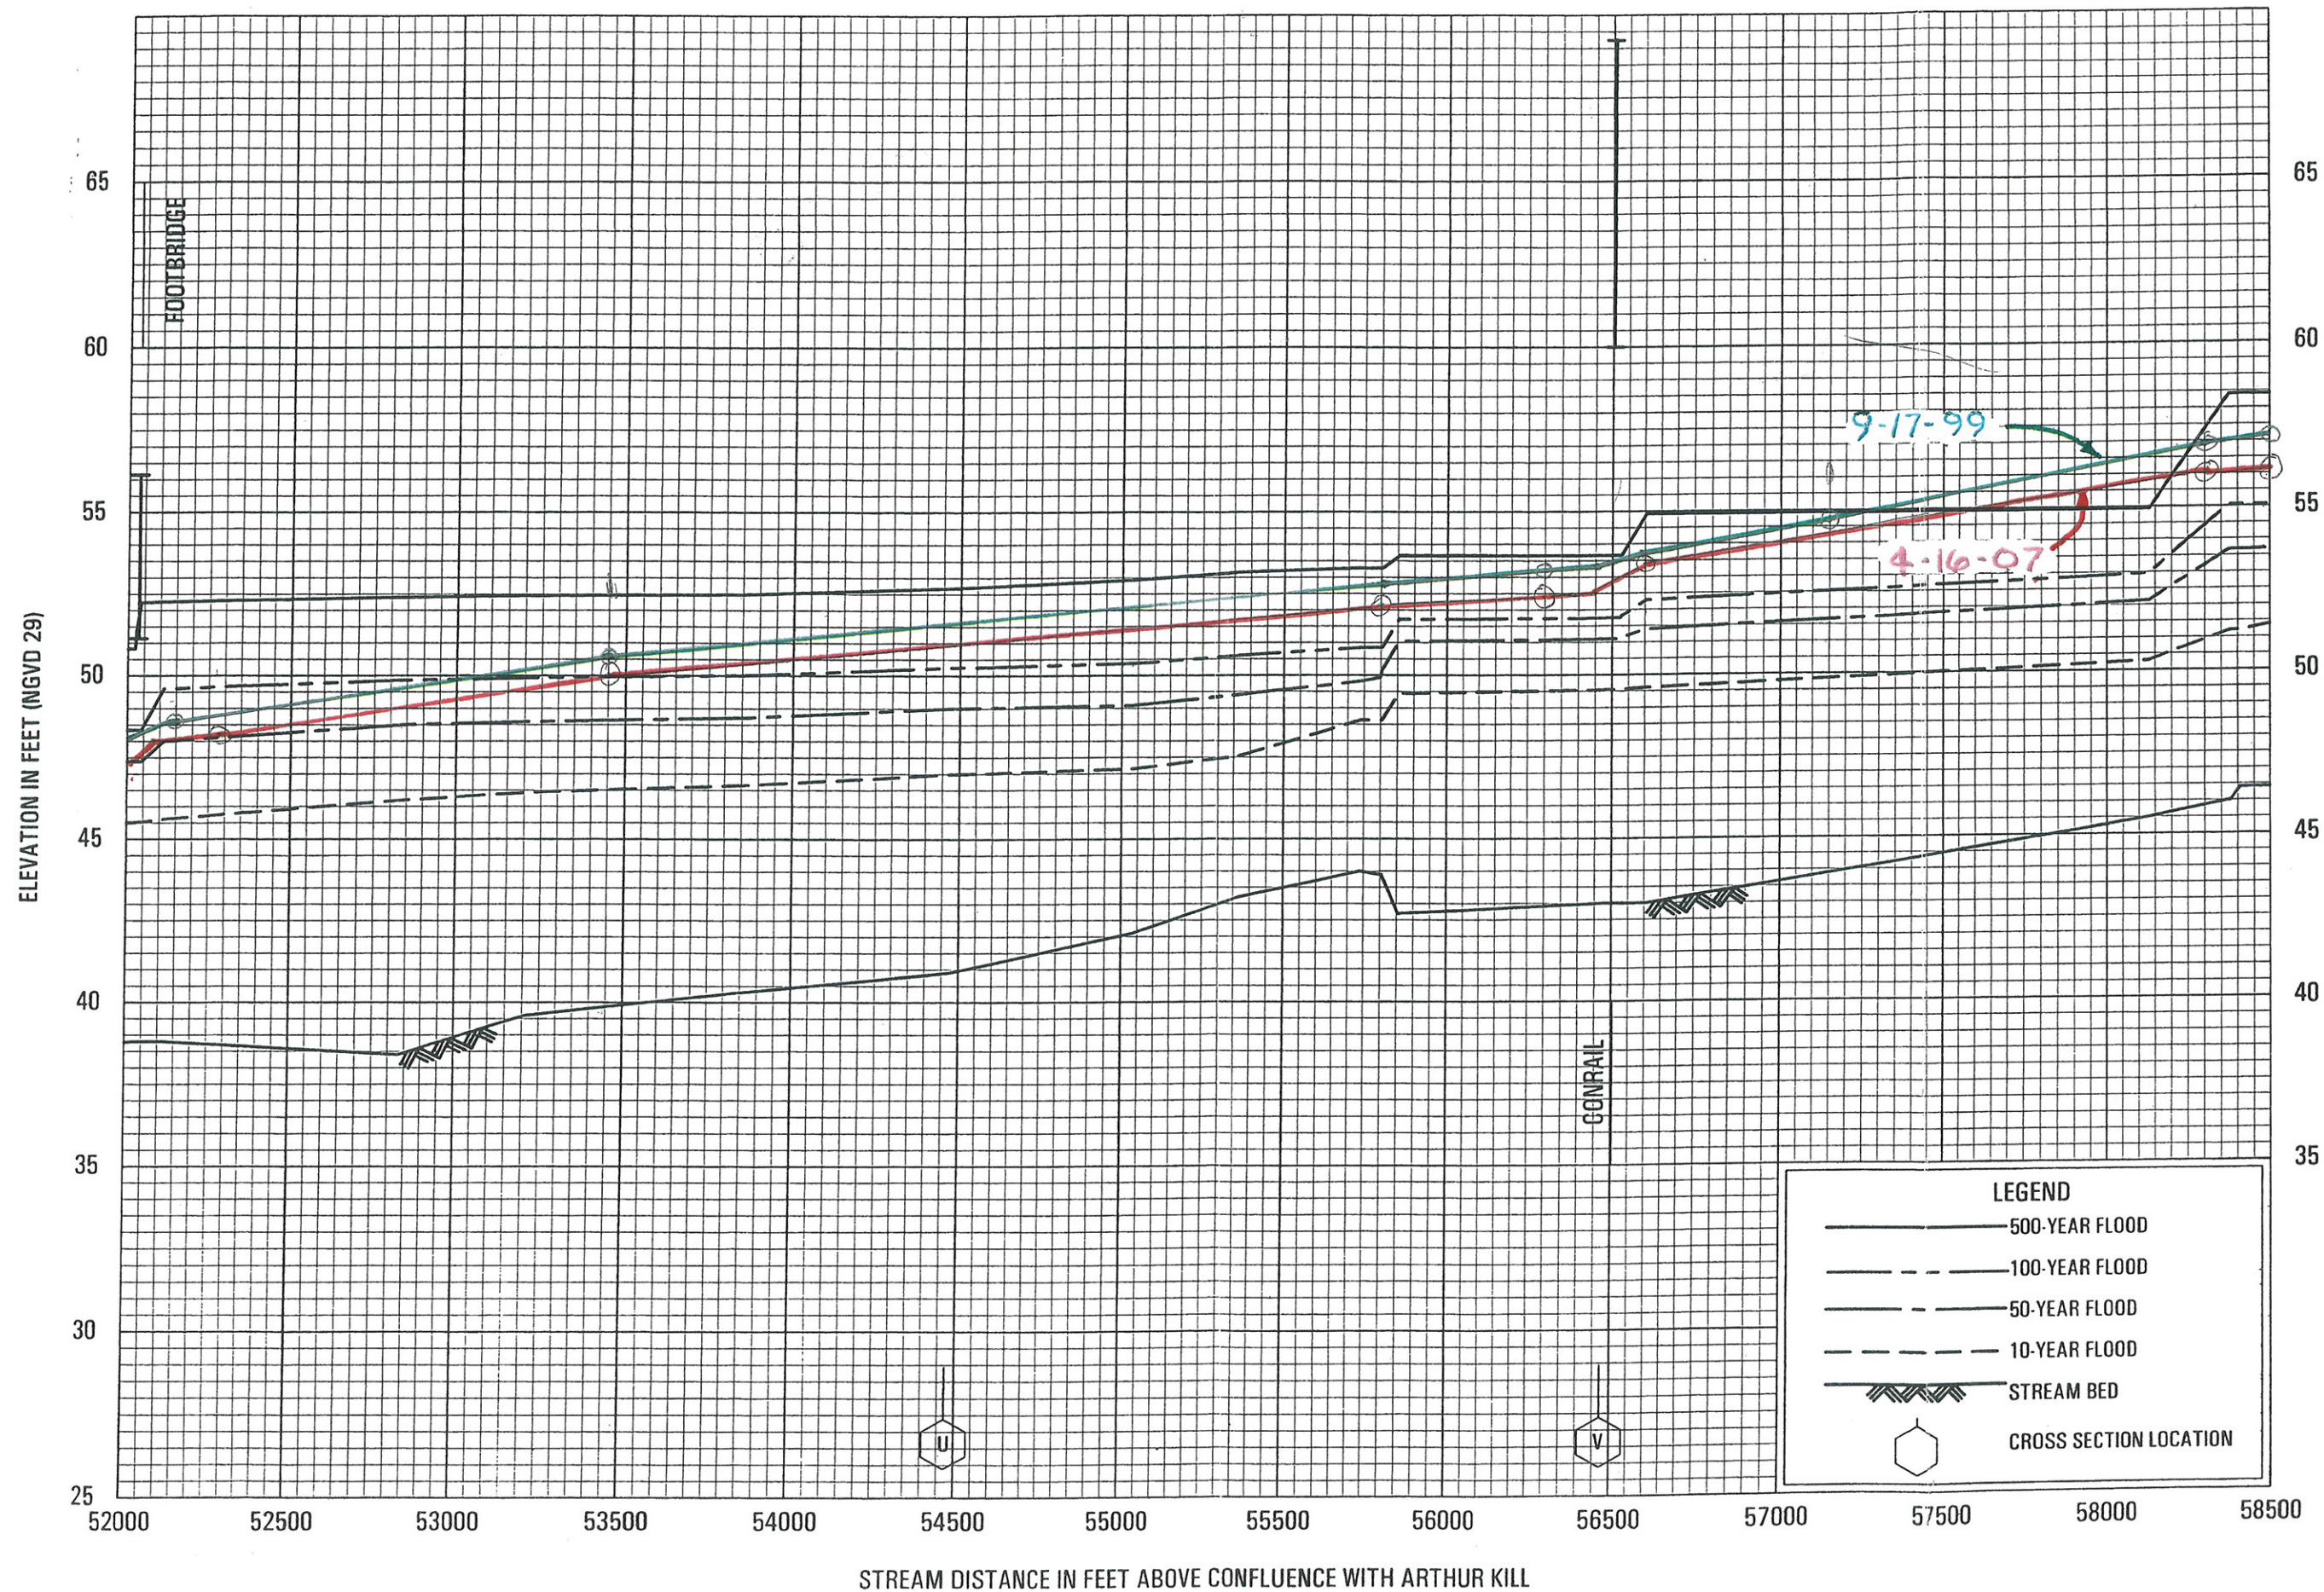
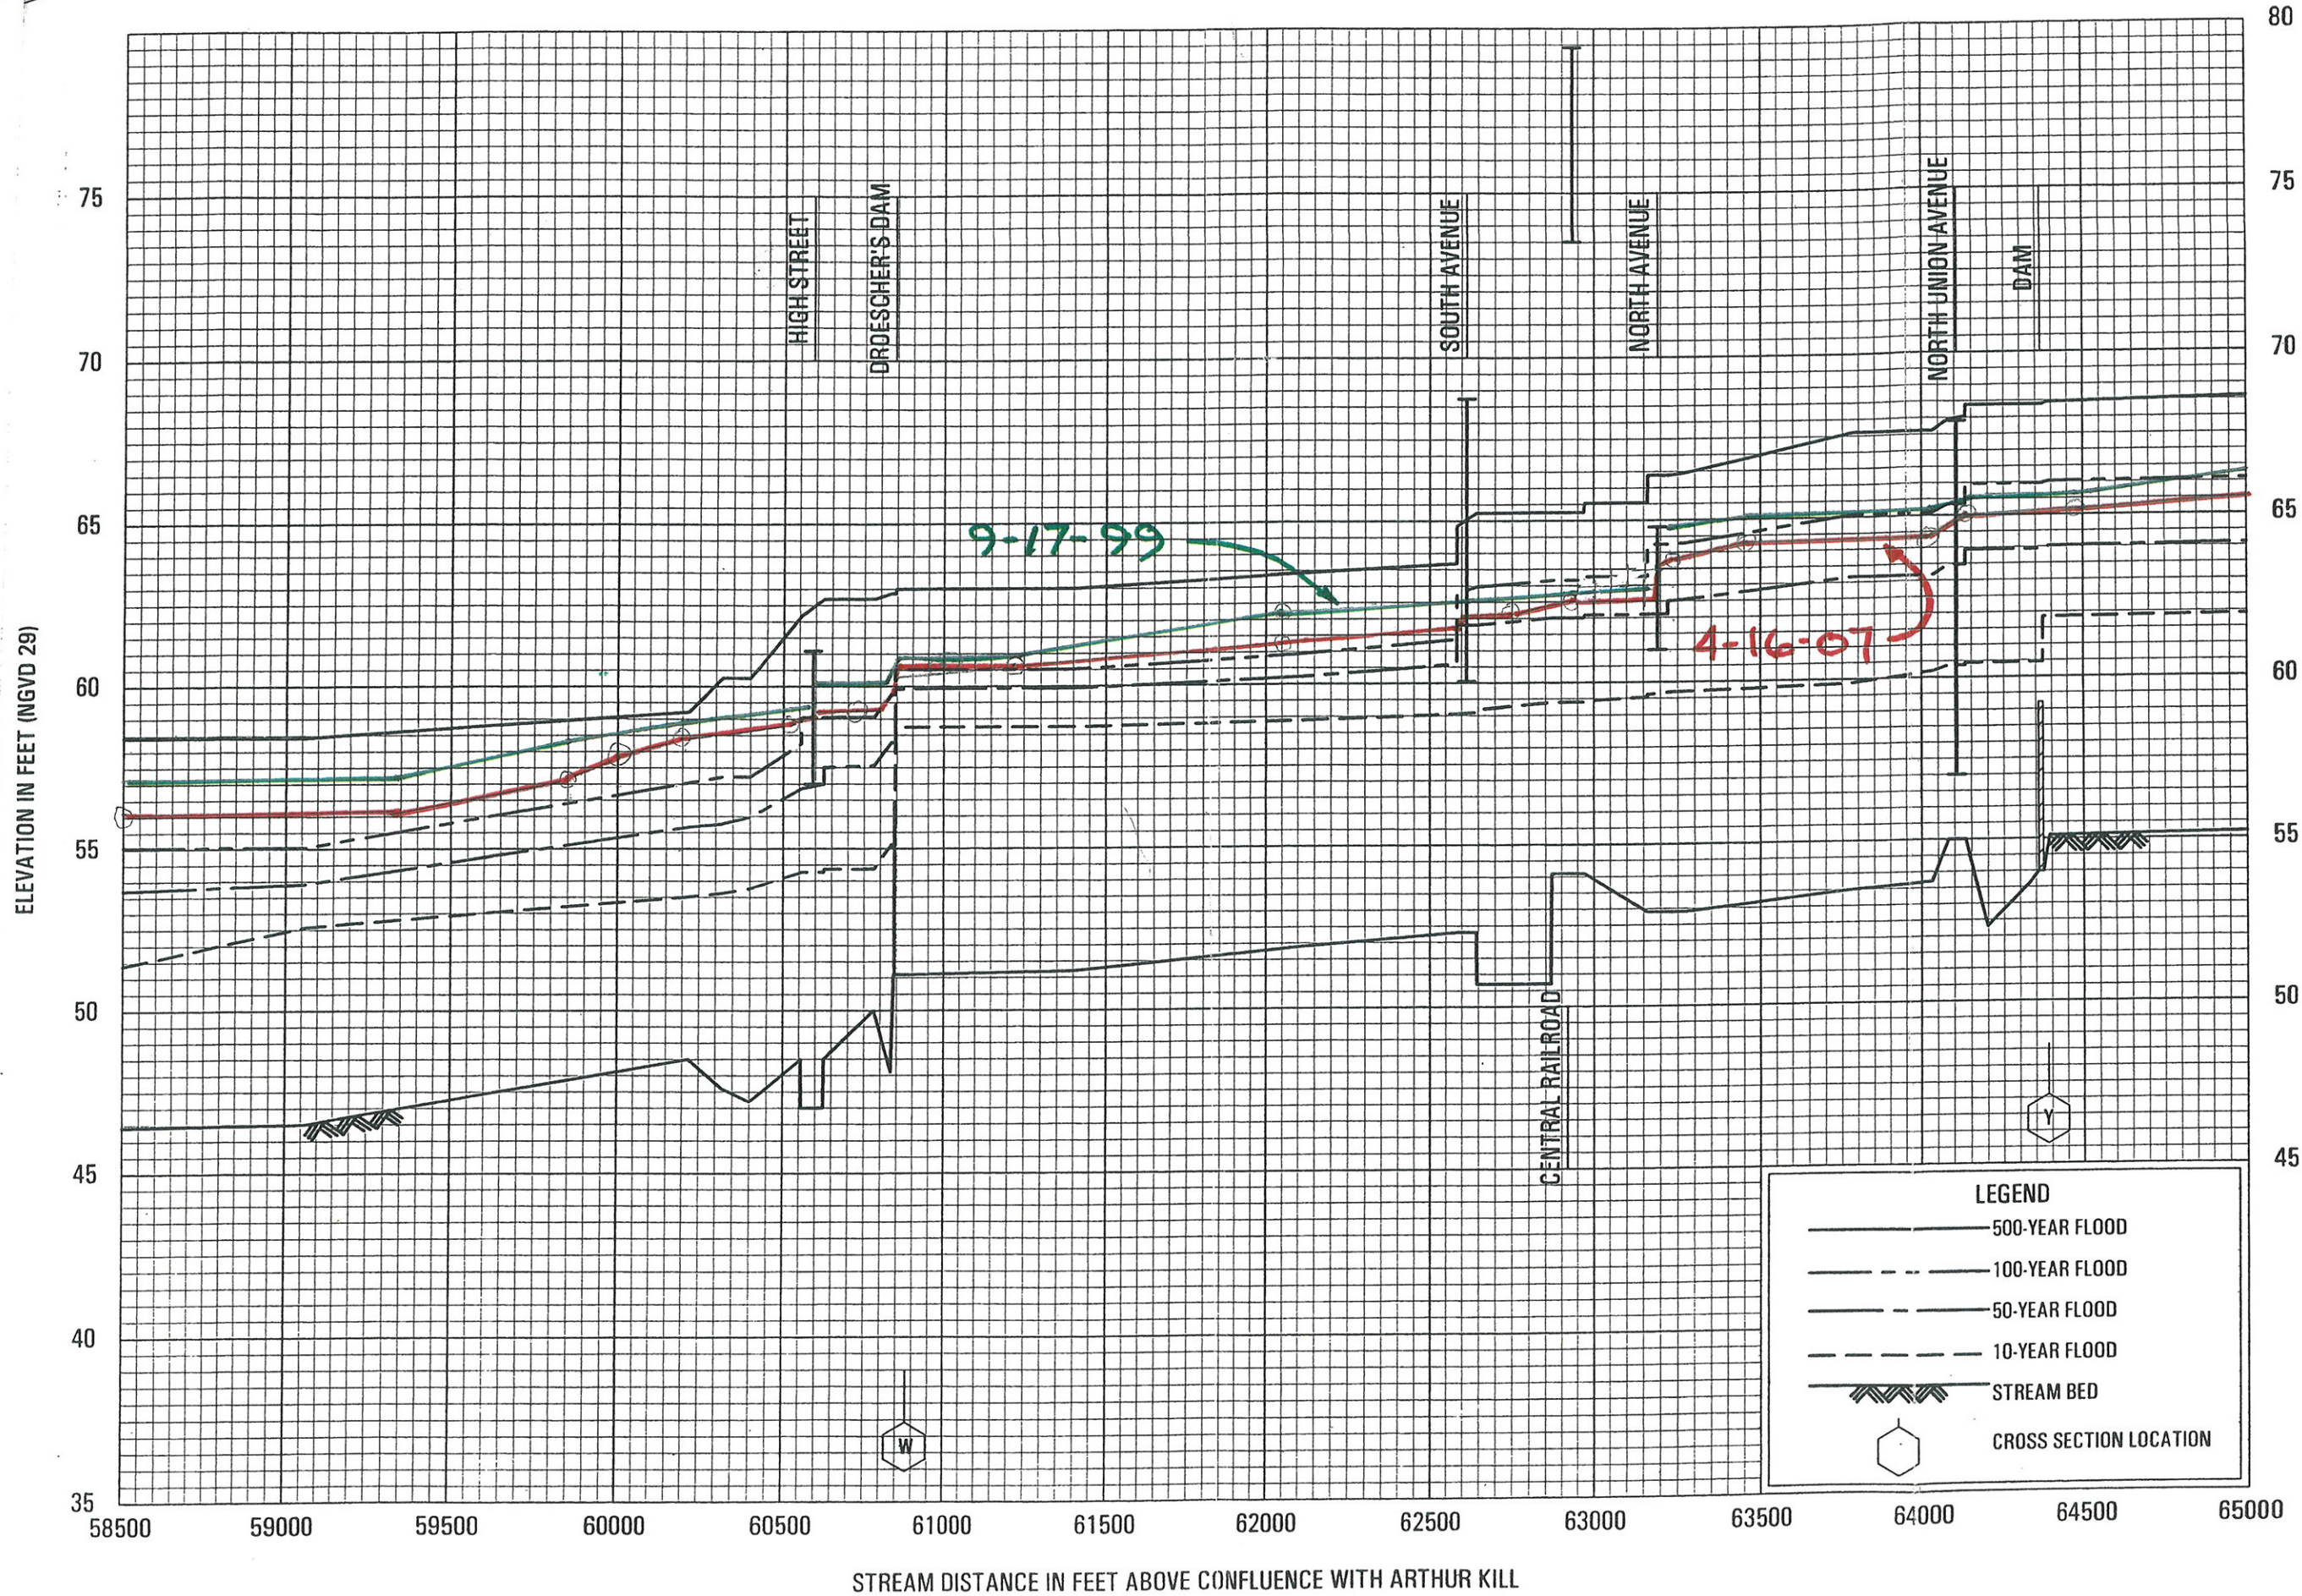
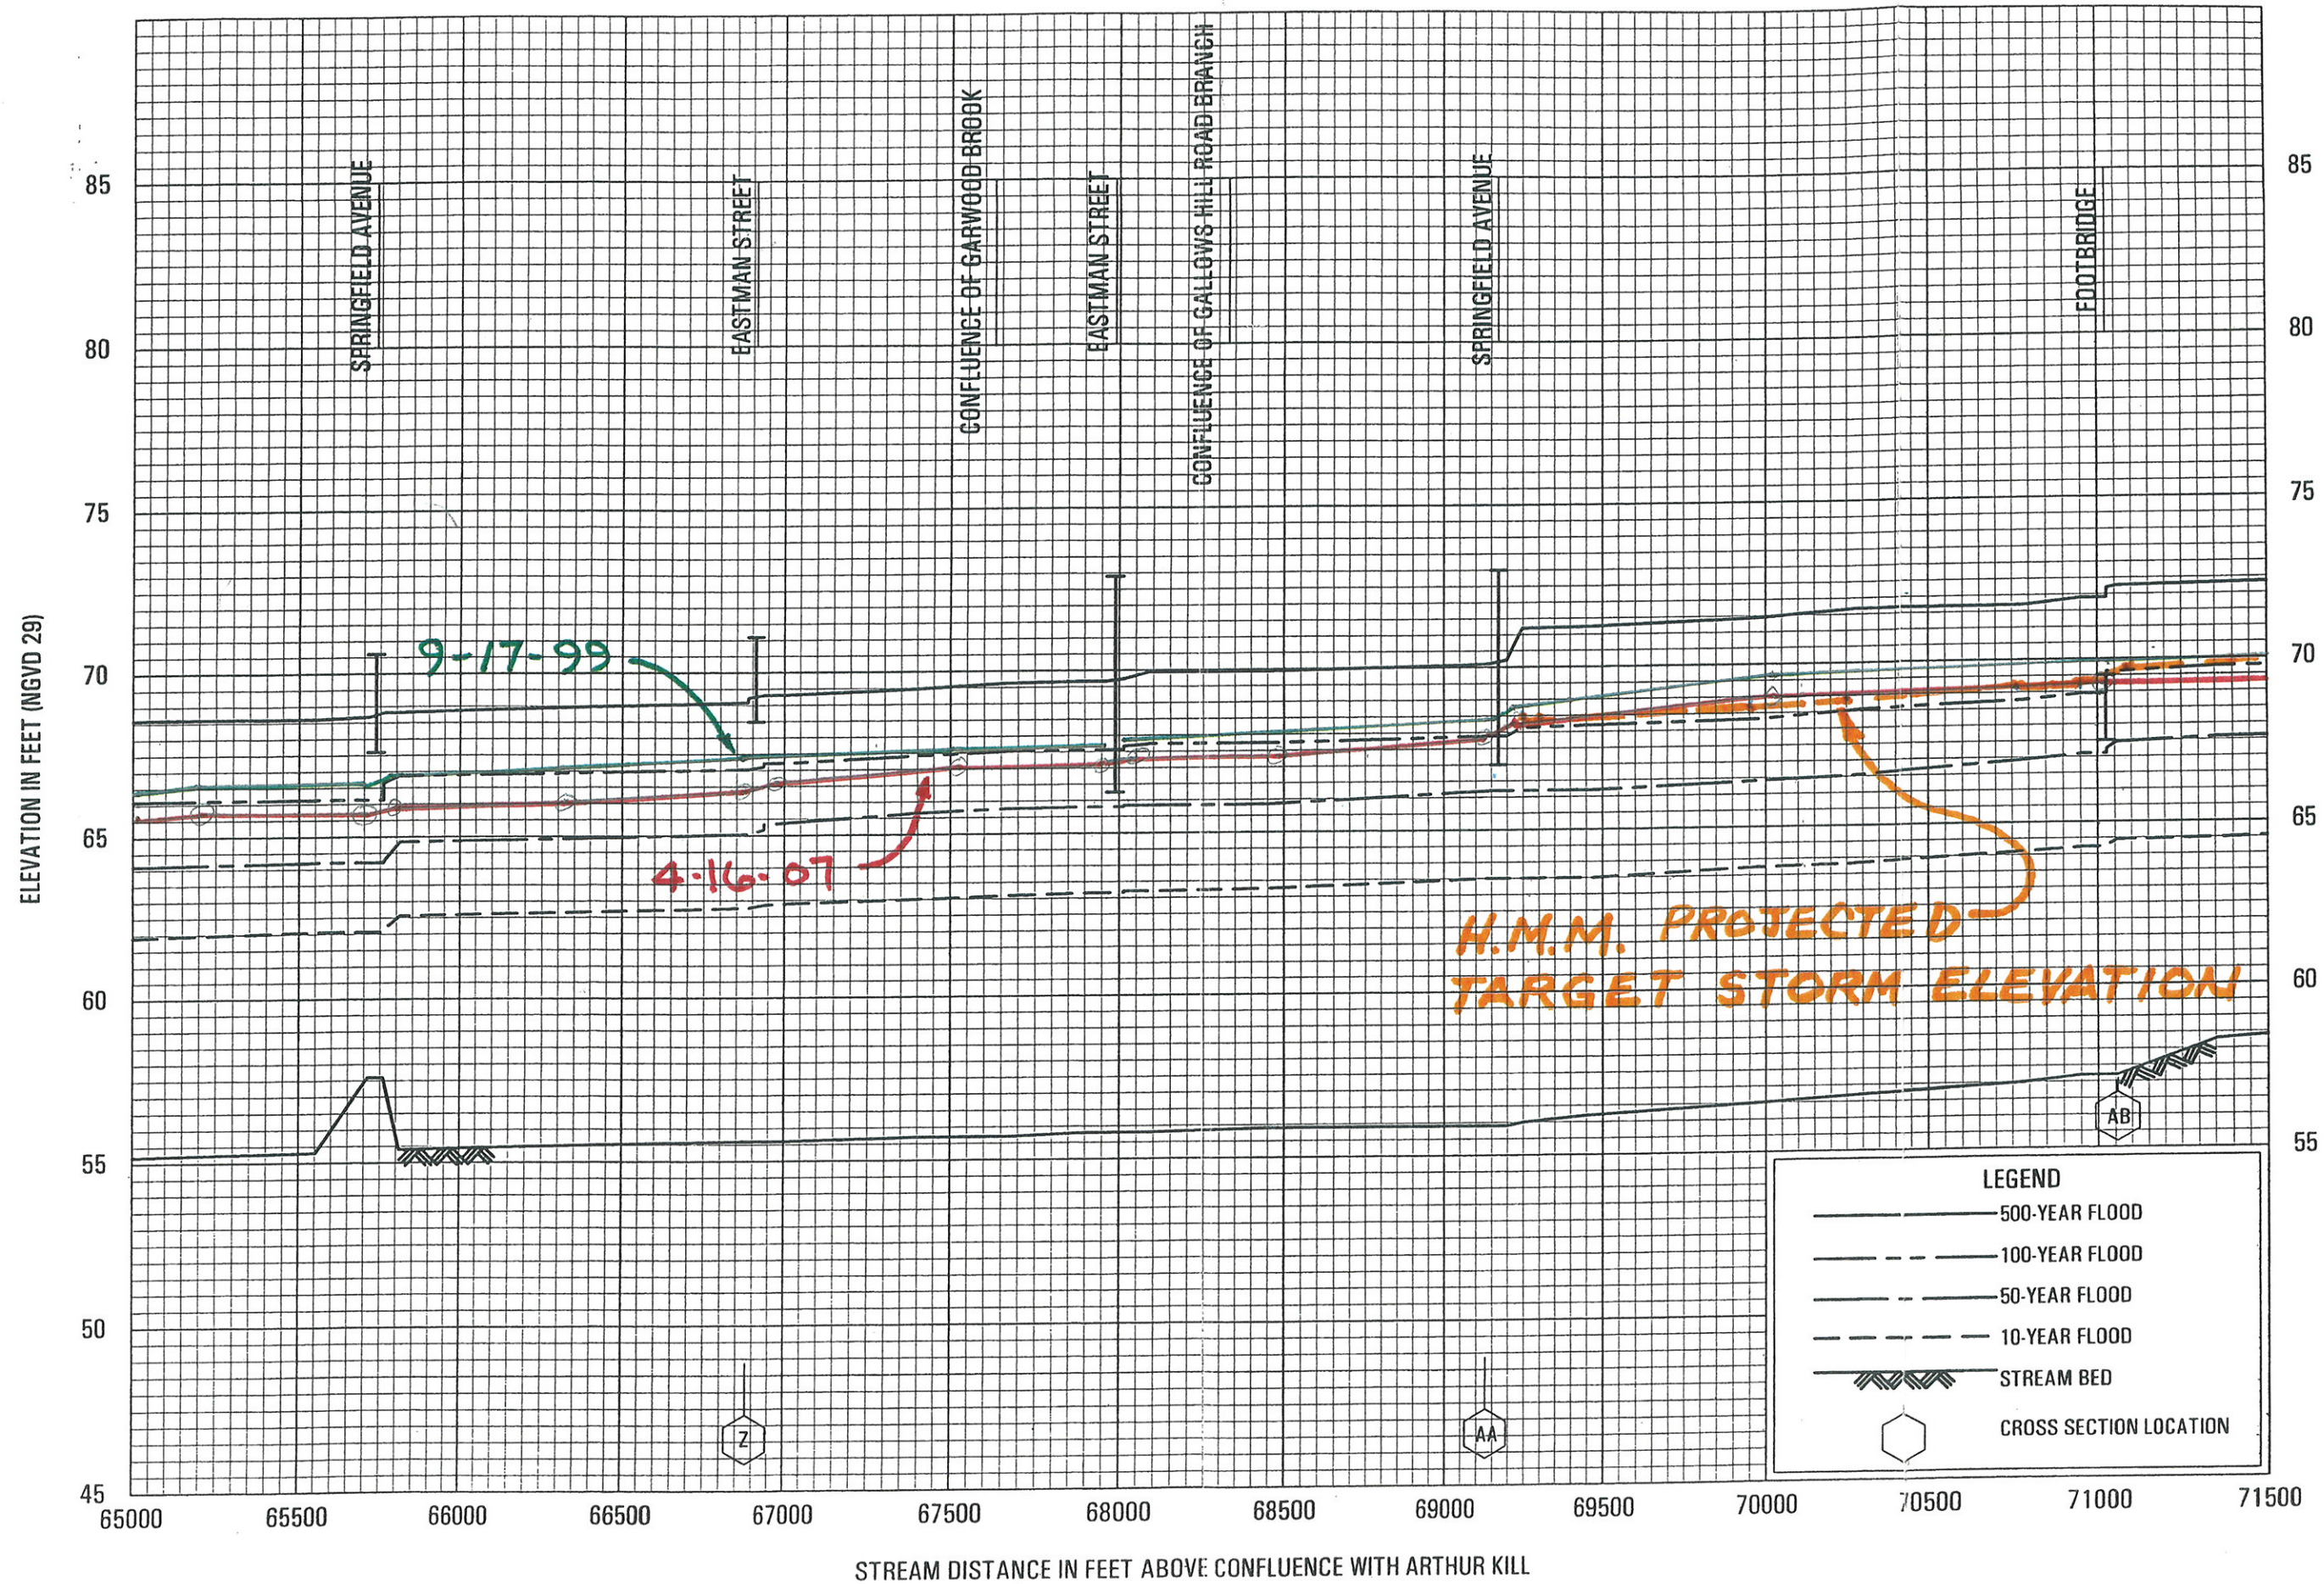
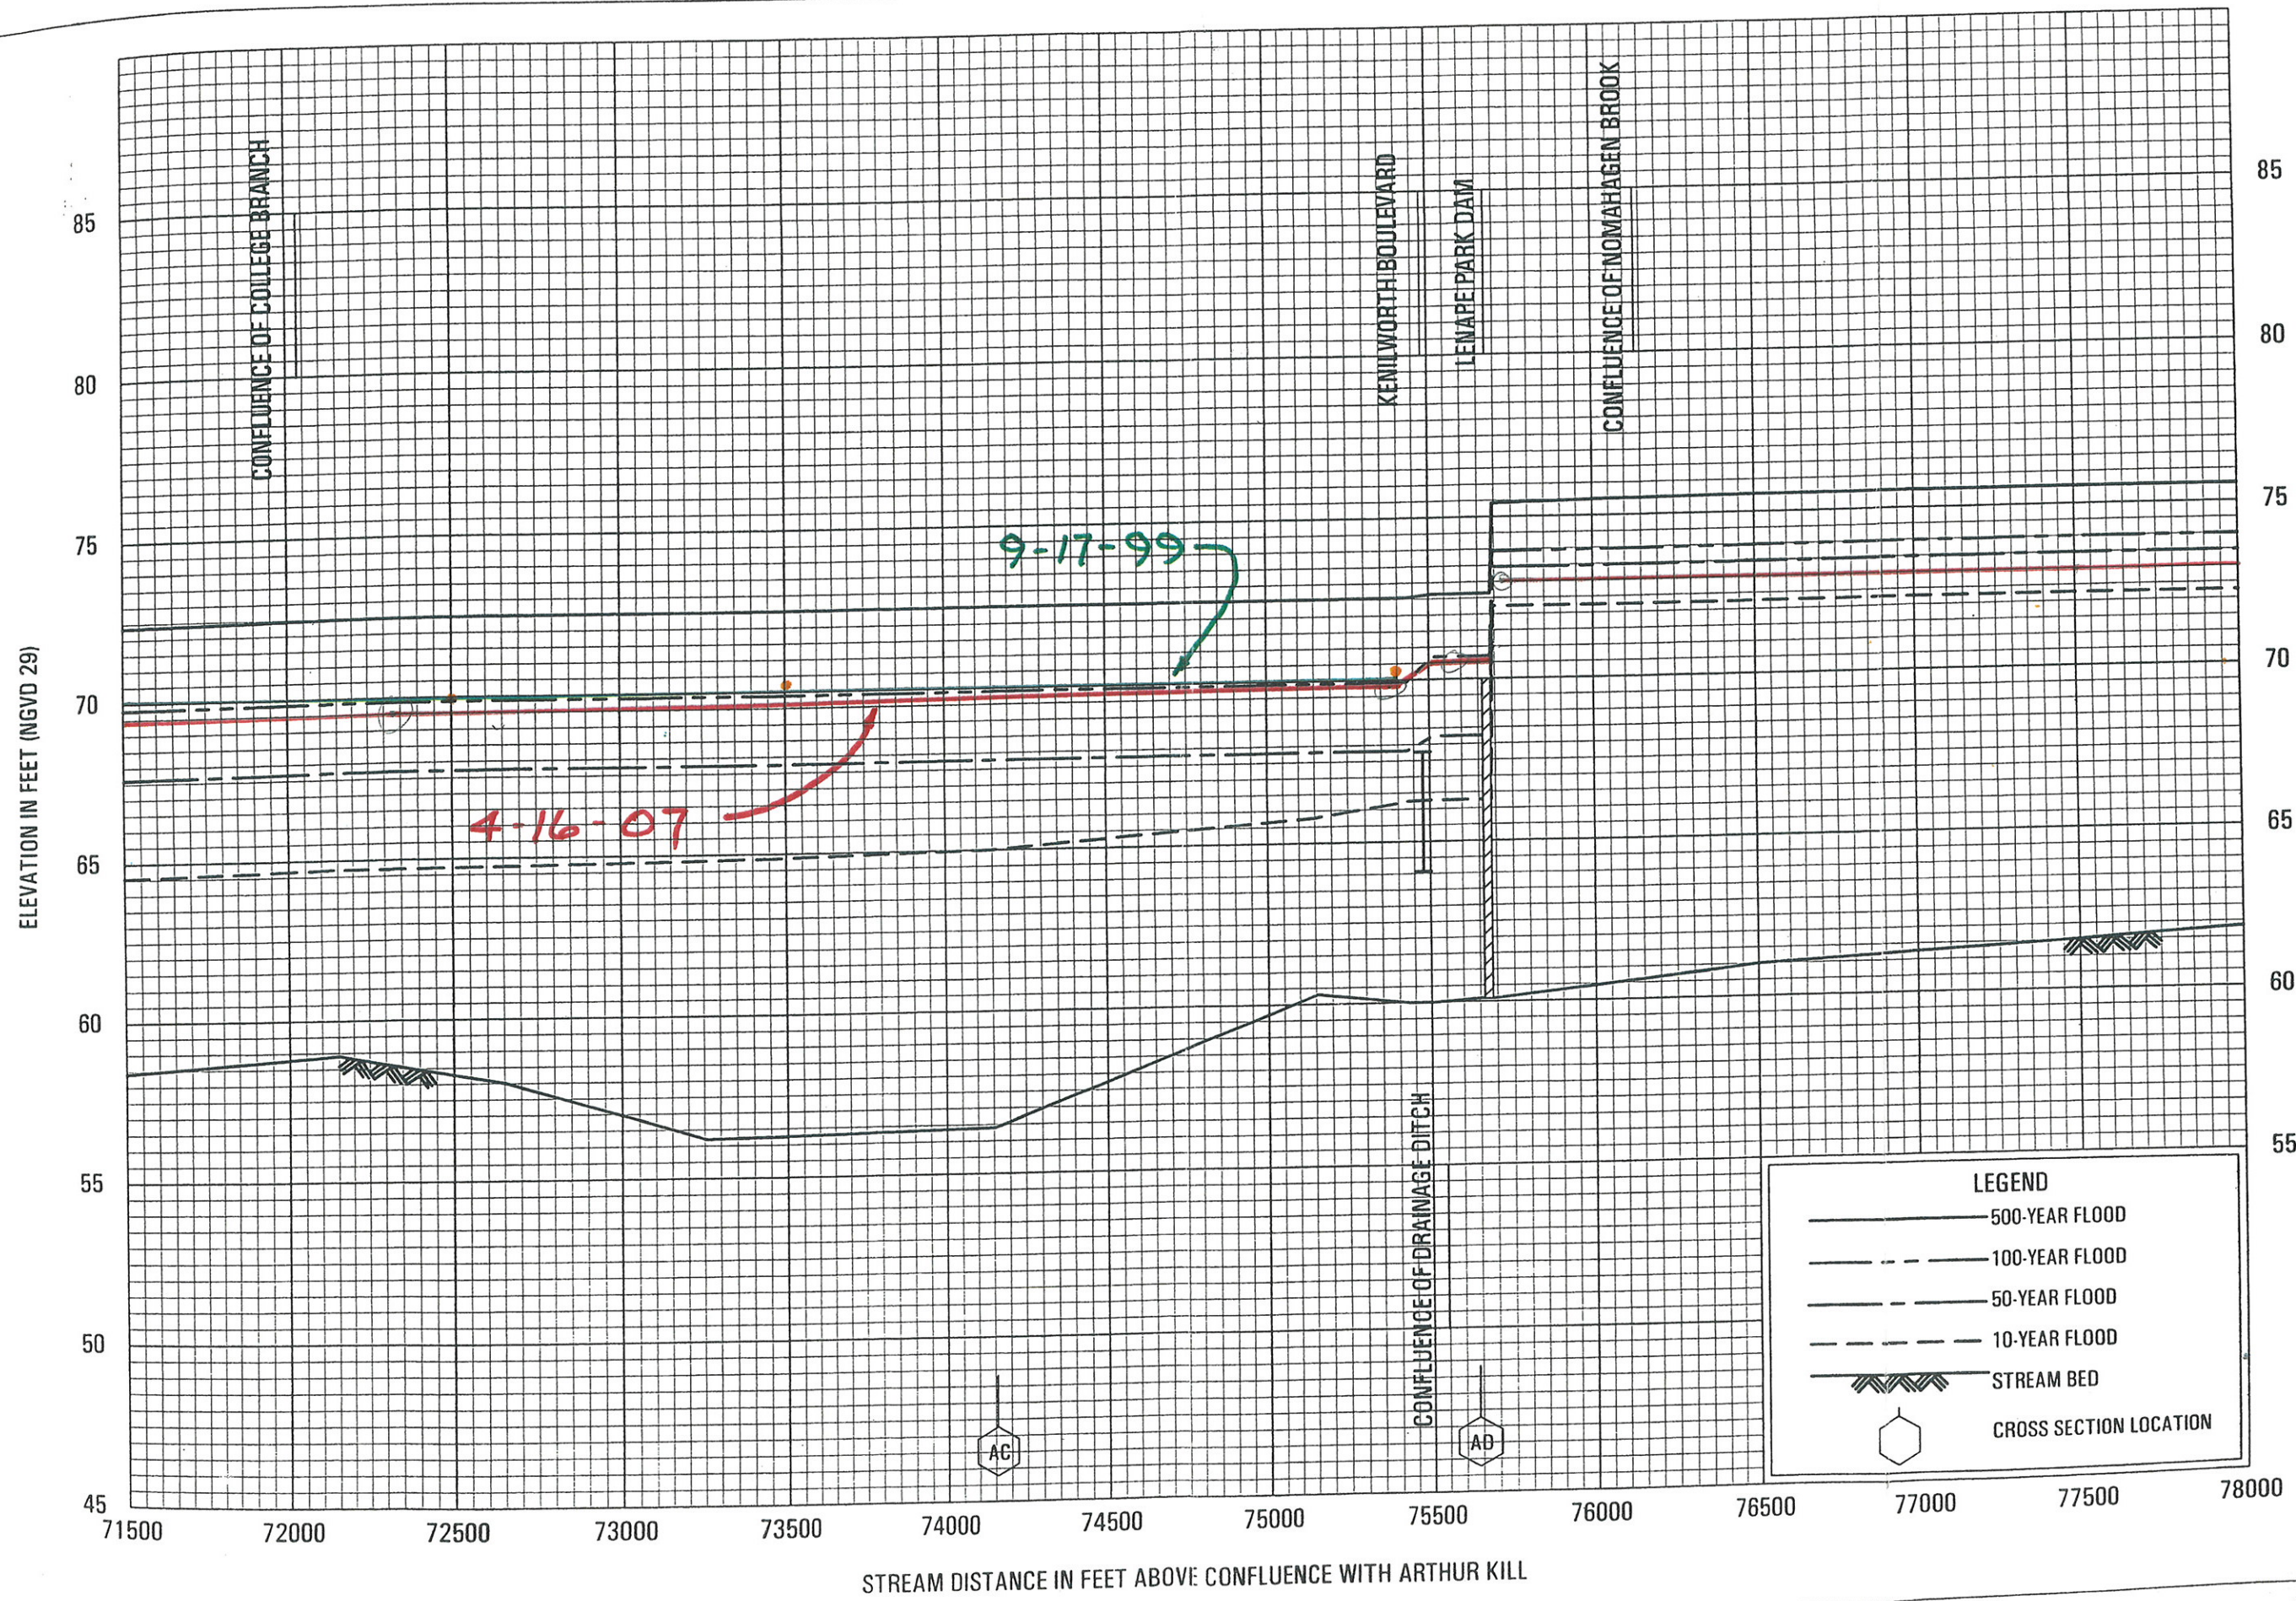
FLOOD PROFILES

**2.5 HOW THIS STORM COMPARED TO FLOYD AND FEMA:** From the flood elevation data recovered in the field, as shown on Exhibit H, the Engineering Department plotted the profile of the Tax Day Storm and Floyd over the new FEMA profiles. (See Exhibit I ‘Flood Profiles”). Both the chart (Exhibit H) and the Flood Profiles (Exhibit I) show that this April 15, 2007 Tax Day Storm was lower then the 1999 hurricane Floyd storm. The variation went from as small as 0.25 feet to as large as 1.15 feet. In the area of the dikes, the variation was much tighter and only averaged 0.5 feet. From South Avenue, and going downstream, both Floyd and the Tax Day Storms were higher then the FEMA projected 100-year storm. From South Avenue, and going upstream, Floyd was pretty much the same height as the FEMA 100 year event projection. Only in the area between Springfield Avenue Bridge located near Hampton Road and the Belmiere Parkway Footbridge did both the Floyd and Tax Day Storms surpass the FEMA 100 year storm projections. Beginning from the footbridge all the way to Lenape Park Detention Basin the Tax Day Storm was just under the 100-year FEMA flood elevation projections, However this storm was much higher then the FEMA 50-year flood elevation projections.

**3.2 STORM CLASSIFICATION:** Based on the 61 peak flood elevations recovered by the Engineering Department, the 2007 Tax Day Storm did not peak as high as the 1999 Floyd Storm. However, in the south end of the Township this storm did peak beyond the FEMA 100-year probability storm. Only in the area between the Balmiere Footbridge and the Lenape Basin did this Tax Day Storm not surpass the FEMA 100-year projected storm, but it was much higher than the FEMA 50 year projected storm. By observing the placement of the peak height of this storm on the FEMA Flood maps, it would appear that this storm in the north end of the township would be between the 80 and 100-year event.

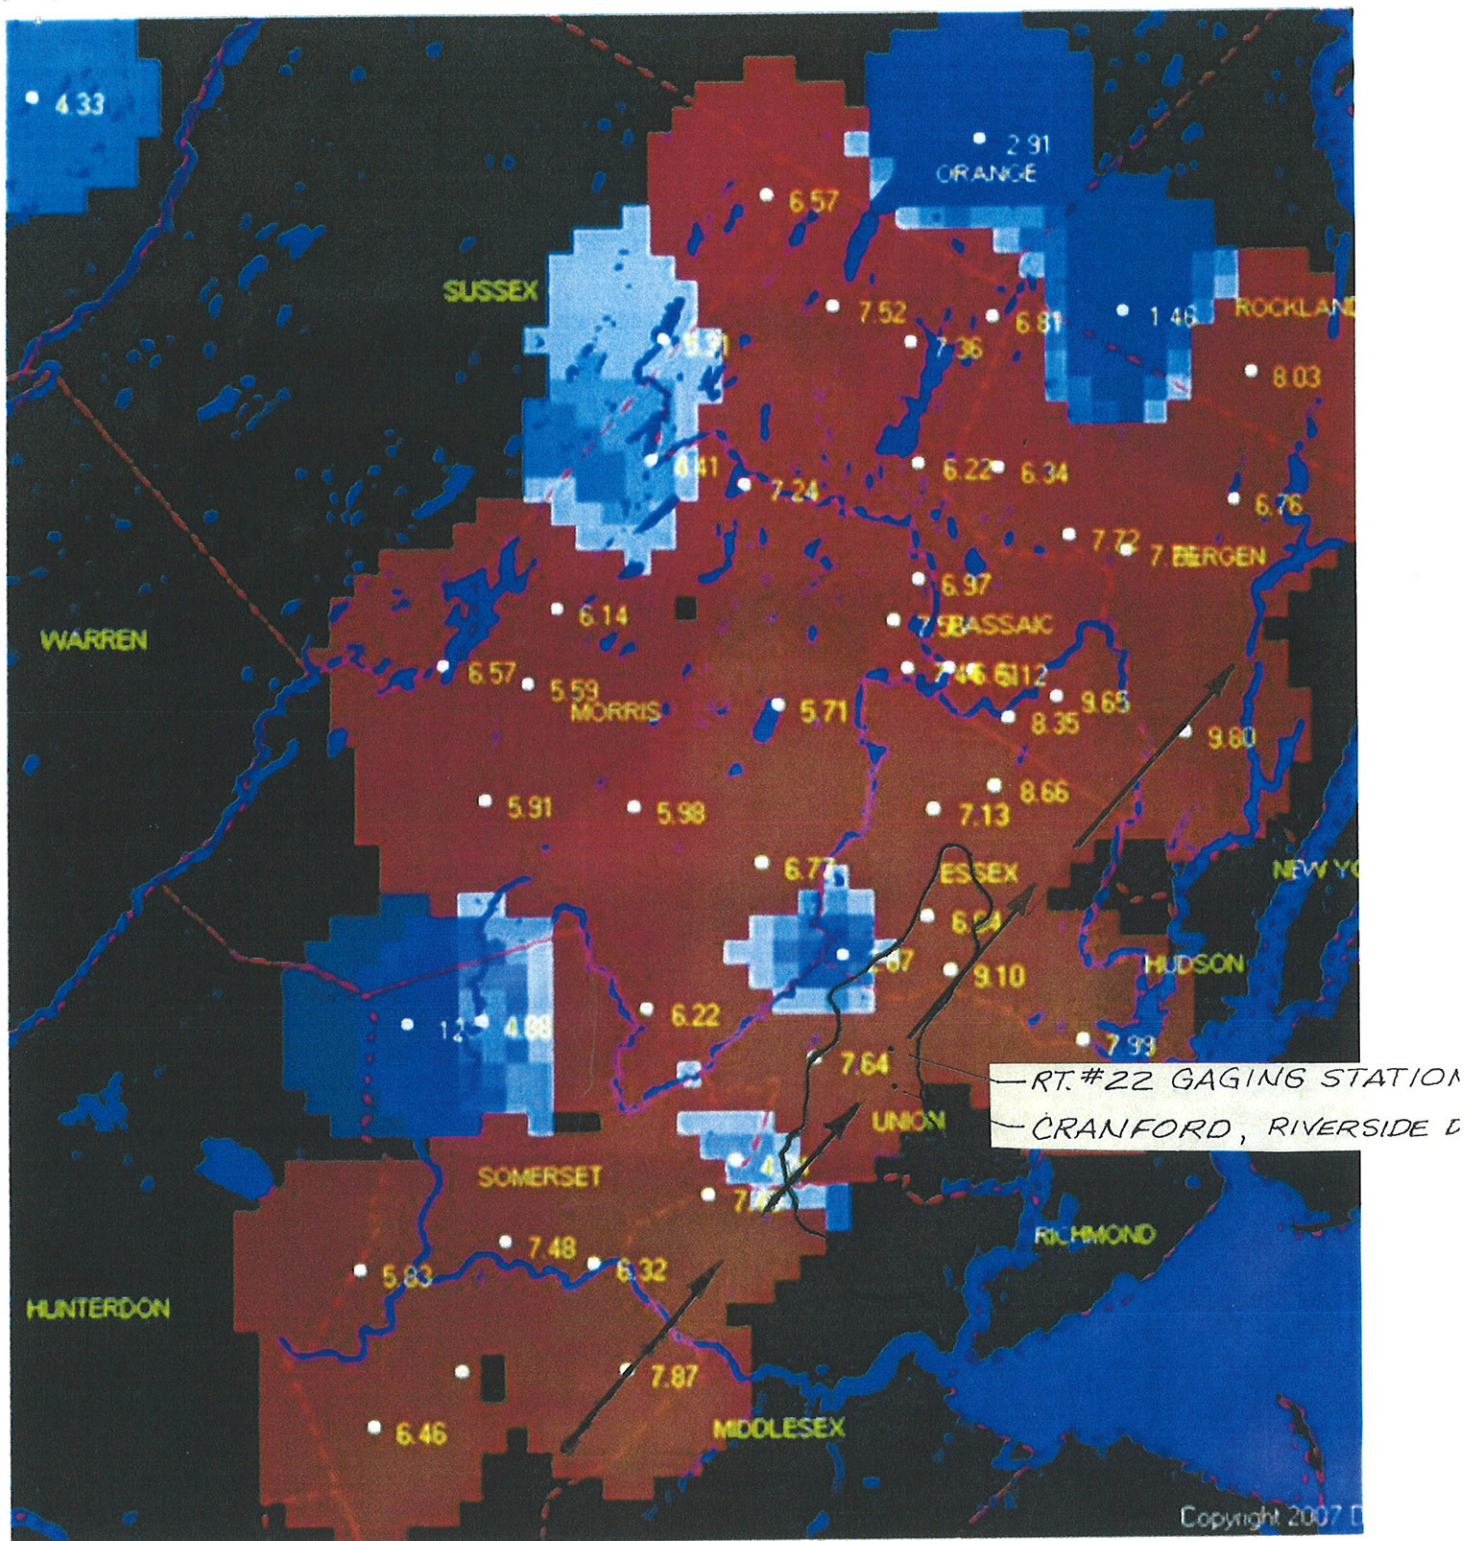
**PRECIPITATION TOTALS  
IN NEW JERSEY  
EXHIBIT D**

**2.2.2 Tract of Storm:** The storm developed over Texas on April 13, and move off the coast of Virginia on late Sunday, April 15. The storm then moved slowly northward reaching the New York City area early Monday Morning April 16. The heaviest rainfall tract of this storm went through the center of New Jersey. (See Exhibit C, “Map of Tract of Heaviest Precipitation of Storm,” taken from a USGS report entitled “Summary of April 15-18, 2007 Flooding in New Jersey.”) Based on the precipitation total from IFLOWS rain gages in northern New Jersey, as represented on a map in the same above referenced USGS report, the tract of the heaviest rain, shown in inches, came through Cranford. (See Exhibit D, “Precipitation Total in North Jersey”)

**2.2.3 Precipitation:** Even though the National Weather Service indicated that precipitation totals averaged between 5 to 7 inches across most of the state, this thin tract of heavy rain dumped 9.1 inches over the Irvington area, and 7.87 inches in the New Brunswick area. On either side of this tract in the Union County Area, a low of 2.87 inches was recorded in Millburn area and very little rain was deposited in the Woodbridge area, as can be seen from this Exhibit D map. Even the local newspaper, The Star Ledger, reported that a cumulative 10.27 inches of rain fell in Newark, and stated that other areas got as little as April showers. (See Exhibit E “Cumulative Rainfall Yesterday in Newark”) Based on this precipitation information, Cranford may have gotten over 8 inches of rain in less than a 24-hour period. There were areas in Cranford that had flooding that normally do not have flooding. For example, it was reported that Casio Brook system, located to the west of the river, flooded so high that the entire roadway that parallels the brook, Casio Avenue, was a raging river, not seen by the residents in the area before.
