Area in Need of Rehabilitation Report

Certain Properties on South Avenue
and Chestnut Street

Township of Cranford

January 28, 2021

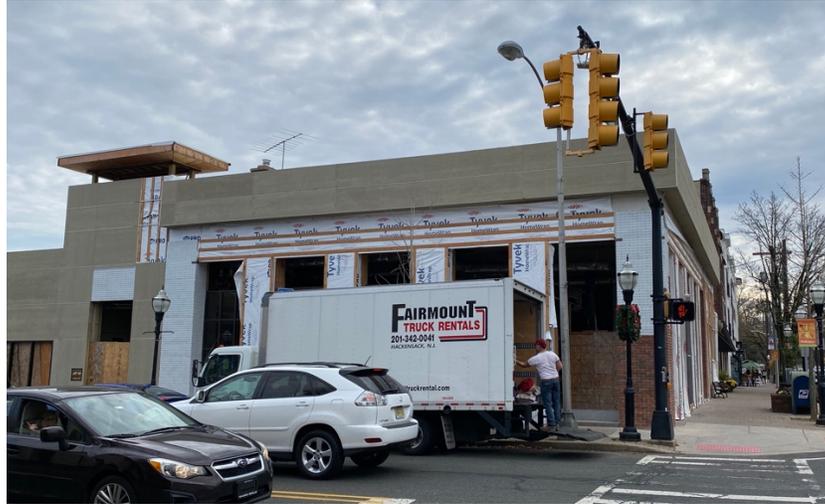
Based upon an inspection of the property, Block 478, Lot 1.01 does **not** meet Condition 1 as the one-story commercial building on site is currently undergoing extensive renovation of both the façade and interior.

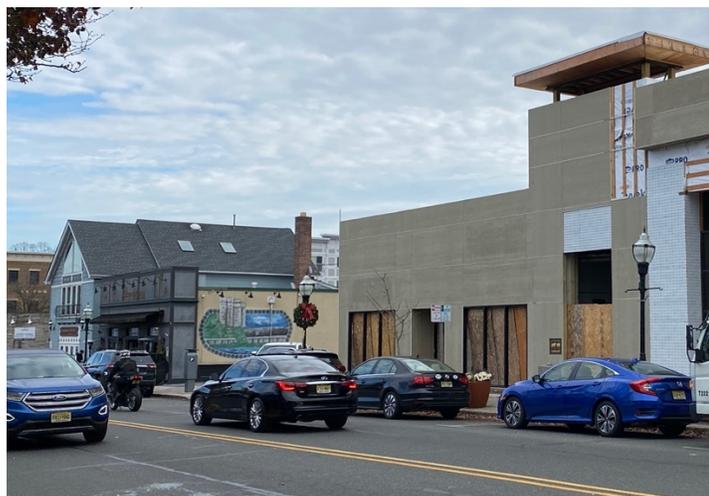
Based upon an inspection of the property, Block 478, Lot 1.02 does **not** meet Condition 1 as the one-story commercial building on site is currently undergoing extensive renovation of both the façade and interior.

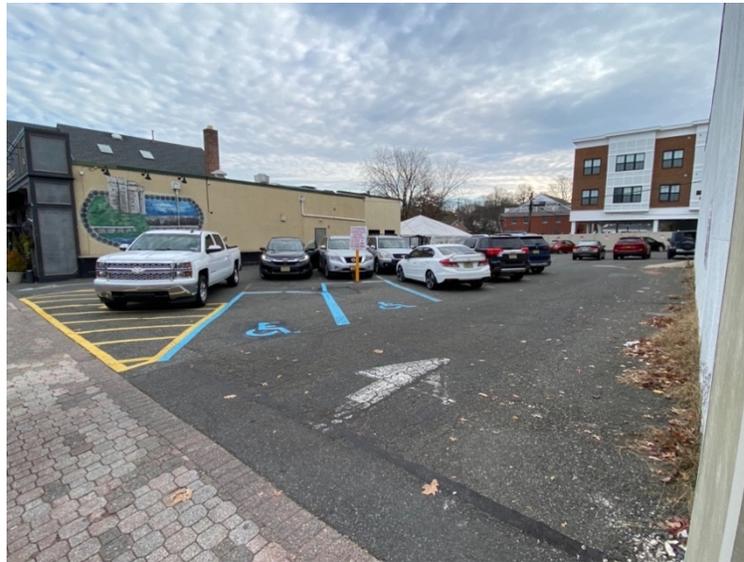
Based upon an inspection of the property, Block 478, Lot 2 does **not** meet Condition 1 as the property is a surface parking lot without any structures.

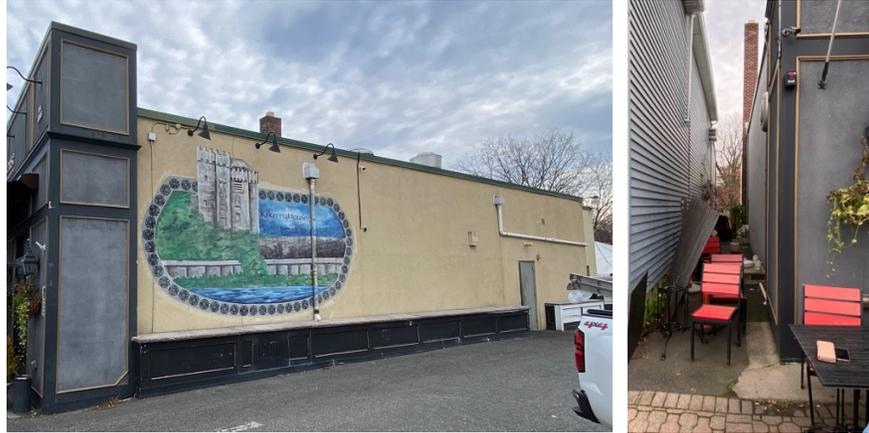
Based upon an inspection of the property, Block 478, Lot 3 meets Condition 1 as the structures thereon are in a deteriorated condition.

The property contains a one-story commercial building. The building shows signs of deterioration as evidenced by cracked masonry, wood paneling and damaged stone 3' tall addition along the western façade. Also, the fence separating the site from an abutting commercial property on South Avenue East is in need of replacing or repair. Finally, the fence gate enclosing the side alley is broken and partially unhinged.

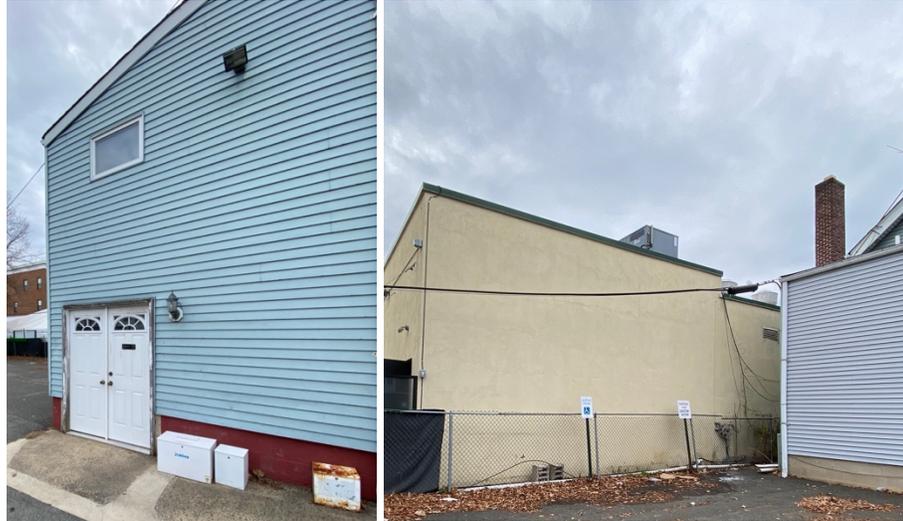
Based upon an inspection of the property, Block 478, Lot 4 meets Condition 1 as the structures thereon are in a deteriorated condition.

The property contains a three-story commercial building with parking in the rear accessible from South Avenue East by means of a driveway. The building shows signs of deterioration as evidenced by missing downspouts, damaged door frames, and peeling paint. Also, the fence separating the site from an abutting commercial property on South Avenue East is need of replacing or repair.

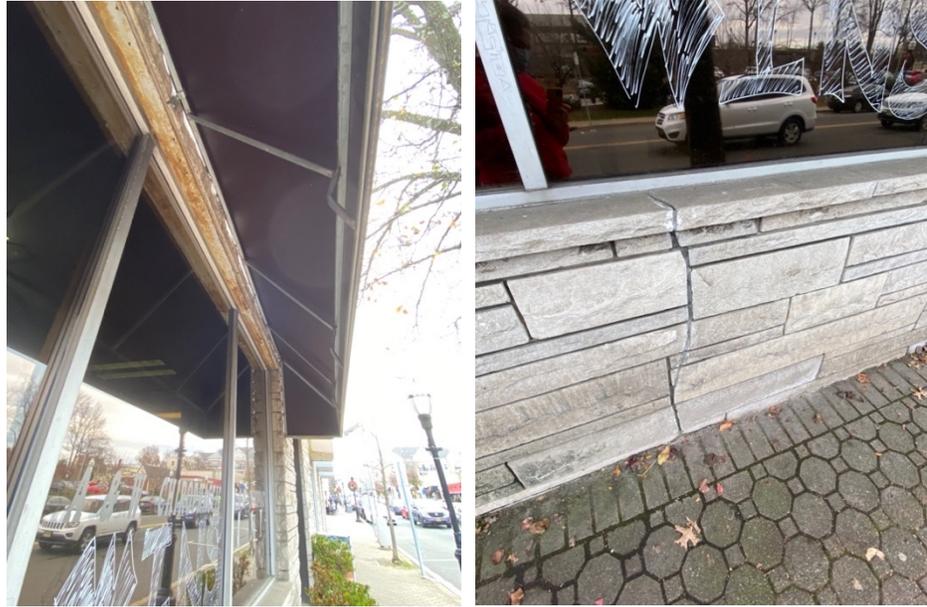
Based upon an inspection of the property, Block 478, Lot 5 meets Condition 1 as the structure thereon is in a deteriorated condition.

The property contains a one-story commercial building with three separate storefronts. The building is in a deteriorated condition as exhibited by cracked masonry, damaged window frames and storefront awnings, and damaged gutters causing water damage on the façade facing the rear parking area.

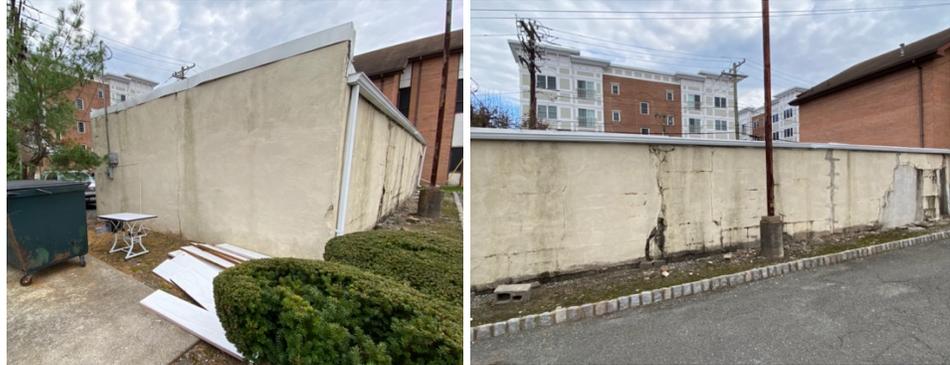
Based upon an inspection of the property, Block 478, Lot 6 meets Condition 1 as the structure thereon is in a deteriorated condition.

The property contains a one-story commercial building with three garage bays fronting on High Street. The building is in a deteriorated condition as exhibited by cracked and spalling masonry, fascia elements in need of repair, and patch mortar work.

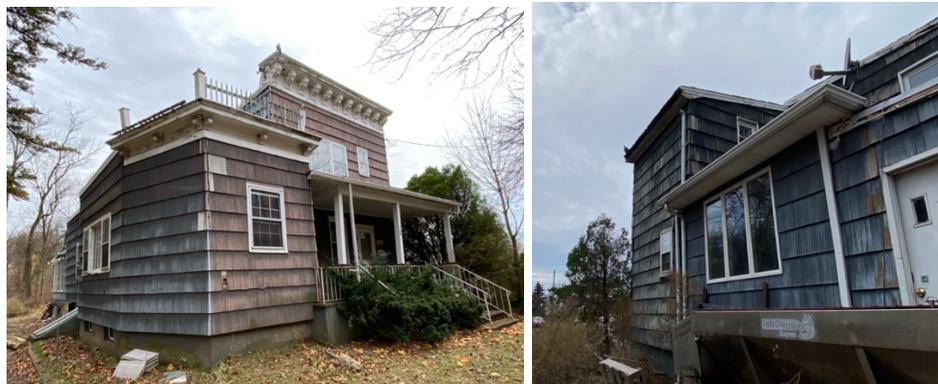
Based upon an inspection of the property, Block 483, Lot 18 meets Condition 1 as the structure thereon is in a deteriorated condition.

This property contains a residential two-story structure located on the western riverbank of the Rahway River. The single-family detached home evidences severe deterioration as exhibited in missing siding, broken and missing roof elements, peeling paint, a cracked foundational wall, and damaged window frames.

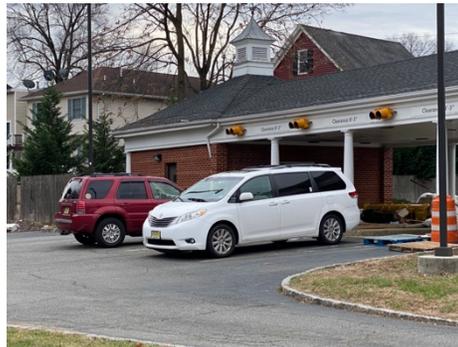
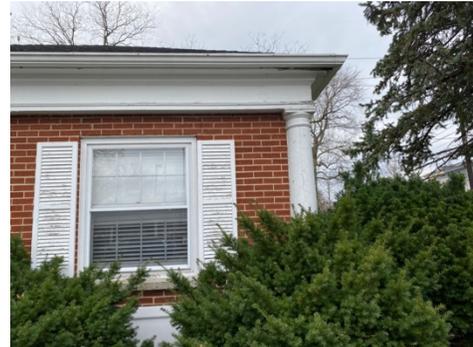
Based upon an inspection of the property, Block 484, Lot 19.01 meets Condition 1 as the structures thereon are in a deteriorated condition.

This site contains two principal buildings formerly used for a commercial bank operation. In addition to the main one-story building, a separate structure has four drive thru lanes for ATM services. Both structures evidence general structure deterioration as exhibited by cracked masonry, damaged roof and window elements, peeling paint, and broken light fixtures. Furthermore, the fences separating the site from abutting residential properties on Walnut Avenue and High Street are in need of replacing or repair.
