Condemnation Area in Need of Redevelopment Investigation

CRANFORD
—New Jersey—

Block 193, Lots 6.01, 10, 11, 12, 13, and 14

Date Prepared: July 2020

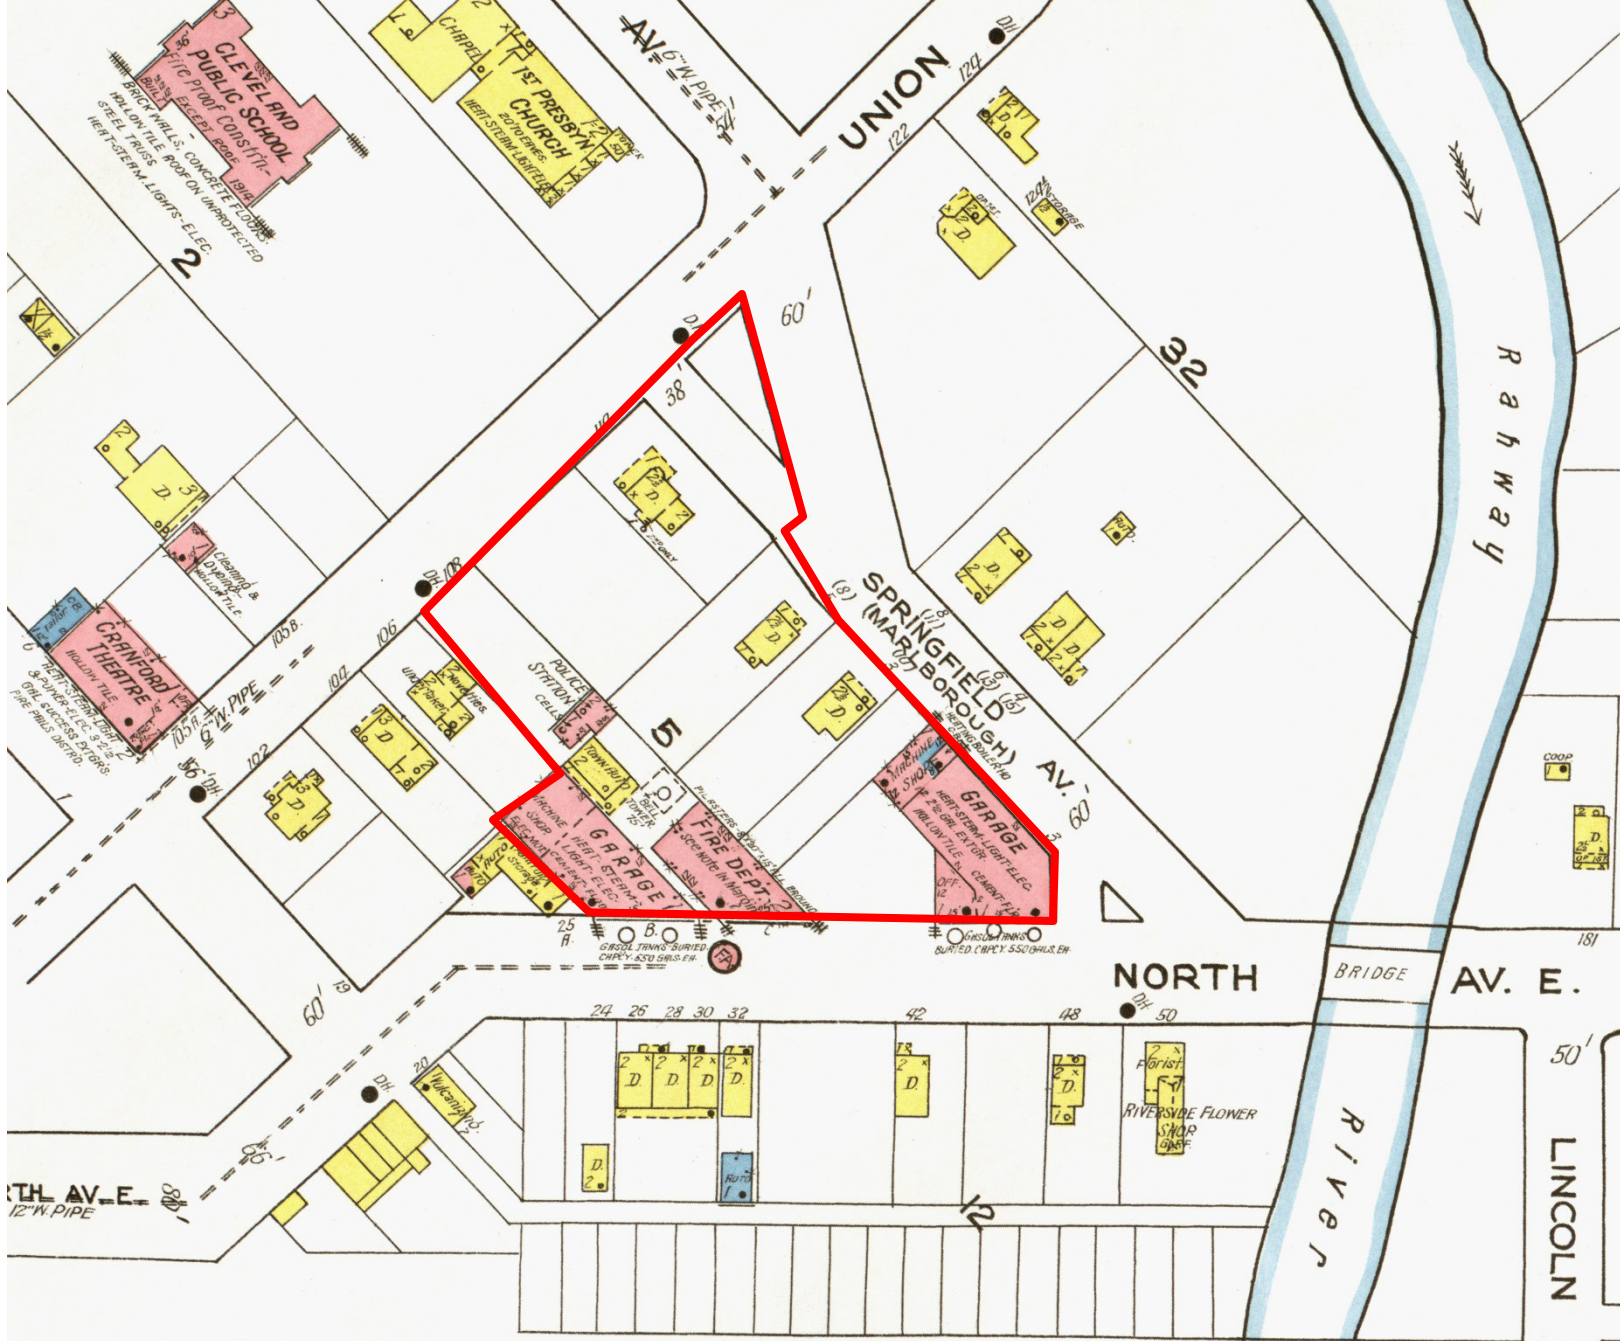
Map 3: 1922 Sanborn Insurance Map of Cranford, with Study Area boundaries approximated.
Source: Princeton University Special Collections

Map 3, which depicts the study area in 1922, suggests that present day Lot 6.01 was formed through the consolidation of multiple lots. These lots included three frame-structured dwellings, two of which appear to be located in the area of the present-day fire station, as well as a police station, fire department, bell tower, and a building labeled "Town Auto" in the southern half of the lot, an area used presently as the Union Avenue North and North Avenue East entrances to the municipal parking lot, and driveway to the municipal fueling station. Property tax data for Lot 6.01 indicates that the existing firehouse structure was originally constructed in 1909; this appears to be incorrect, as subsequent communications with the Township's Fire Chief revealed that the present-

day firehouse was constructed in 1979, and that the previous fire house was located where it is shown on the 1922 Map along North Avenue East.² Additionally, the sewer right-of-way shown on the tax map (Map 2) appears to have been a roadway in 1922.

The structure found on Lot 14 was constructed in 1920, which appears to correspond to the 1922 map showing a brick structure on the property labeled “Garage” and “Machine Shop.”

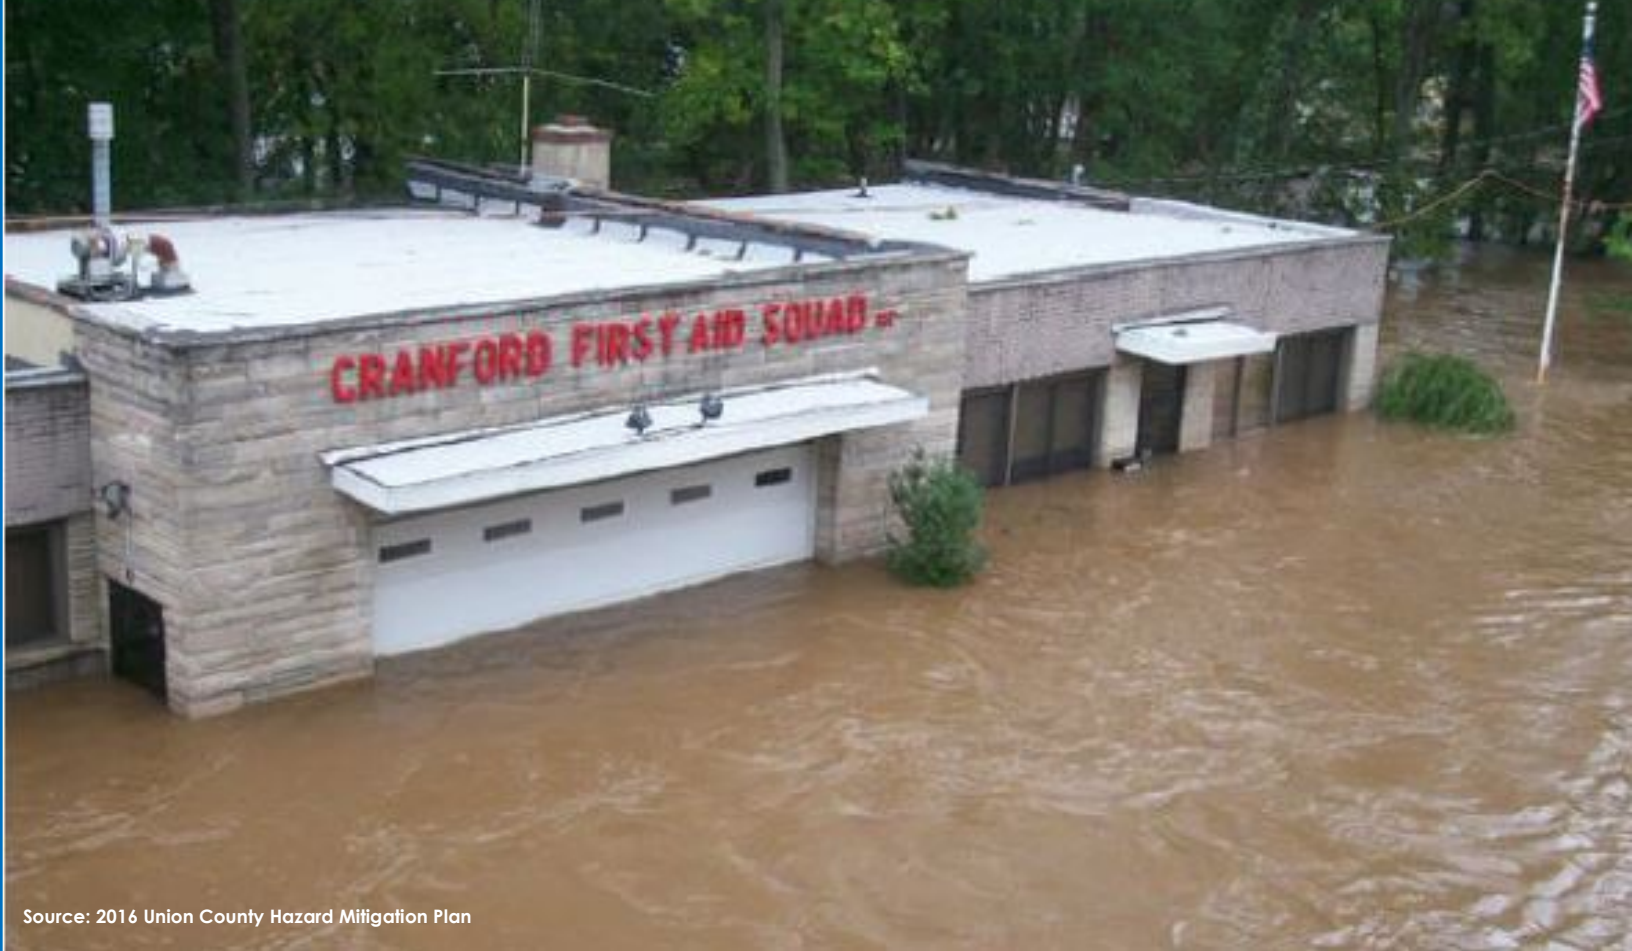
Source: 2016 Union County Hazard Mitigation Plan

residential homes in Cranford including the downtown area."⁷ Generally, though the Study Area is not specifically referenced, flooding poses a concern to the general area. The picture, shown above, is provided in the Hazard Mitigation Plan, which shows the extensive flooding of the Cranford First Aid Squad, which is located less than 300 feet from the southeast portion of the Study Area.

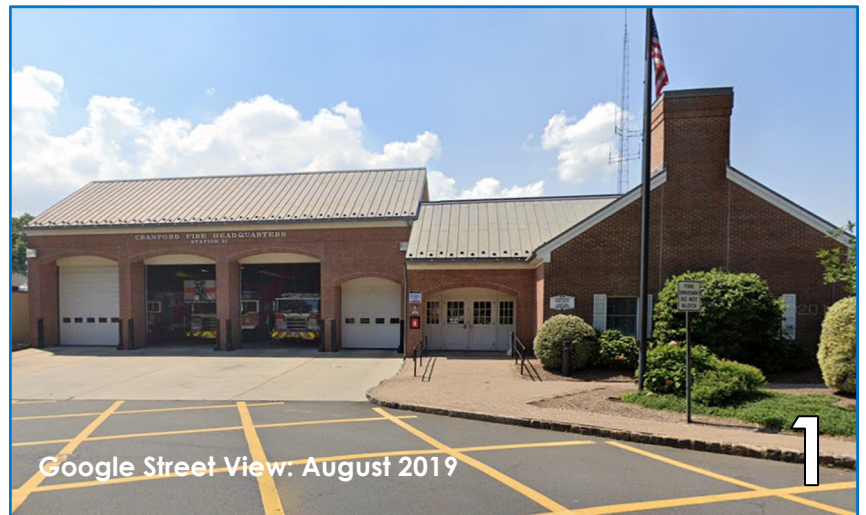
Lot 6.01 is the site of a one-story brick building with frontage on Springfield Ave, occupied by the Cranford Fire Department (**Photo 1**). At the rear of the structure are two fueling pumps—one diesel and one unleaded gasoline—used for Township vehicles.

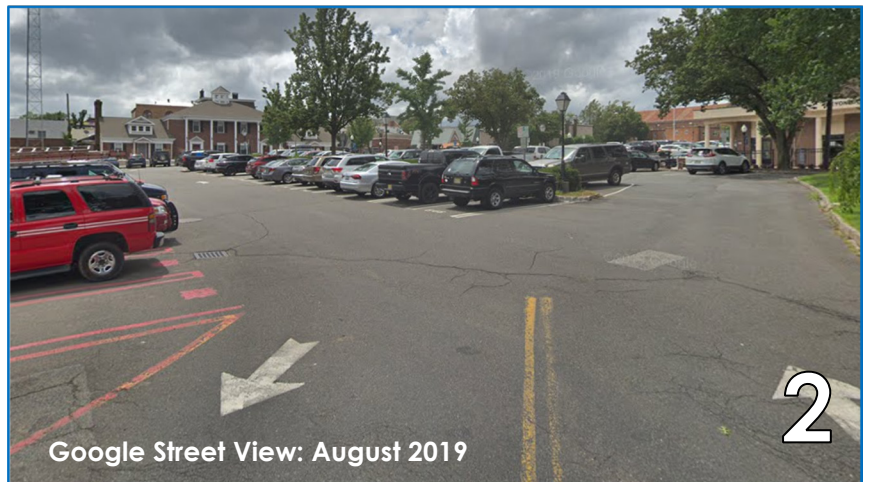
Lot 6.01 is also the site of Municipal Parking Lot #1, which provides 86 public parking spaces (**Photo 2**).

Both uses, when combined with the internal circulation, creates a parcel that is almost entirely impervious. The northern corner of the lot has a gazebo with landscaping around it. This area appears to correspond with a sanitary sewer easement that is shown on the tax maps.

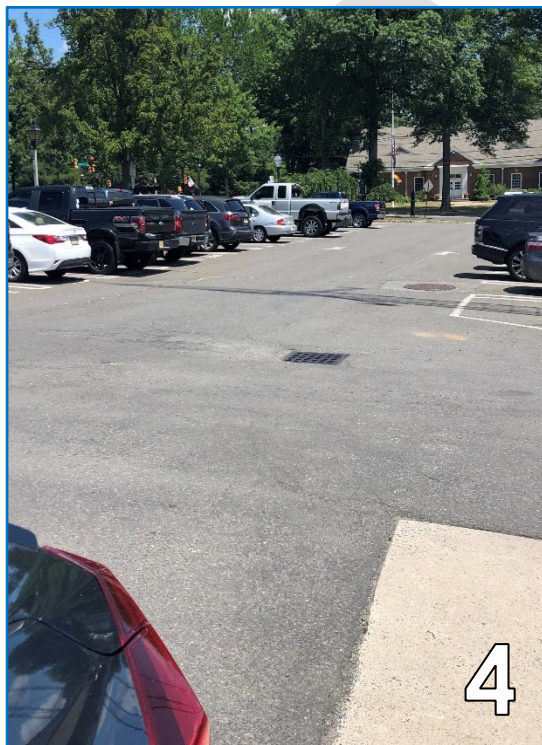
Data from the New Jersey Department of Environmental Protection ("NJDEP") indicates that the site contains multiple underground storage tanks (PI No. 000911), including a 10,000-gallon unleaded gasoline tank and a 2,000-gallon diesel fuel tank. A 550-gallon waste oil tank was removed in 2002.¹⁰ As a result of these underground fueling tanks over the years, the property is identified as a known contaminated site, which is also evident by the numerous monitoring wells located throughout the property (**Photos 7 and 8**).

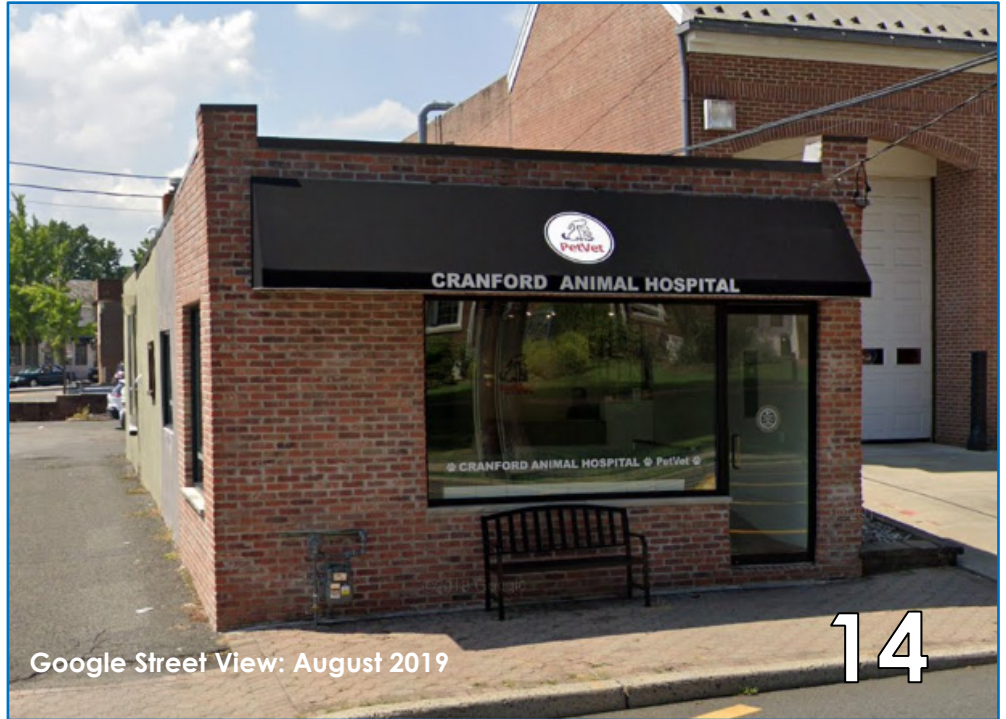
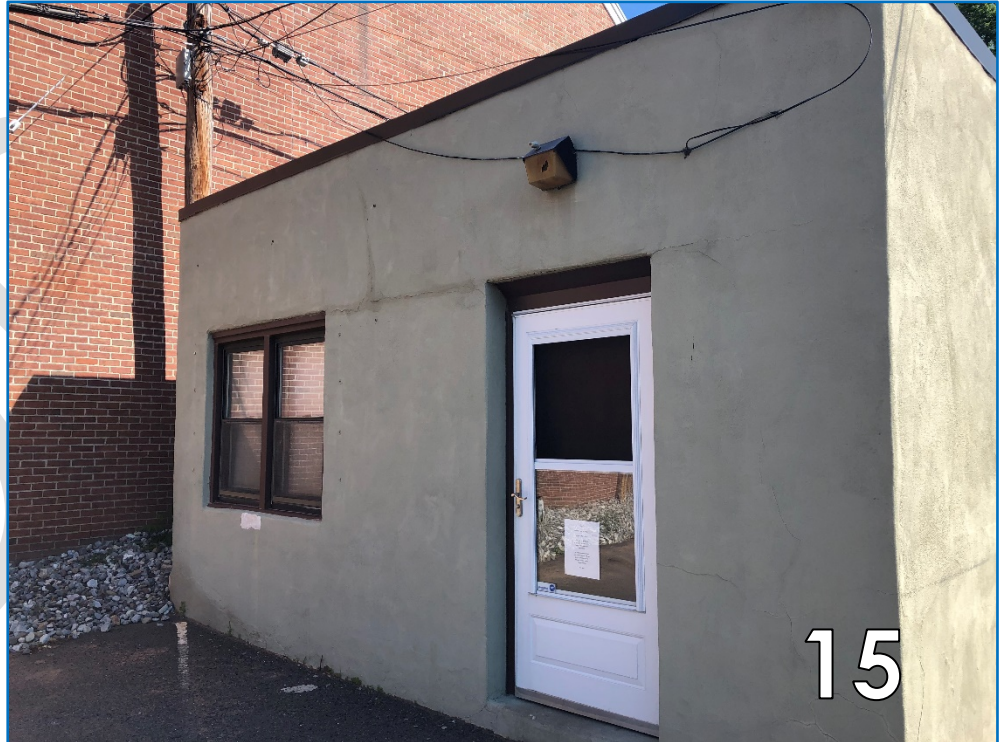
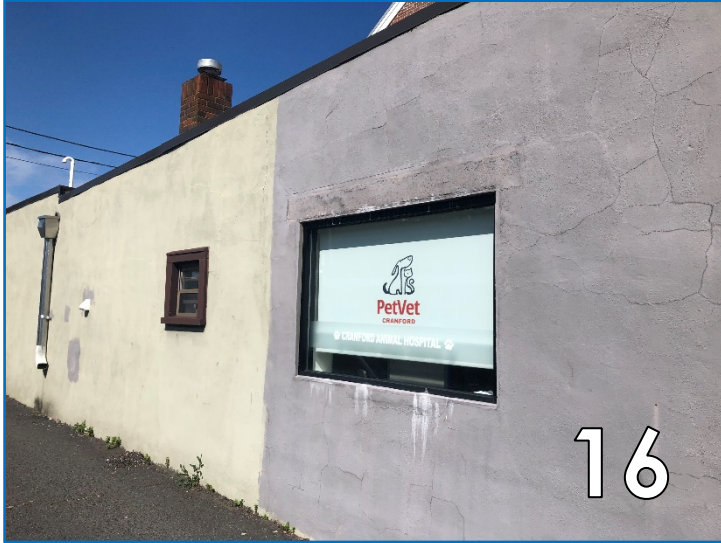
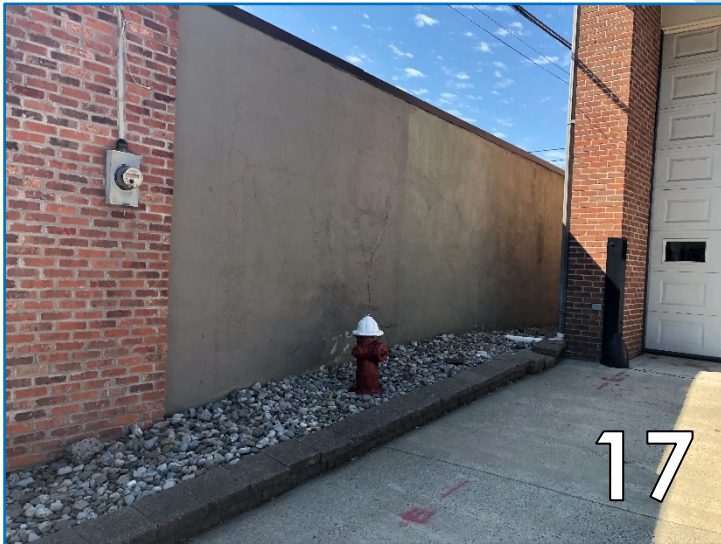
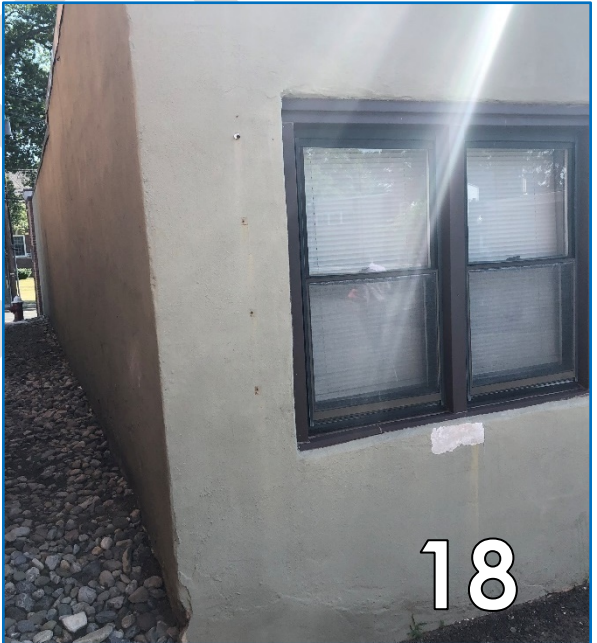
The exterior of the structure is fairly well maintained, with only minor deterioration observed, including a cracked rear light fixture (**Photo 15**), and minor façade damage including cracks and peeling paint (**Photos 16-18**).

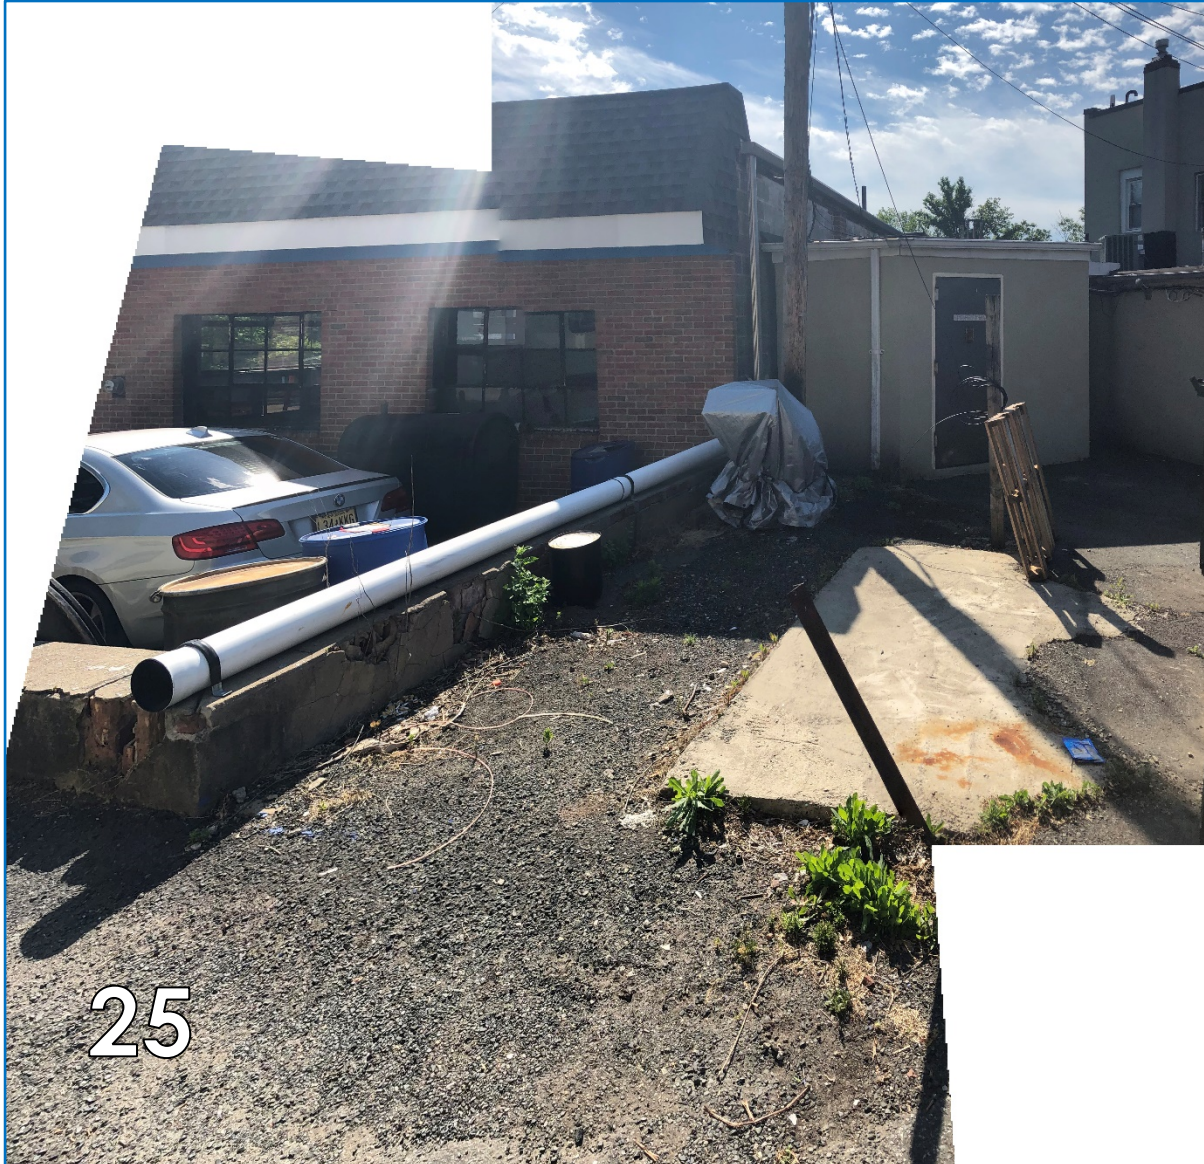
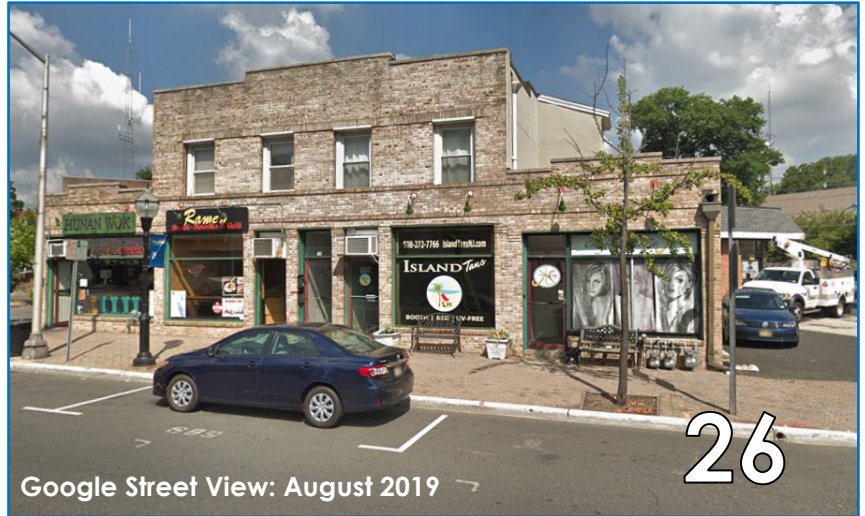
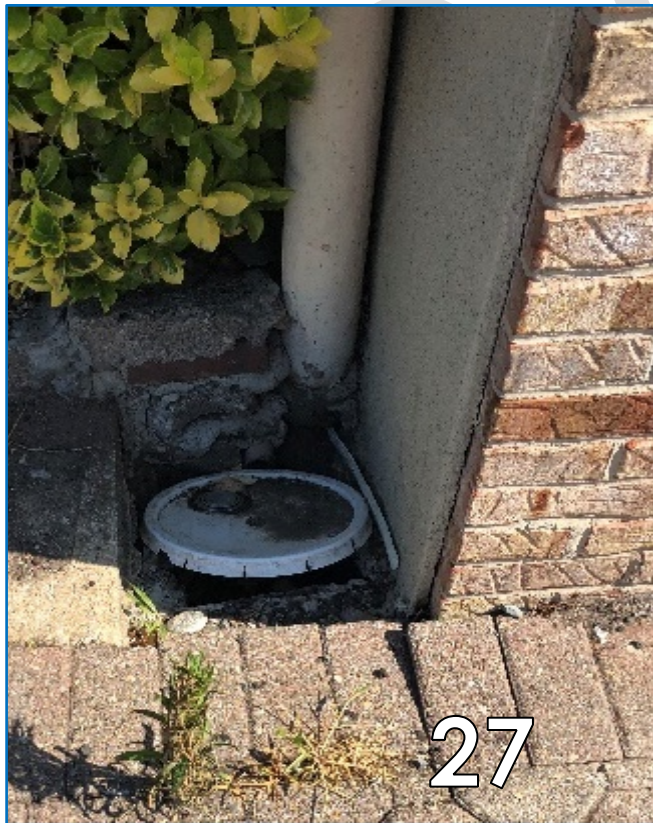
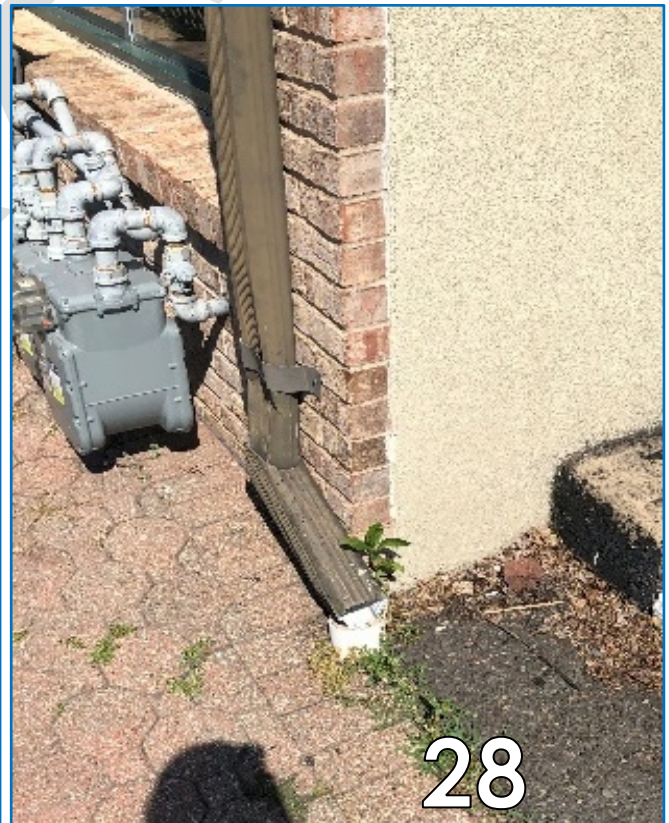
the downspout appears to empty above an open pit, seemingly protected from tripping hazards by a bucket lid. In **Photo 28**, the downspout connection to the drain is not flush, creating the potential for stormwater to empty onto the sidewalk or entrance driveway of the neighboring gas station. Uncontrolled stormwater allows relatively clean rainwater collected on rooftops to pick up various pollutants before emptying into storm drains or the Rahway River. The location of these roof downspouts above walkway and loading areas create a potentially hazardous condition for pedestrians and vehicles, particularly during the winter months when ice can quickly accumulate.

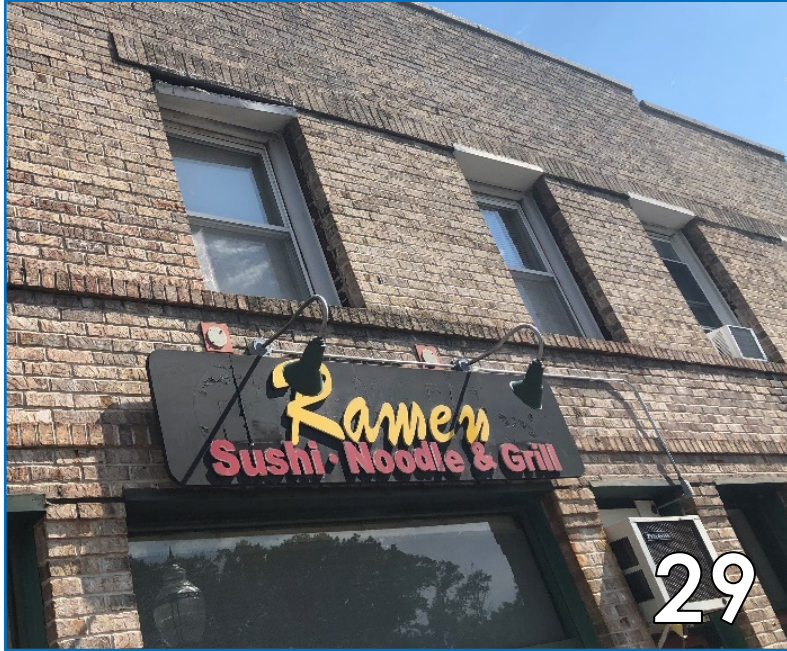
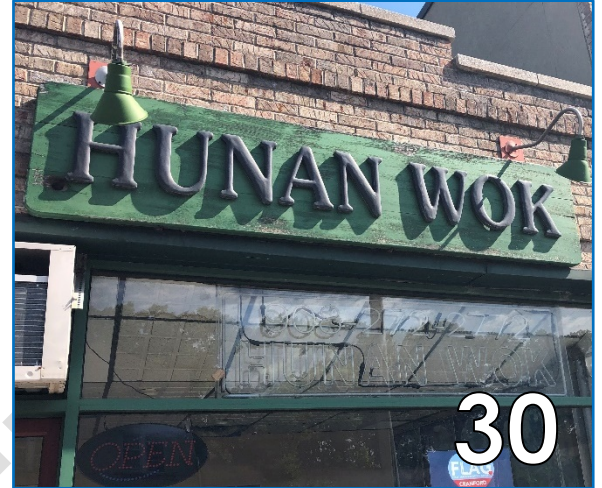
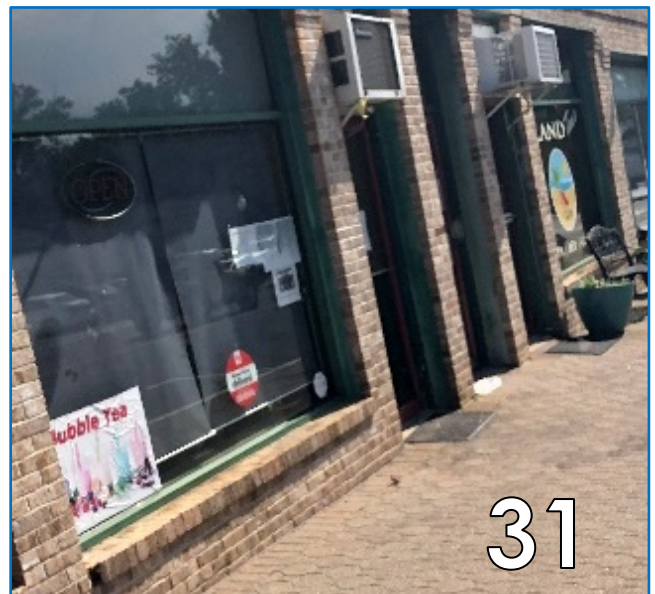
The structure's exterior exhibits minor signs of deterioration, including peeling paint from the wall signs (**Photos 29-30**), a detached window lintel (**Photo 29**), and missing bricks from the front façade (**Photo 31**). As seen in **Photos 29-31**, the entryways for the storefronts each have a window air conditioning unit mounted above the doorway, despite the presence of numerous HVAC units found on the rooftop (**Photos 32-33**). These doorway units each appear to have been modified with a makeshift funnel and tube system to prevent air conditioner condensation from dripping on patrons or pedestrians on the sidewalk. Other unconventional improvements were observed at the rear of the structure, where an enclosure appears to have been constructed above the first floor to provide some shelter for mechanical equipment (**Photos 32-33**); the use of the gardening hose attached to this shelter is not immediately clear, but it would seem that it is also used for the purposes of redirecting air conditioning condensation to the parking area. It is unclear if any of these improvements received or would require a building permit. Similarly, one of the rear access doors seen in **Photos 32-33** appears to be stuffed with plastic sheeting. It is not clear if this is used for insulation or as a makeshift screen.

Similar to Lot 10 (which is in common ownership with Lot 13), the entrance drive appears to be deteriorating, with areas of uneven pavement, cracking, and potholes (**Photo 34**). As visible in **Photos 32-33**, no enclosures for dumpsters and other waste receptacles are provided; this lack of organization between the waste area, parking, loading, and circulation can reduce the overall efficiency of each.

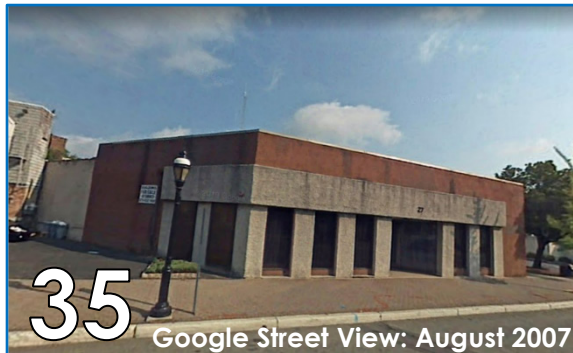
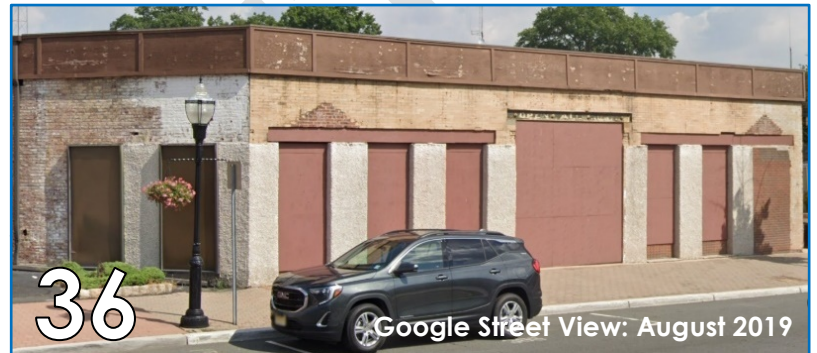
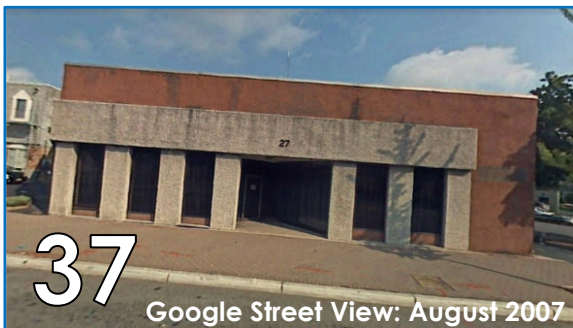
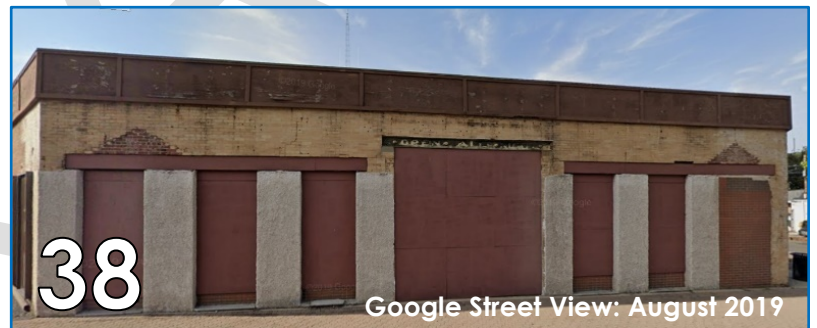
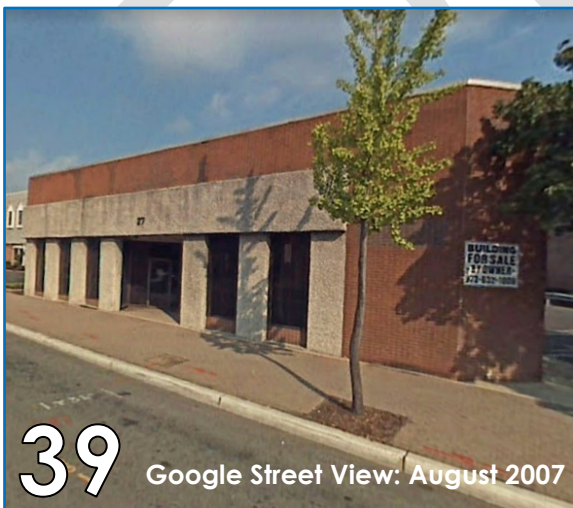
The entirety of Lot 14 consists of a boarded-up one-story building. Records indicate it was previously a commercial use. Based on communications with Township Officials, historic Google Street View imagery, and news articles, the site does not appear to have been utilized since at least since 2007.¹⁶ The building was acquired by the Township in December 2015. The building's rapidly deteriorating facades can be seen in **Photos 35-40** below, which shows the Google Street View imagery in 2007 and 2019. **Photos 41-43** show portions of the brick and exposed aggregate façade peeling away, and **Photos 42-43** show damage to the underlying brick structure, including

As evident in **Photos 35-40** and **Photo 45**, the building's brick facade façade has been removed, leaving only wood, which is also showing signs of deterioration.

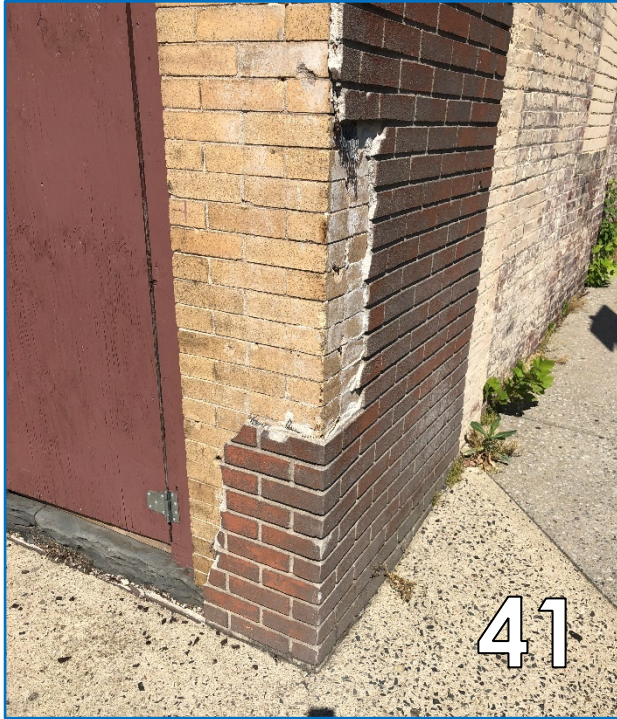
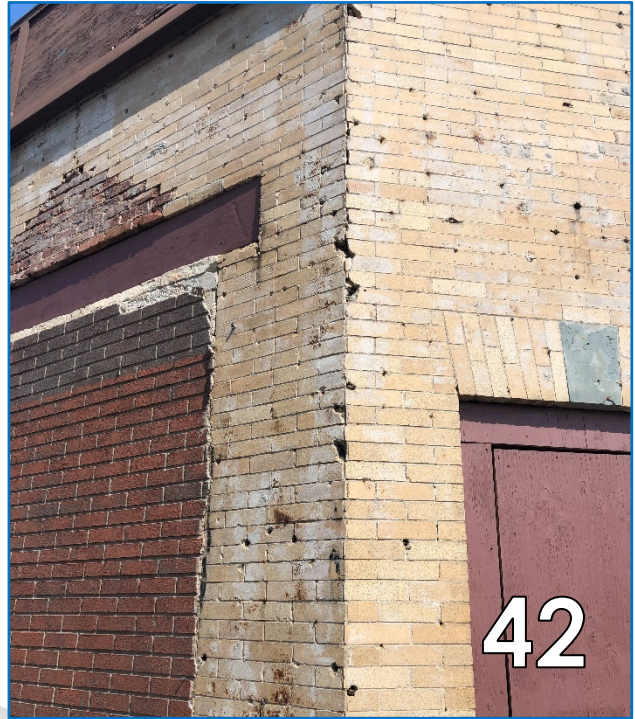
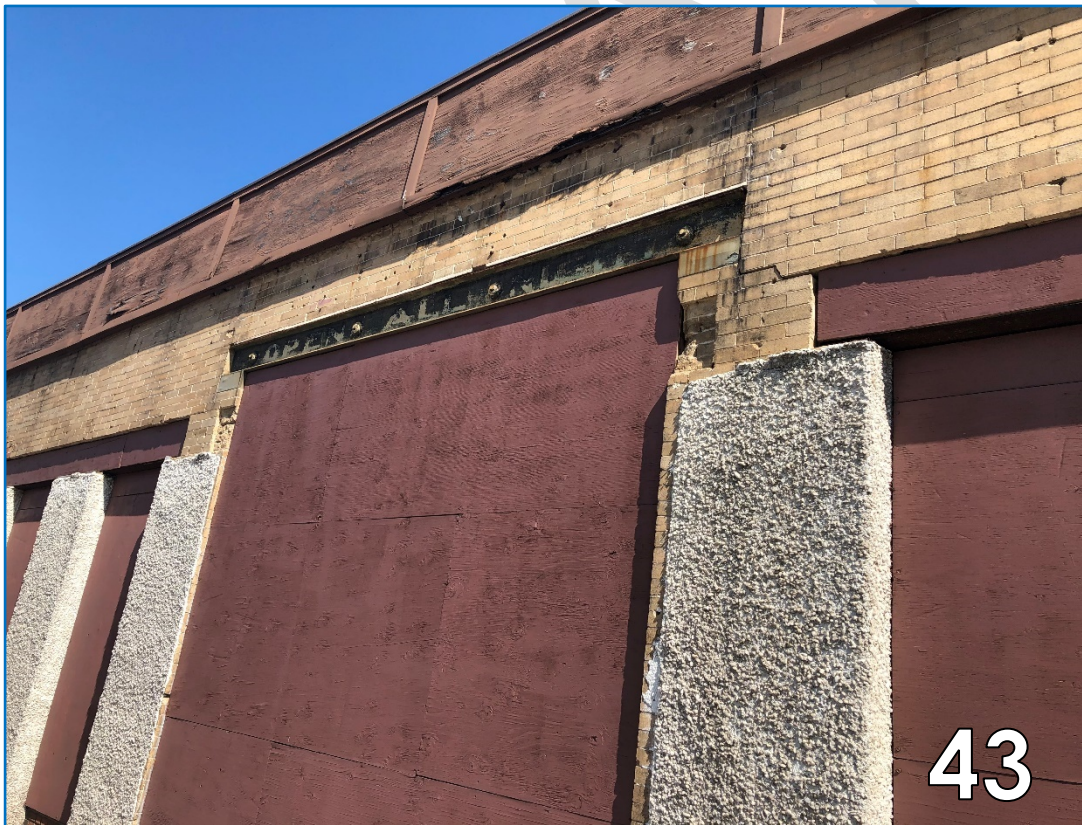
cracks and missing bricks. **Photo 44** shows peeling paint, found primarily on the eastern façade of the structure, facing the public parking lot and along the sidewalk access to the parking lot. It is not clear when this paint was originally applied; if the paint dates back to 1978 or earlier, then it is possible it contains lead.

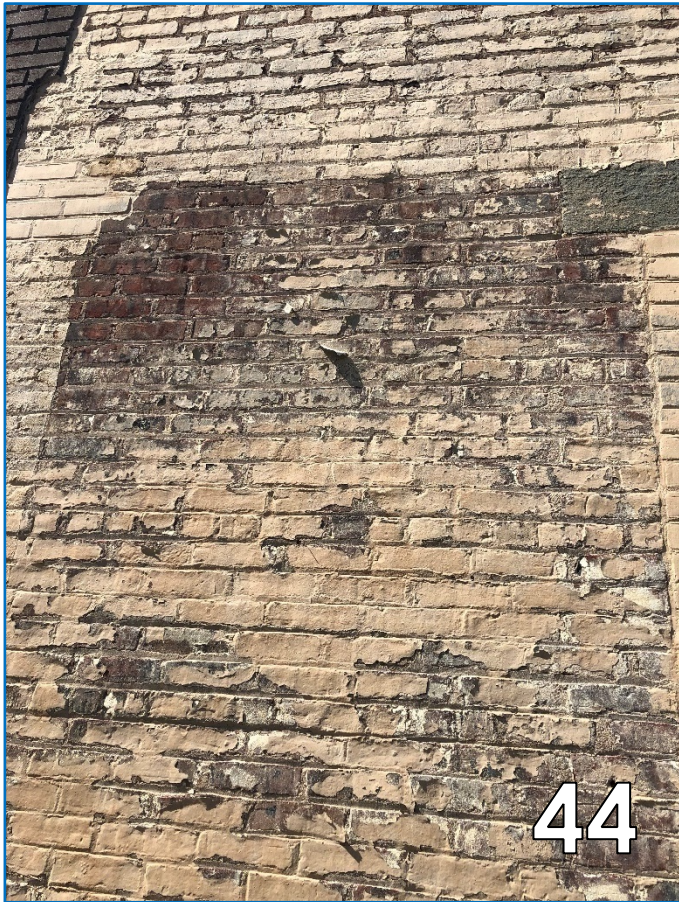
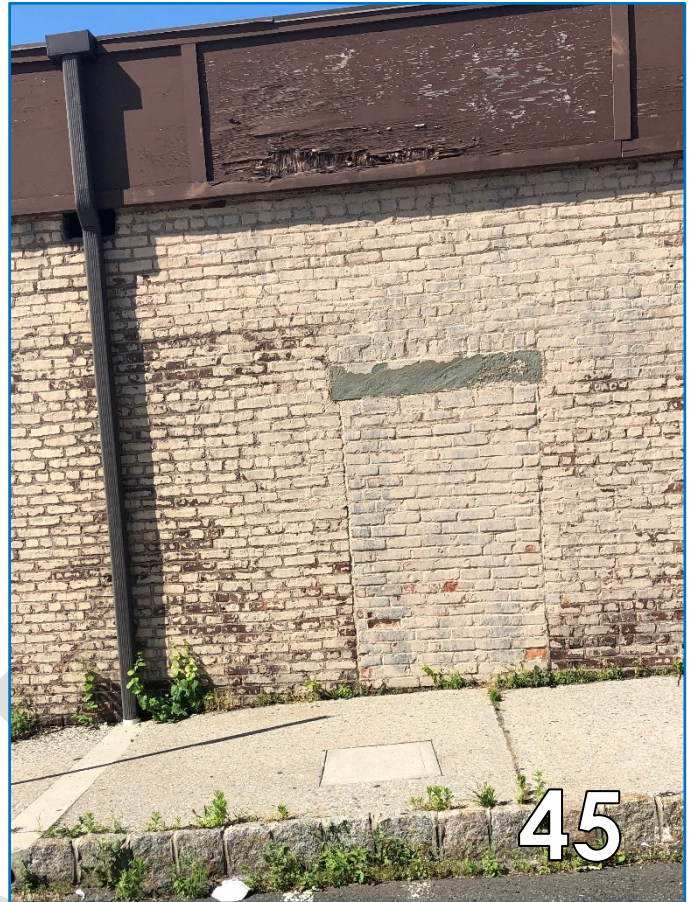
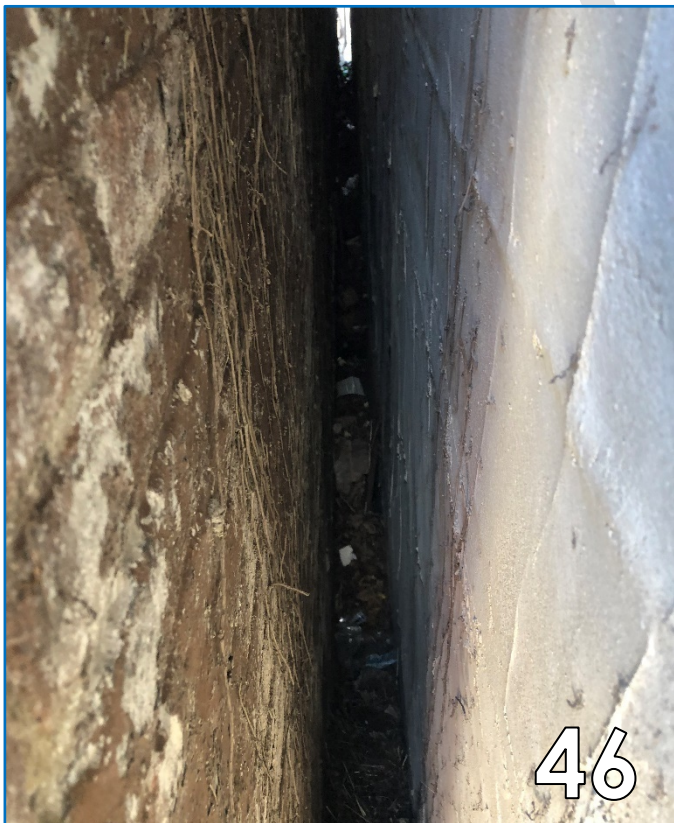
A narrow gap exists between the subject structure and the neighboring property (**Photo 46**) which is filled with litter and bricks. Communication with the neighboring property owner indicates that this has interfered with stormwater drainage, leading to stagnant water that is resting along the foundation of the neighboring structure. There is also a concern that the presence of litter, including food and beverage containers can attract rodents and other pests.

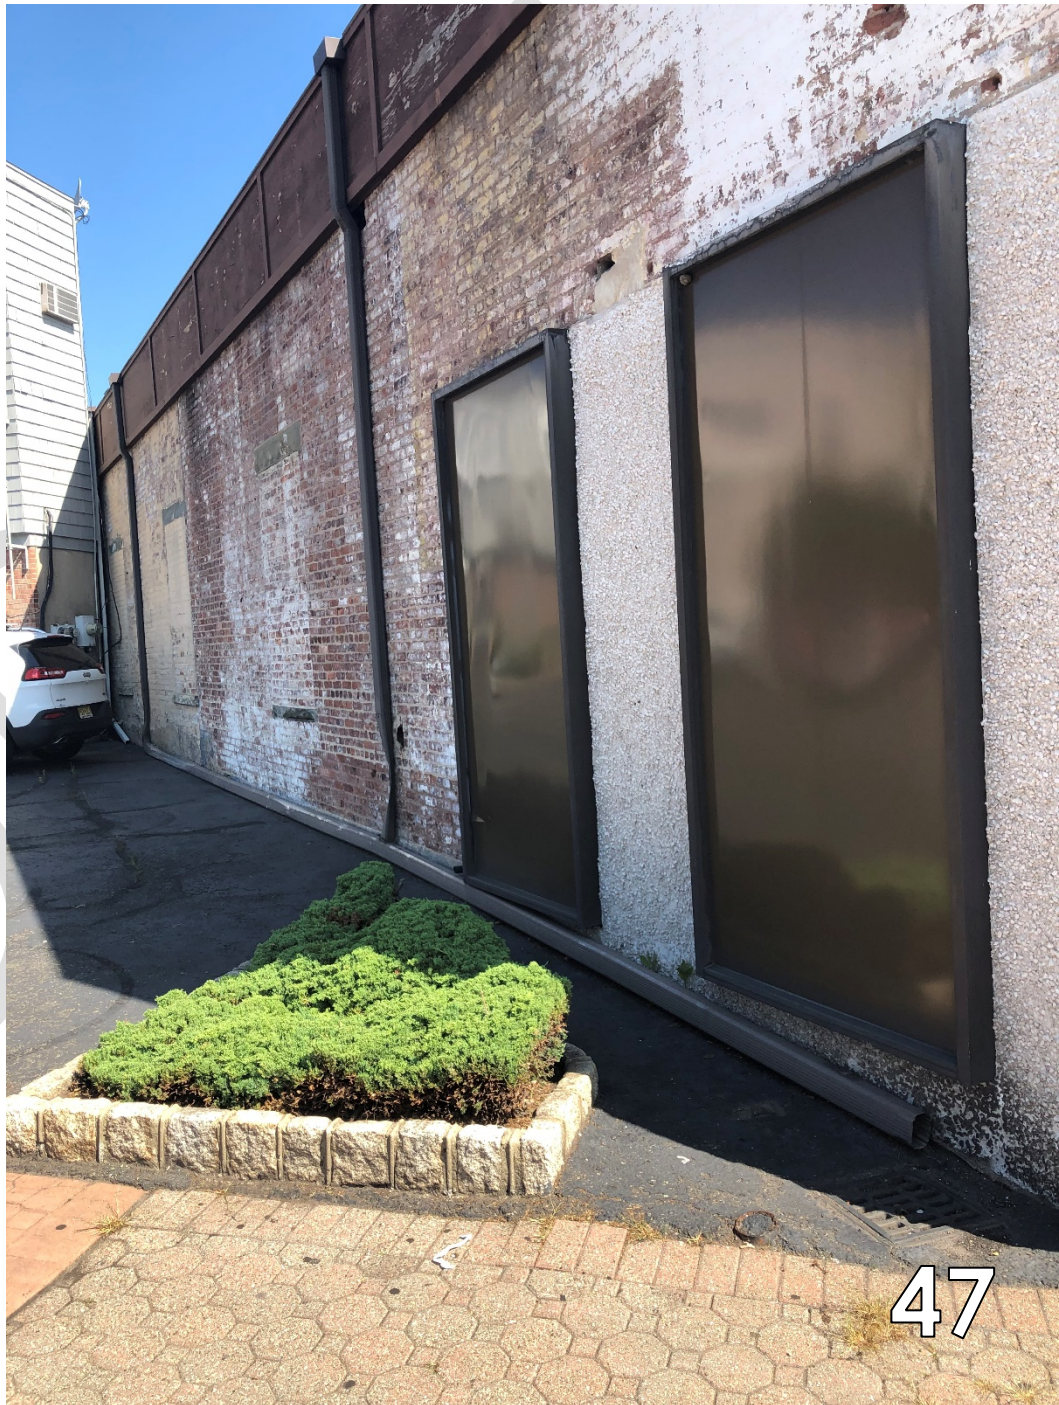
- The structure is in a state of neglect and disrepair since at least 2007, with boarded up windows and doors, peeling paint, and an aging brick infrastructure, including missing or broken bricks (**Photo 47**). Multiple façade treatments to the building are in varying states of disrepair.

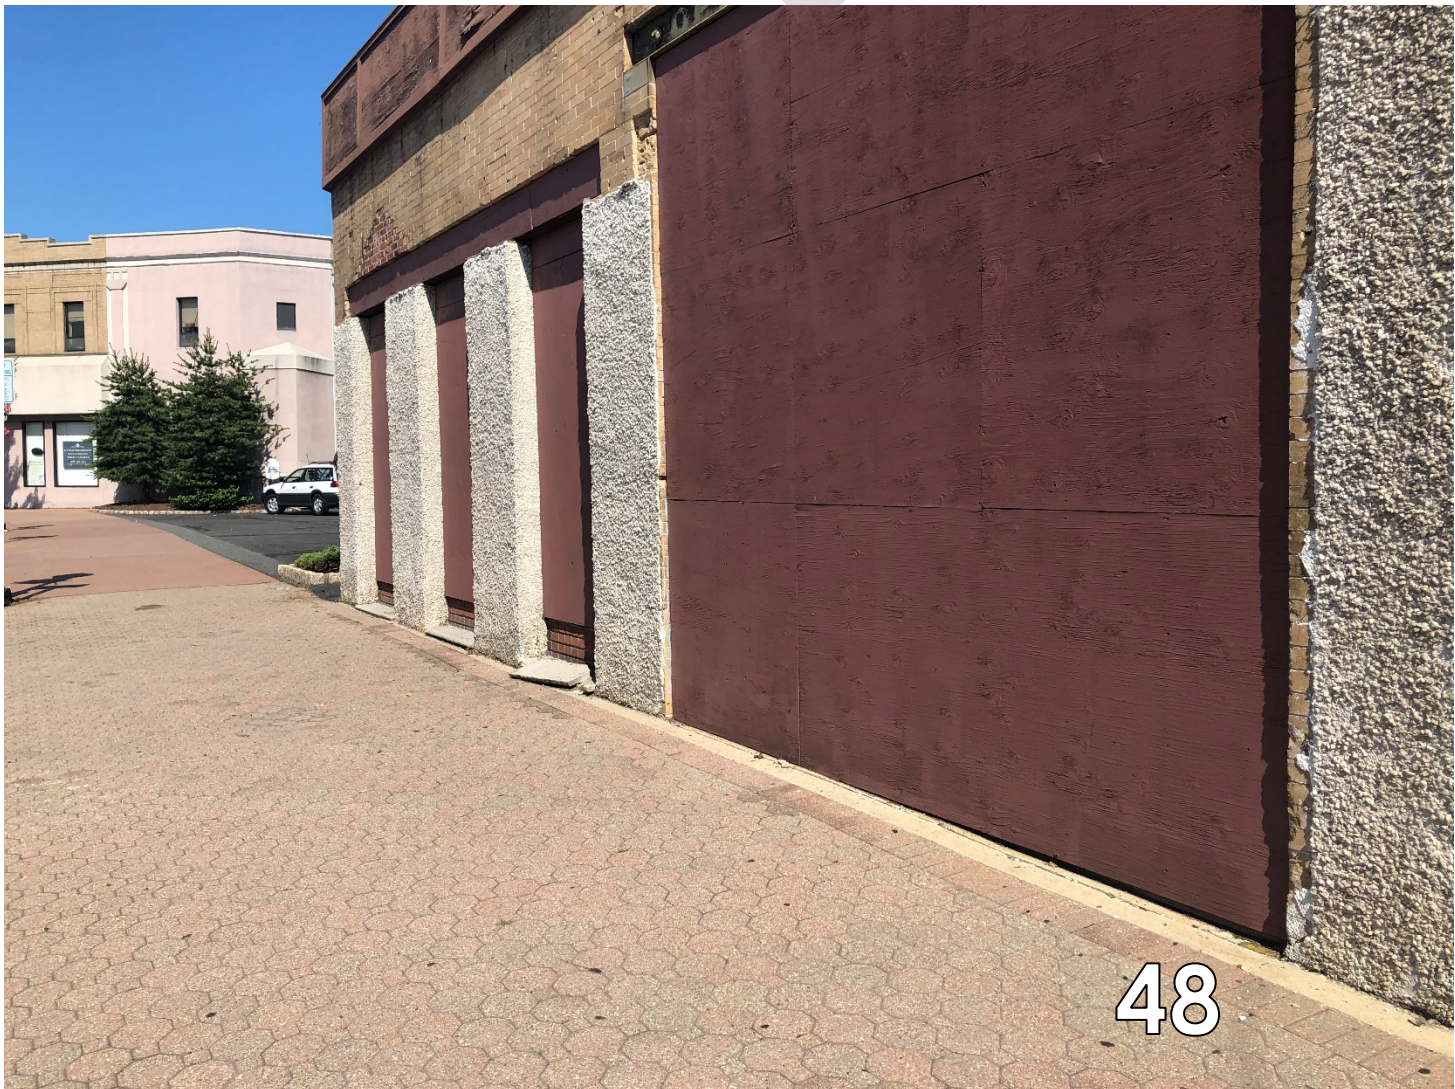
- The structure has exhibited a significant vacancy rate lasting in excess of seven (7) years. During this time, the building has continued to deteriorate, ranging from cosmetic damage, such as peeling paint and façade treatments, to more serious structural issues, including missing and cracked bricks (**Photo 48**).
