Condemnation Area in Need of Redevelopment Investigation

CRANFORD
—New Jersey—

Block 193, Lots 6.01, 10, 11, 12, 13, and 14

Date Prepared: July 2020

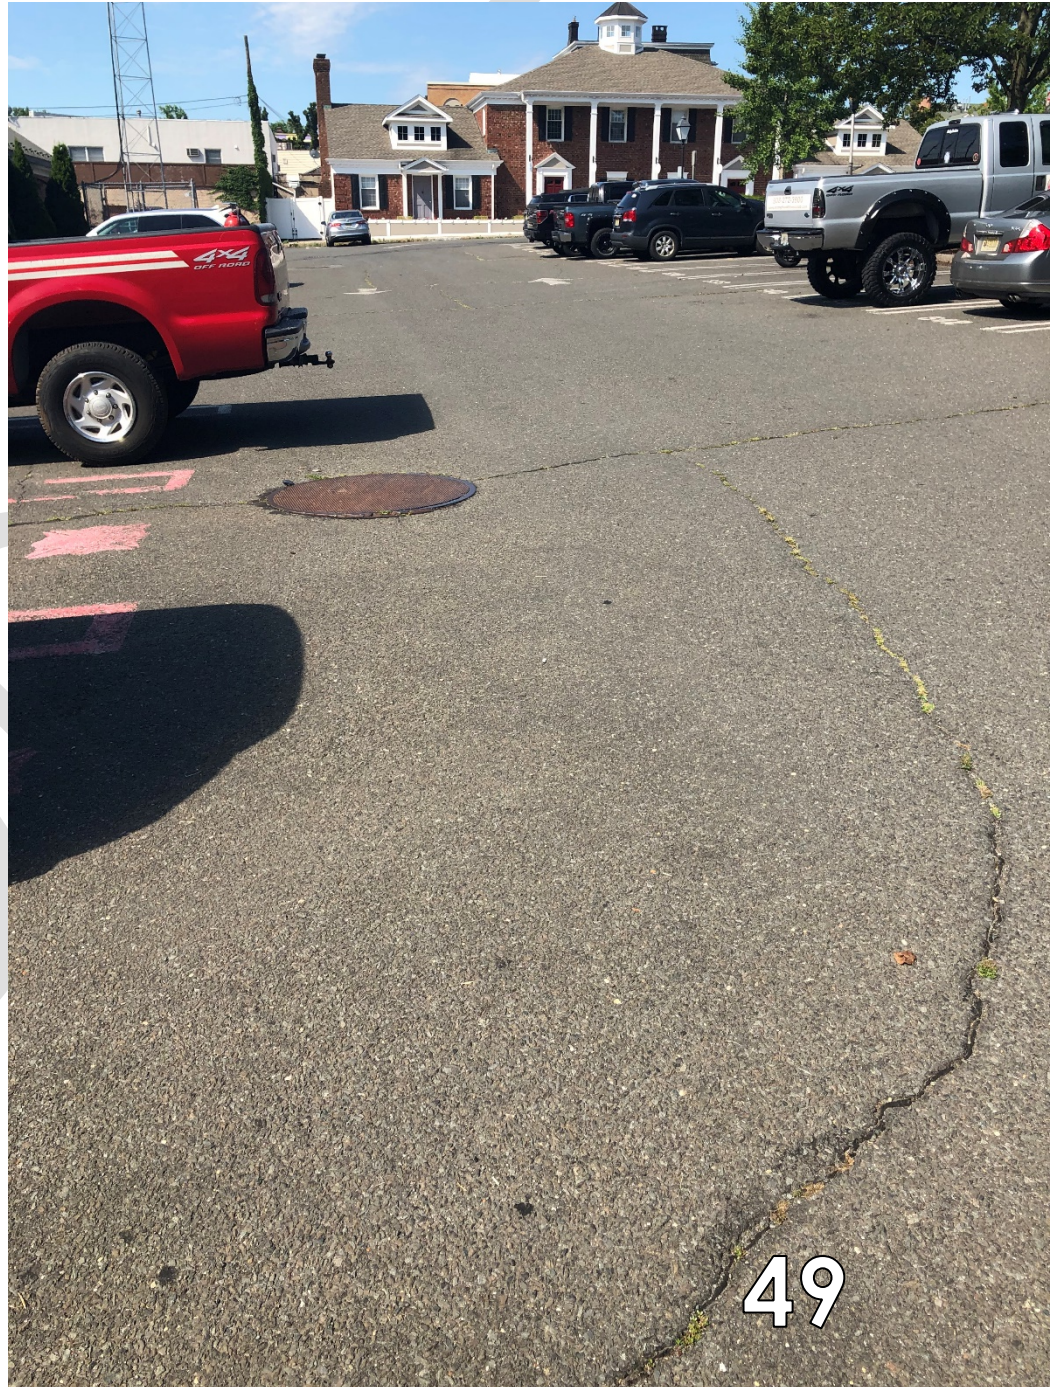
- This site is owned by Cranford Township, and while a portion of the site is utilized by the Fire Department, the majority of the property serves as a surface parking lot for the downtown (**Photo 49**). The presence of an active known contaminated site limits the development potential of the lot.

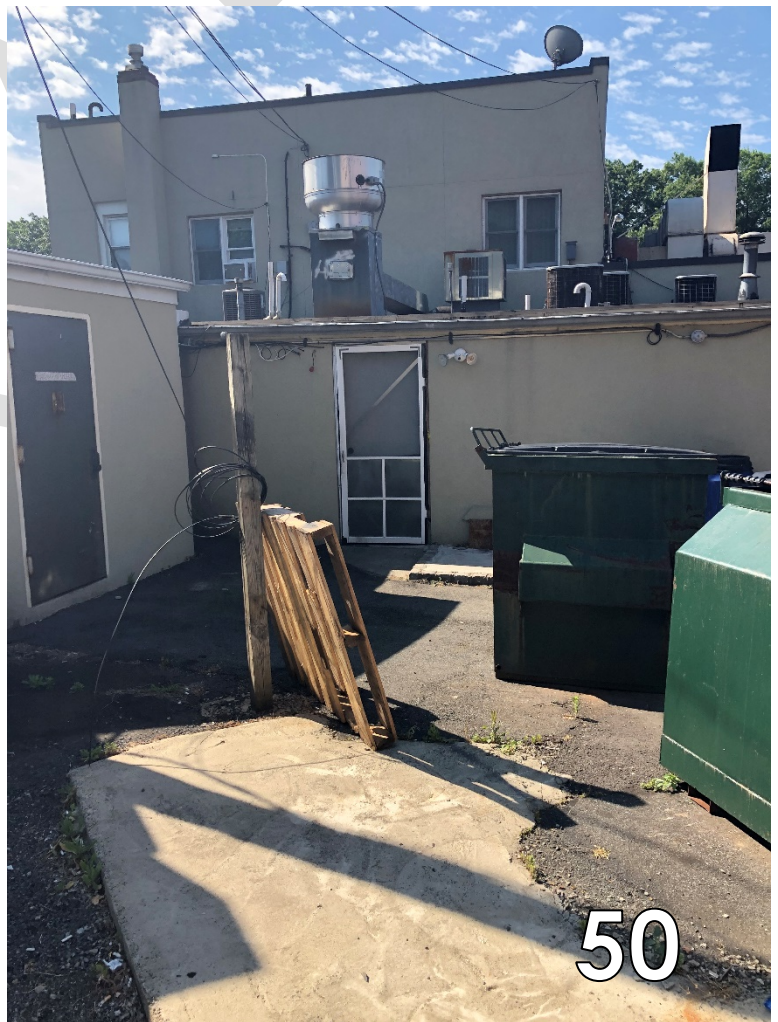
- Lot 13 contains numerous unenclosed dumpsters, whose haphazard and disorganized arrangement creates underutilized space in the downtown that inhibits efficient parking and loading (**Photo 50, also Photos 32 and 33**)
