# 750 Walnut Avenue Preliminary Investigation

Topology

Cranford Planning Board

**September 2, 2020**

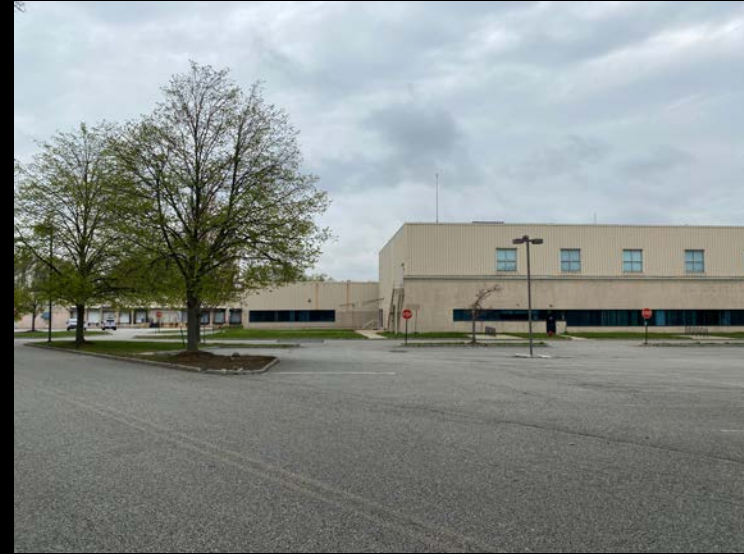
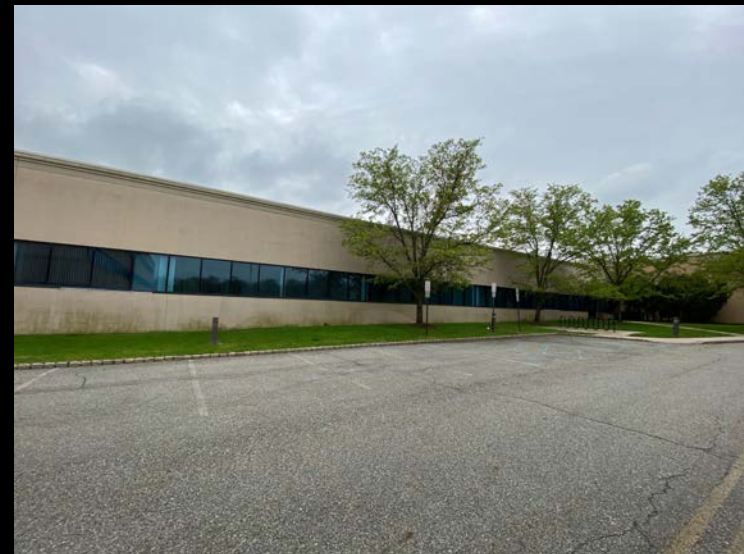
# Obsolescence

The existing 100% vacancy plus the following characteristics exhibiting its obsolescence suggest that the building does not meet market demand:

- Due to size, accessibility and location, this site is not appropriate for **Class A**.
- For **Class B** tenants, the site is lacking many of the basic amenities and aesthetics that this market would be interested in.
- This leaves **Class C** tenants, who are usually seeking smaller spaces as start-ups, making leasing risky for a building of this size.
- In general, the lack of light is not conducive to a wholesome work environment or in-line with modern demand, according to HMC Architects.

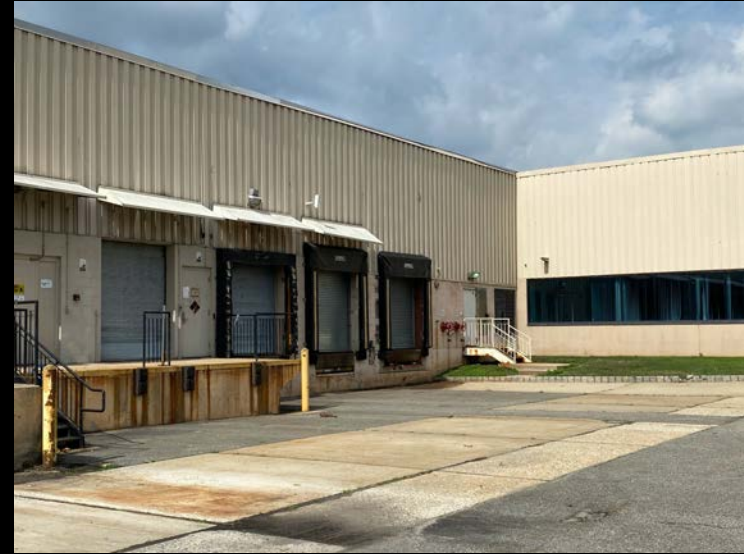
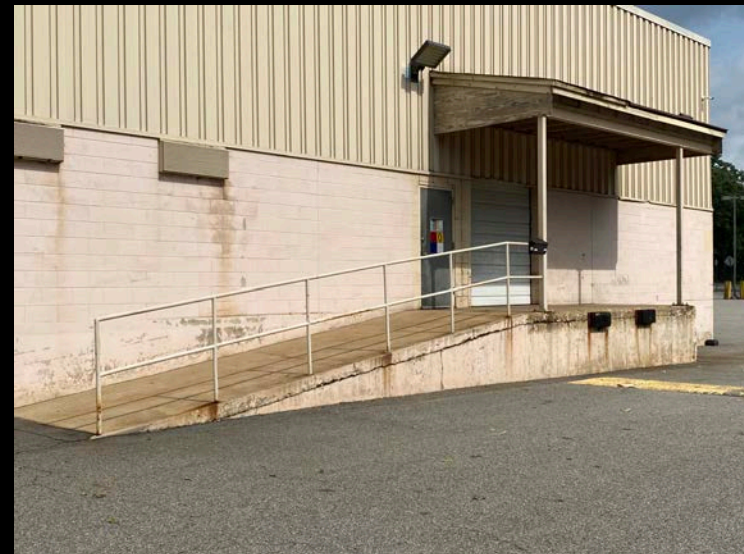
# Obsolescence

**The existing building, in its current configuration, does not meet standards of modern industrial uses, due to:**

- The segmented and complicated floorplan which would create a large degree of unusable space for warehouse users.
- The placement of scattered loading docks around the building which does not allow for cross-docking.
- The building's ceiling height of 18-20 feet that does not meet the modern minimum standard of 40 feet (source: F. Curtis Barry & Company).
- The existing loading bays are at grade or about 30" above grade. The modern standard is about 55" above grade (source: National Institute of Building Sciences).

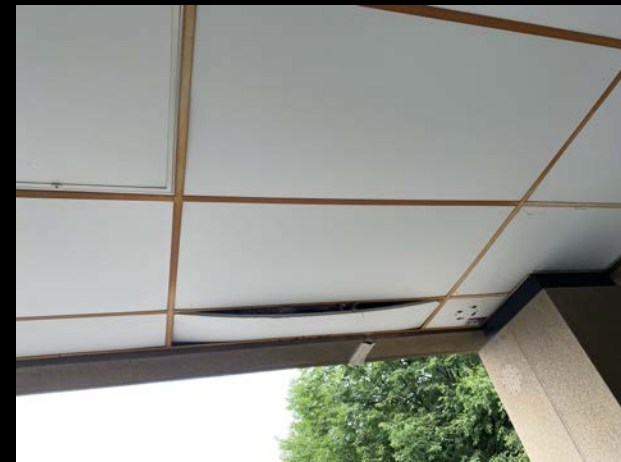
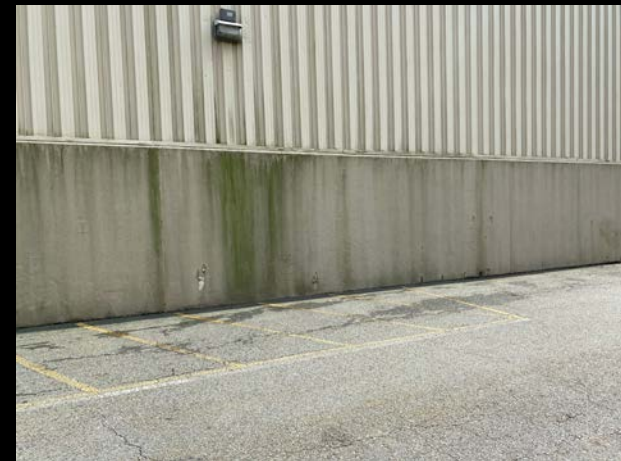
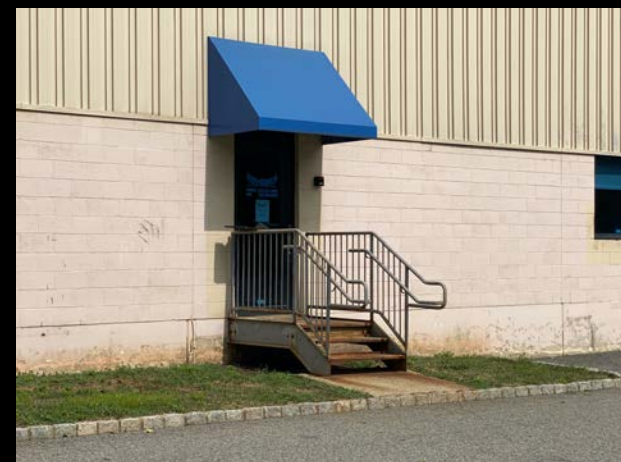
# Substandard

The existing structure shows significant signs of deterioration resulting in a substandard building:

- Water damage in the ceiling of the indoor parking area.
- Cracking/crumbling facades, foundational damage, and damaged/leaking roofs.
- Evidence of water penetration and damage throughout.
- Broken railings and unsafe vehicular and pedestrian access points.

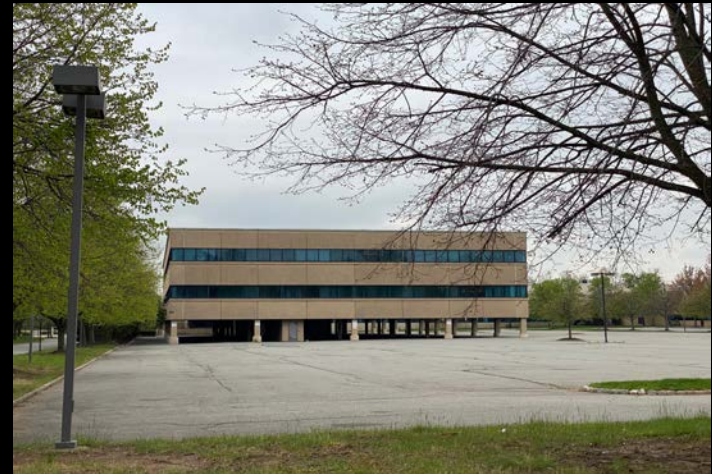
*June 2020: Vacant*

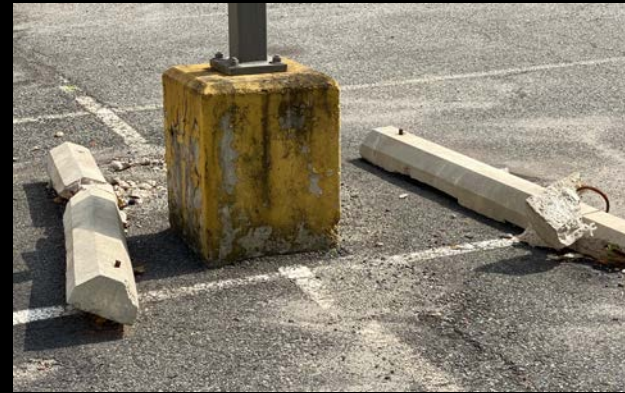
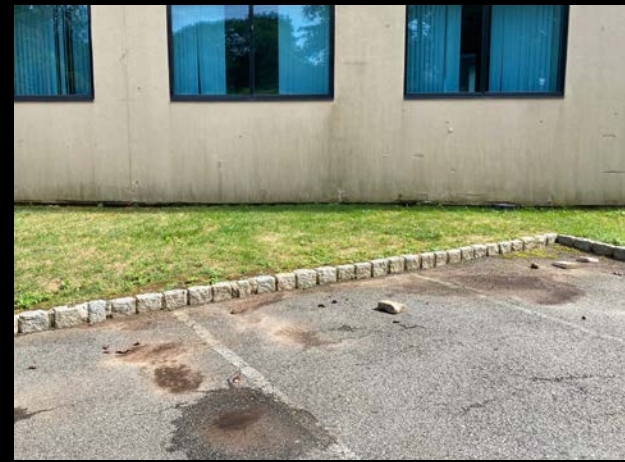
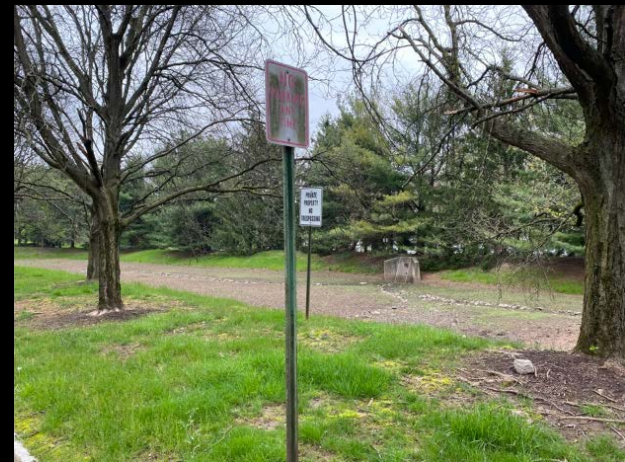
# Dilapidation

- General deterioration and deferred maintenance as evidenced by potholes, missing and damaged speed control devices, improperly maintained stormwater infrastructure, broken pedestrian and vehicular safety lighting, damaged security fencing, faded or non-existent circulation striping, damaged or dead landscaping, overgrowth of weeds, and accumulations of litter.
- This lack of maintenance creates conditions detrimental to the safety, health, morals, or welfare of the community.

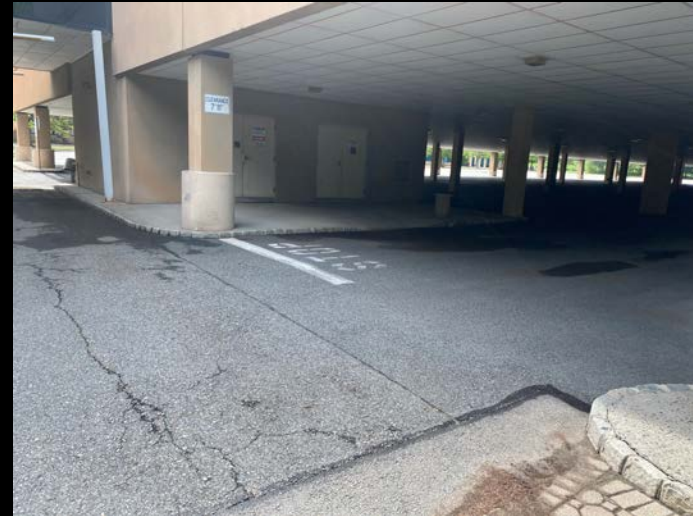
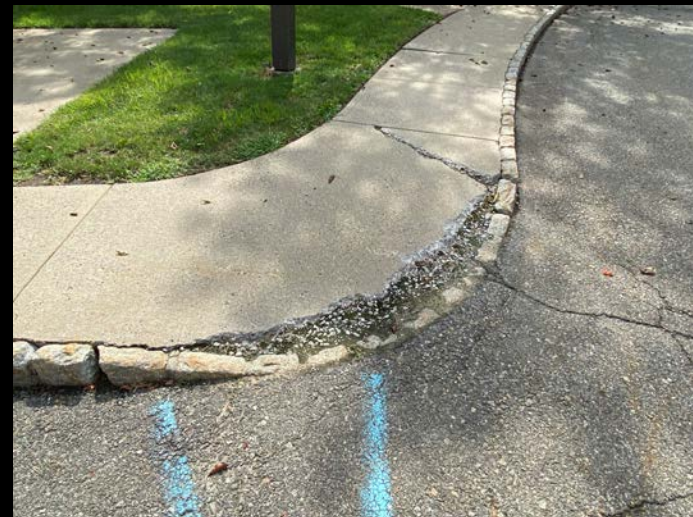
# Obsolete Layout + Faulty Arrangement

The lack of pedestrian amenities and circulation creates an uncomfortable, unsafe pedestrian environment in which visitors are forced to walk in the drive lanes.

- Insufficient number of handicap spaces that meet federal ADA standards for clear access, as they are not adjacent to the building, and marking.
- ADA spaces are spread far apart from one another and are typically connected by undersized, damaged sidewalks with Belgian block curbing at varying heights.

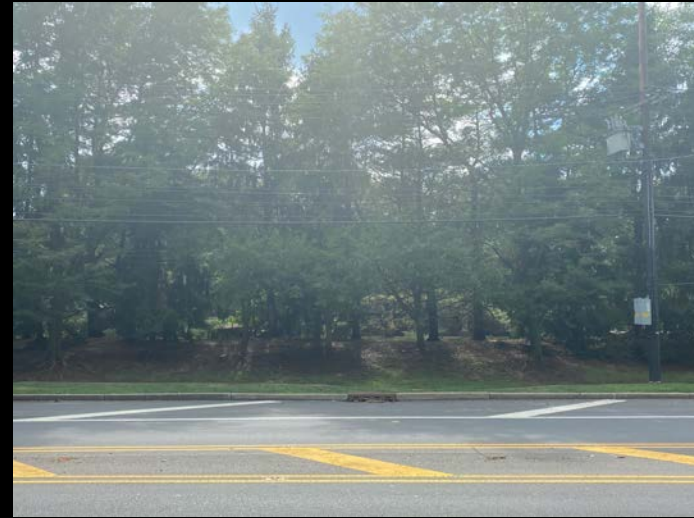
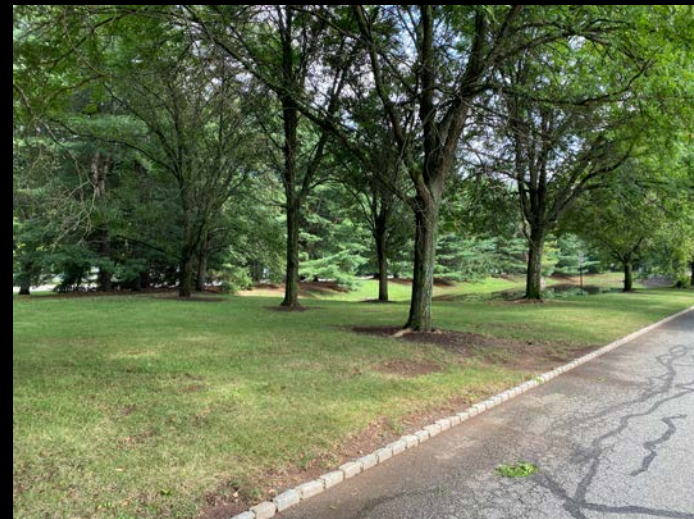
# Obsolete Layout + Faulty Arrangement

- In the last 5 years, 173 property and violent crime related police calls have been made.
- The number of incidents has begun to decrease in 2019, while the number of on-site patrols has almost doubled since 2015 resulting in an average of 35 site patrols per month.
- The increased policing is likely the result of continued vacancy and the limited visibility from Walnut Avenue. The raised berm there would not be a concern if the site was utilized with activity and users.
- This faulty arrangement requires the police to circulate the entire property, wasting valuable time and tax dollars.

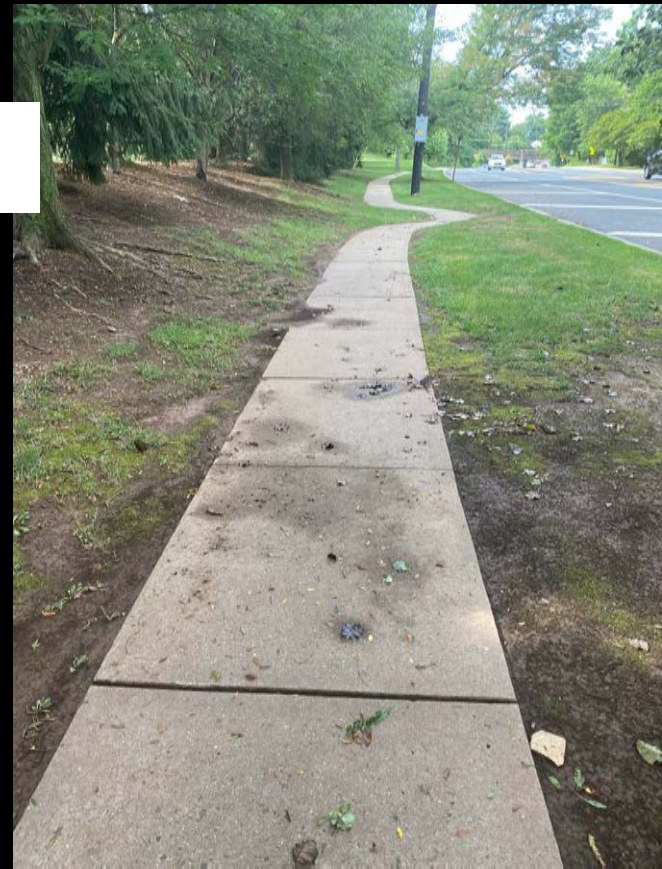
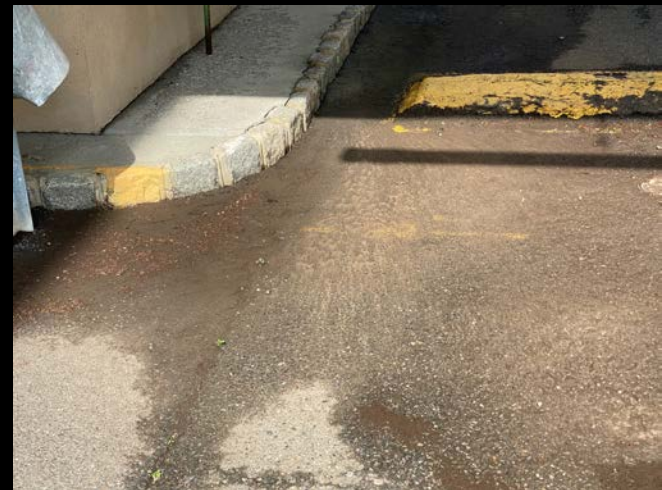
# Excessive Land Coverage

- Excessive land coverage exacerbates stormwater management issues, such as flooding, erosion, and nonpoint source pollution.
- The site is 65.5% impermeable exceeding the allowable percentage of 60%. For this site, a 5.5% excessive land coverage translates into about 66,400 square feet.
- In addition, permeable surfaces (landscaping, detention basins) appear to be compacted, making it harder for stormwater to infiltrate.
