Above the Flood: Elevating Your Floodprone House

FEMA 347/ May 2000

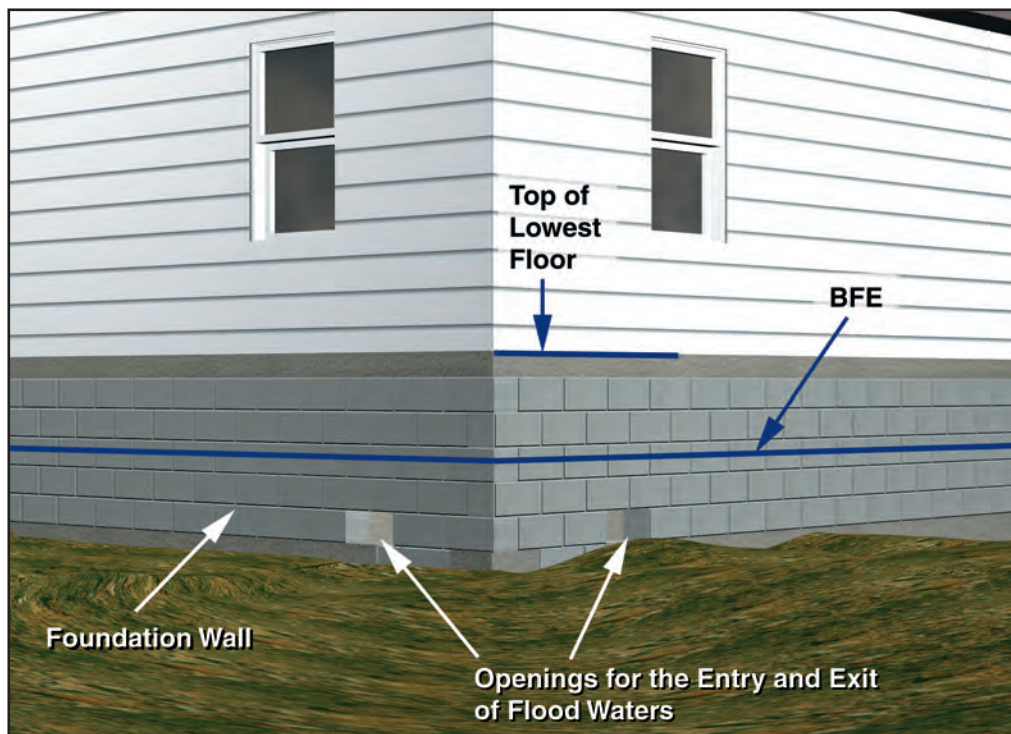
**Figure 6**

In a new, substantially improved, or substantially damaged building in an A zone, the elevation of the lowest floor must be at or above the BFE.

In A zones, where flood hazards are less severe, buildings may be elevated either on an open foundation or on continuous foundation walls below the BFE (Figure 6). Regardless of the type of foundation used, A-zone buildings must be elevated so that the **lowest floor** is at or above the BFE, as shown in Figure 6. If continuous walls are used below the BFE, they must be equipped with openings that allow flood waters to flow into and out of the area enclosed by the walls (Figure 6). Allowing the entry and exit of flood waters ensures that water pressures will be the same on both sides of the walls and reduces the likelihood that water pressure will cause the walls to fail.

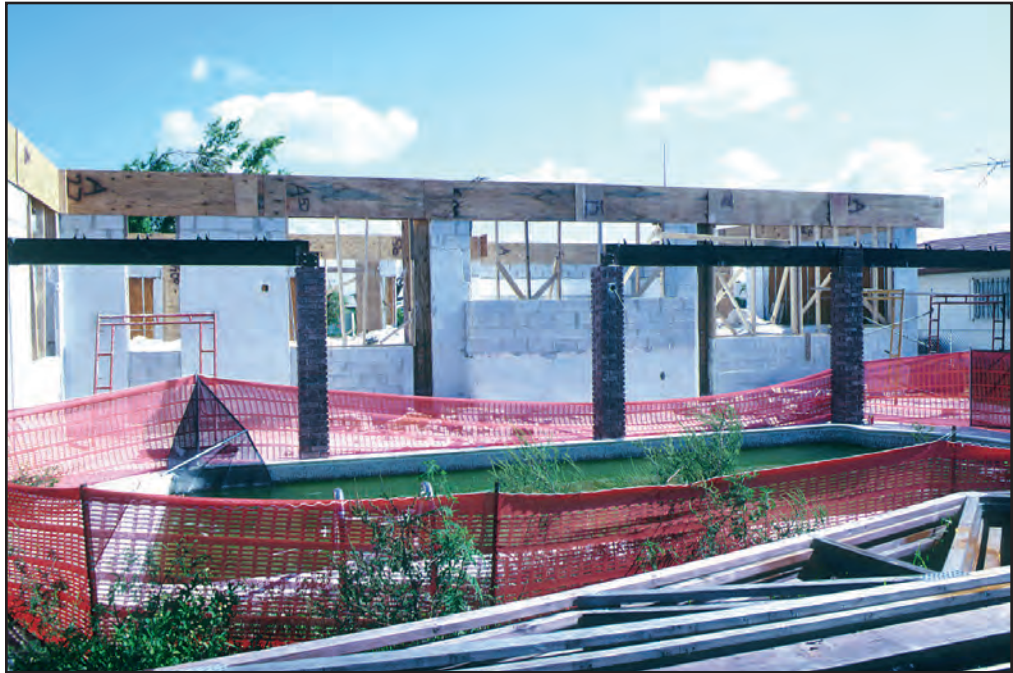
Figure 23
View from the back of the house. The walls have been extended upward with concrete blocks. The plywood visible at the tops of the walls is used to form cast-in-place concrete bond beams that will strengthen the extended walls. The roof trusses shown in the foreground were salvaged for reinstallation. The owner of this house decided to replace the original roof sheathing and shingles with new materials.

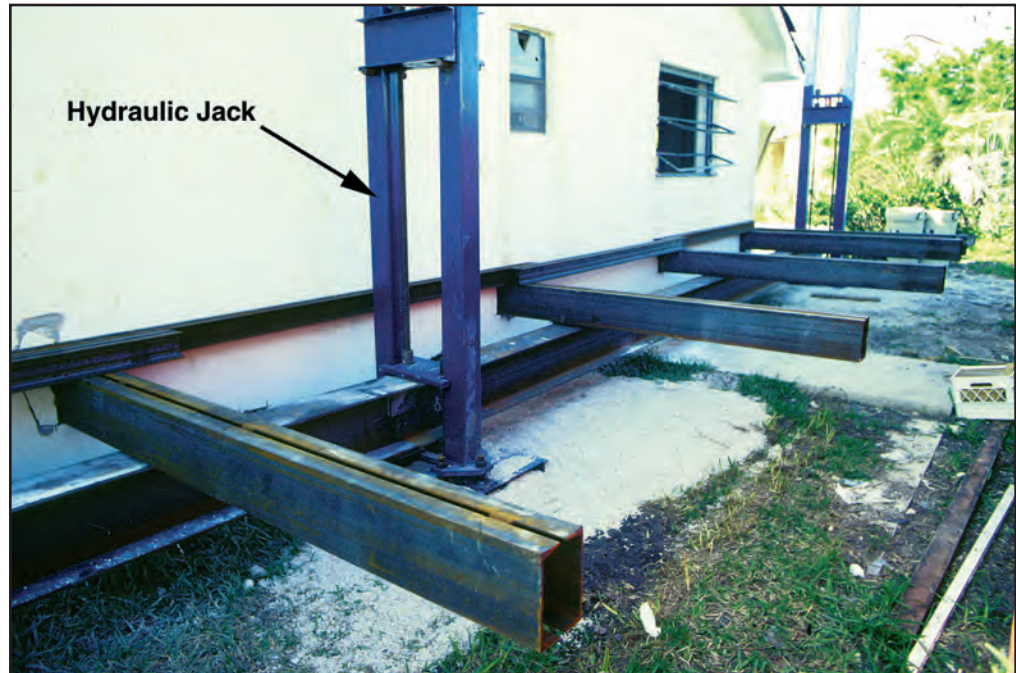
Figure 74

In this variation of Technique 3, steel beams are inserted through the walls of the house rather than under the slab. The beams span the length and width of the house and cross one another inside to create a grid. Outside the house, the beams rest on larger beams that will be raised with hydraulic jacks.
